CHILDCARE CENTRE – 34-36 ST MICHAEL TERRACE, MOUNT PLEASANT NEW DEVELOPMENT

Road Safety Audit Stage 2 - Preliminary Design

Audit Ref: 2511014-RSA-001

Report Issue Date: **17/11/2025**

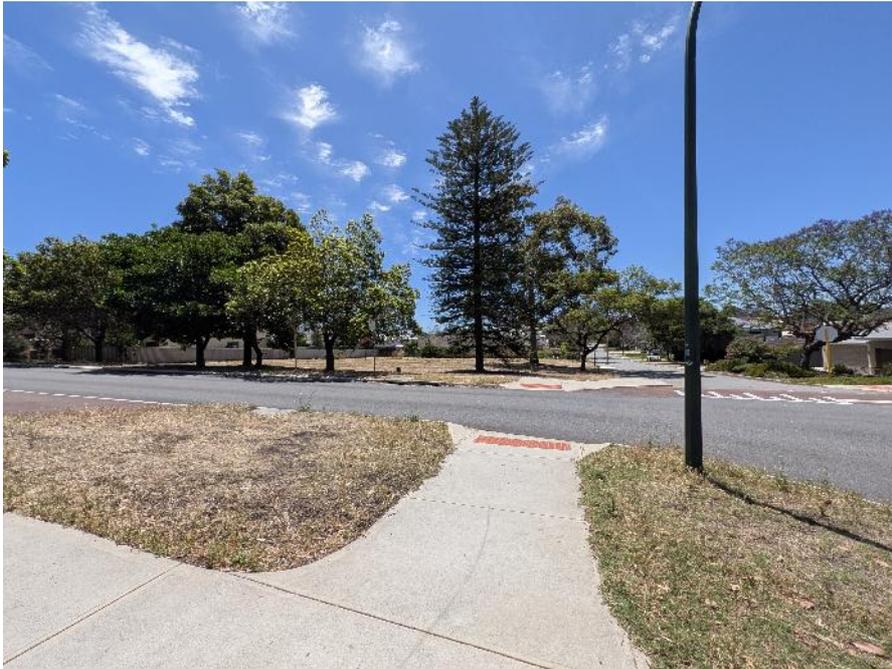
Finding 2.1

It was noted that there were non-frangible trees adjacent to St Michael Terrace and Queens Road within the clear zone.

Unprotected hazards located in the clear zone are likely to pose a risk to vehicle occupants in the event that an errant vehicle leaves the road, this would result in serious injury to the occupants of errant vehicles.

In accordance with the *MRWA supplement to Austrroads Guide to Road Design Part 6 (GRD 6)* the required clear zone width for a road with the design speed of $\leq 60\text{km/h}$ varies between 3.0m to 5.0m depending on the traffic volume. The clear zone should be kept free of non-frangible objects.

[FSI CRASH RISK | LOW]

Ensure that the required clear zone is provided as per the MRWA supplement to Austrroads GRD 6, or that vehicles are protected by a suitable safety barrier.

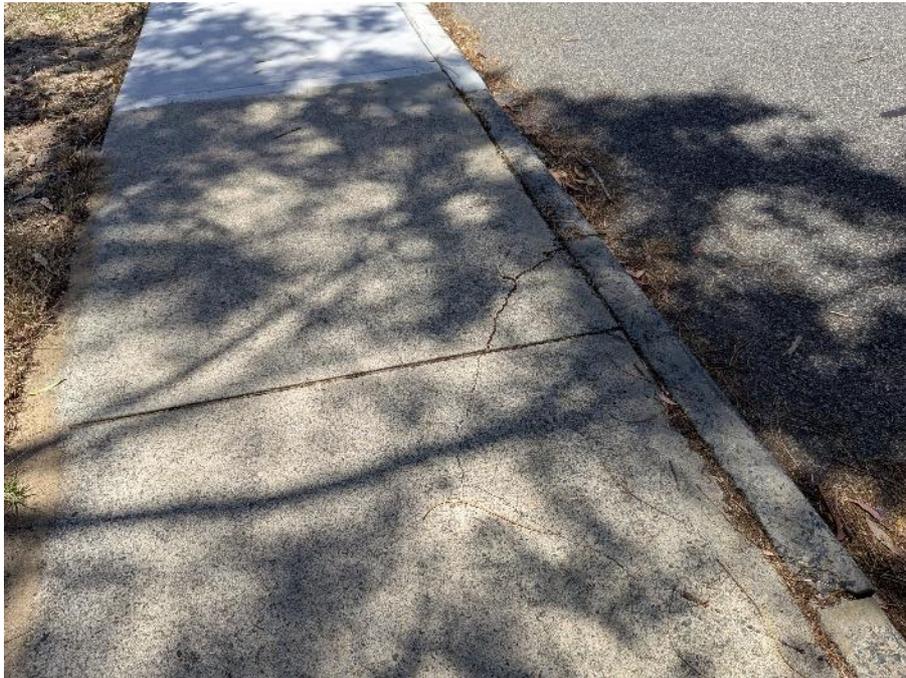
Finding 2.2

It was noted that there were some damaged sections of the path creating tripping hazards, with no further detail on the drawings if the tripping hazards will be repaired. (DA03_A)

Damaged surfaces within the footpath creates a tripping hazard for pedestrians that could increase the risk of pedestrian injury. Additionally, cyclists travelling along these paths could cause wheels to collide with the damaged pavement resulting in off-path crash.

[CRASH RISK| LOW]

Ensure existing footpaths used to be free from tripping hazards.

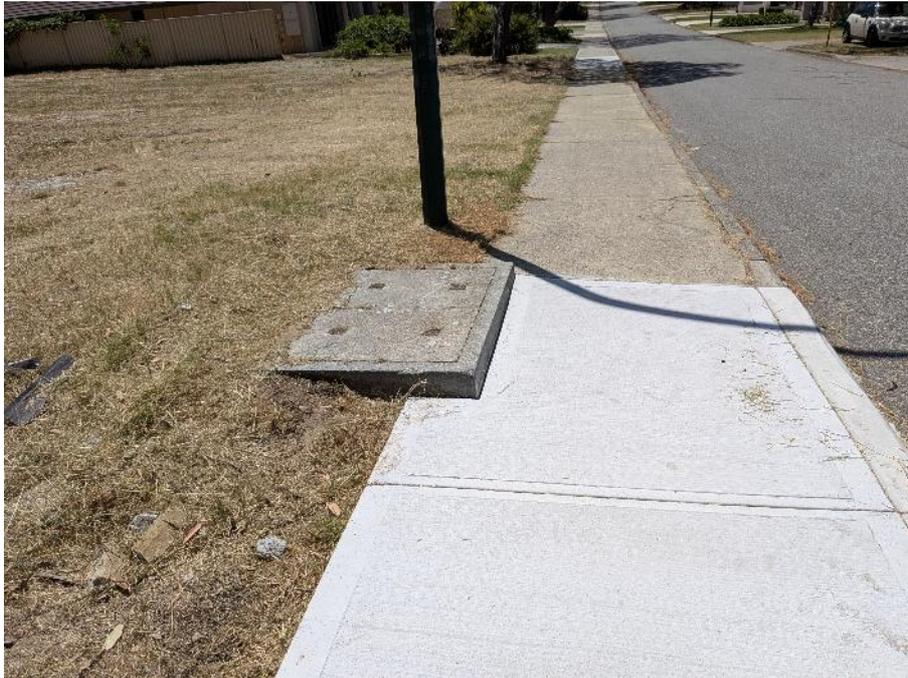
Finding 2.1 and 2.7

It was noted that there is a service cover protruding above ground and onto the footpath, with no detail on the drawings if the service cover will be relocated.

Service covers protruding above the ground and within the footpath creates a tripping hazard and is within the required clearance from the path. This would also create a hazard for cyclist causing a run-off crash resulting in serious injury.

[CRASH RISK | MODERATE]

Relocate the service cover outside of the required clearance from the edge of path.

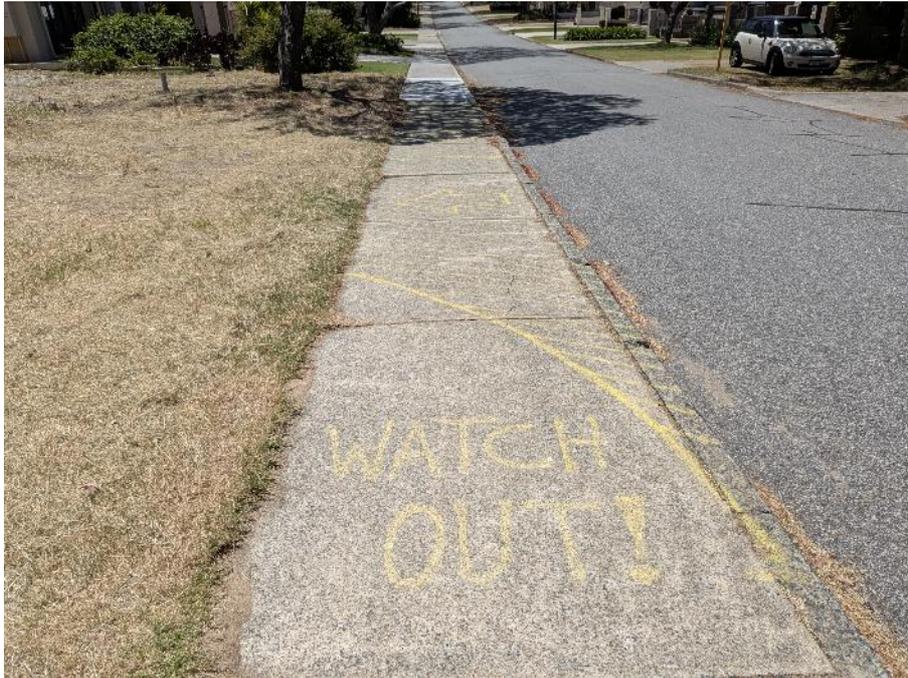
Finding 2.1 and 2.5

It was noted that there is a large tree adjacent to the proposed access that might affect line of sight for exiting vehicles.

Additionally, it was noted that the sight distance at the Queens Road intersection appears be obstructed for vehicles entering Queens Road from St Michael Terrace due to the trees and vegetation.

If the sight distance is reduced a vehicle may enter the through road into the path of an oncoming vehicle resulting in the right-angled crash with serious injury to vehicle occupants.

[FSI CRASH RISK | LOW]

Ensure that sufficient line of sight is provided at the crossover in both directions.

Additionally, sight distance to be assessed at the intersection of St Michael Terrace and Queens Road, with any sight distance obstructions to be removed accordingly.
