RE: ARBORICULTURAL REPORT AT 73 BEAMISH AVENUE, BRENTWOOD

Arboricultural Inspection Report for City of Melville

Date inspected: 4th January 2022
Location: 73 Beamish Avenue, Brentwood
Tree species: *Lophostemon confertus* (Queensland Box)

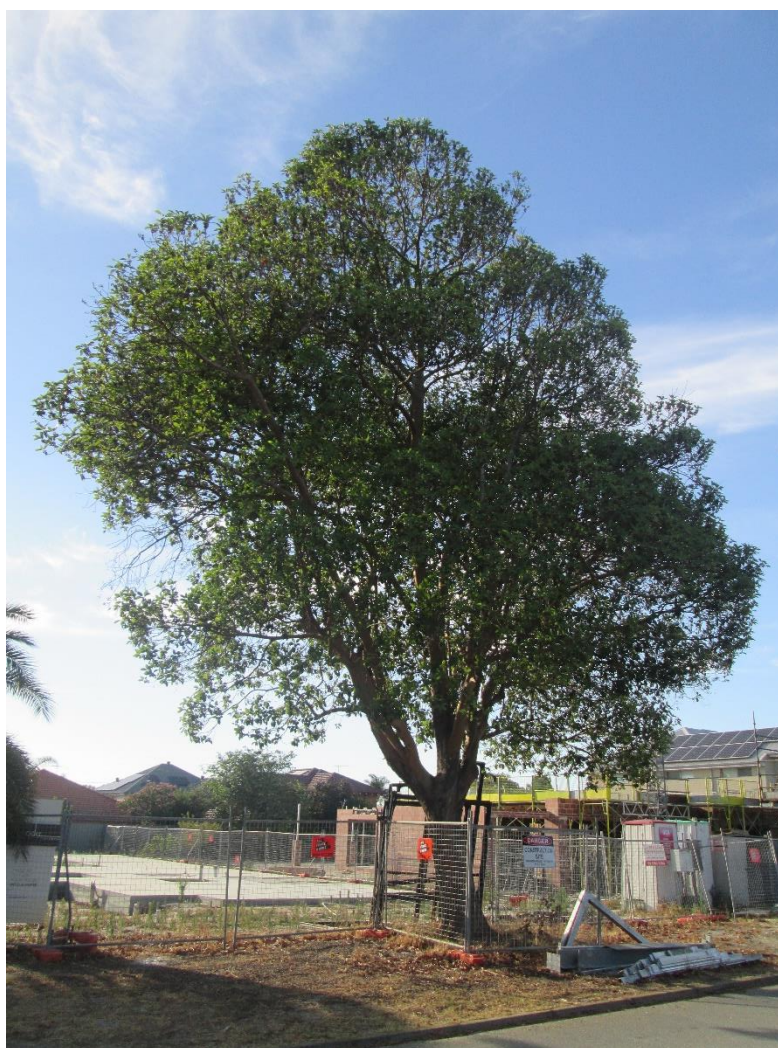
- 2.1. This early mature *Lophostemon confertus* (Queensland Box) has a clinometer height reading of 12.6m, with a canopy spread of 12.0m north/south & 8.0m east/west and an estimated * trunk diameter of 65cm measured at 1.4 metres above ground level (Figure 1).
- 2.2. The trunk of the tree is located within a turfed verge and is approximately * 3m from the adjacent roadway.

Figure 1 Displaying the *Lophostemon confertus* located within the verge adjacent no. 73 Beamish Avenue, Brentwood.

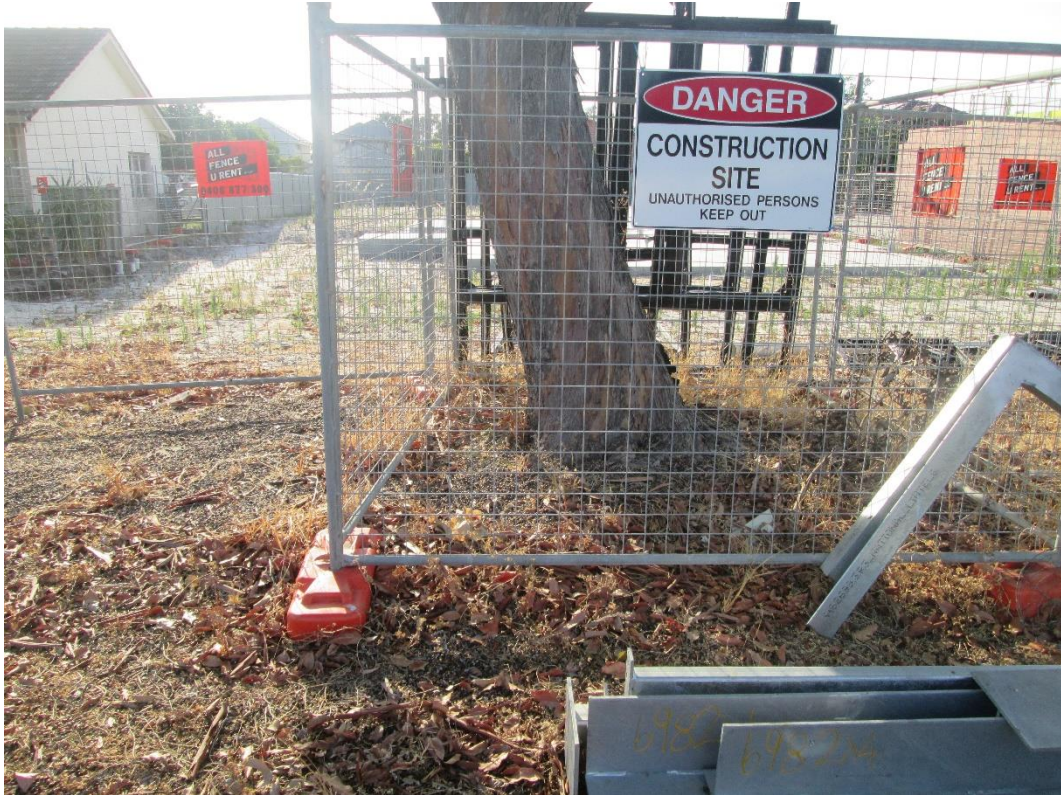
- 3.1. An examination at ground level found the tree leaning in a northerly direction; however, the root plate appears firm at this time with no evidence of significant root heave or soil displacement (Figure 2).
- 3.2. It was evident that the adjacent dwelling has been demolished and new construction works have begun, therefore it is unknown if any roots have been damaged or severed during these works (Figure 3).
- 3.3. Surface roots were not visible and there was no evidence of damage to the surrounding infrastructure.

Figure 2 Displays the base and lower trunk of the tree which is leaning in a northerly direction.

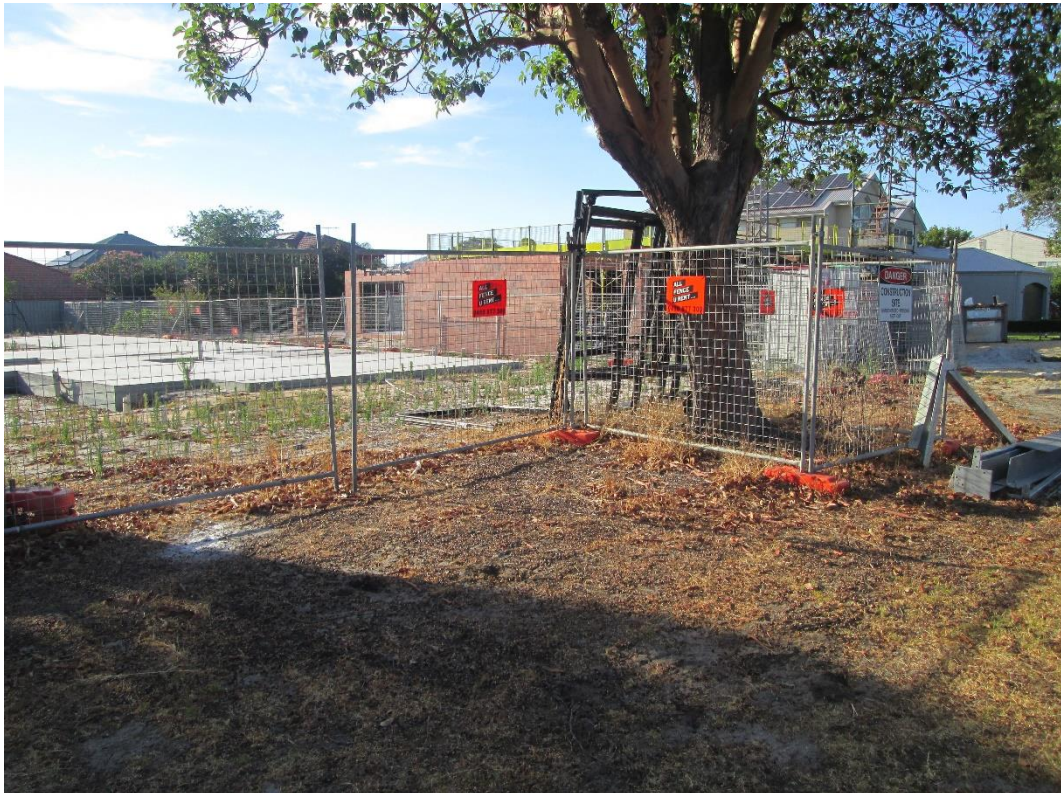
Figure 3 Displaying the tree in relation to the new construction works.

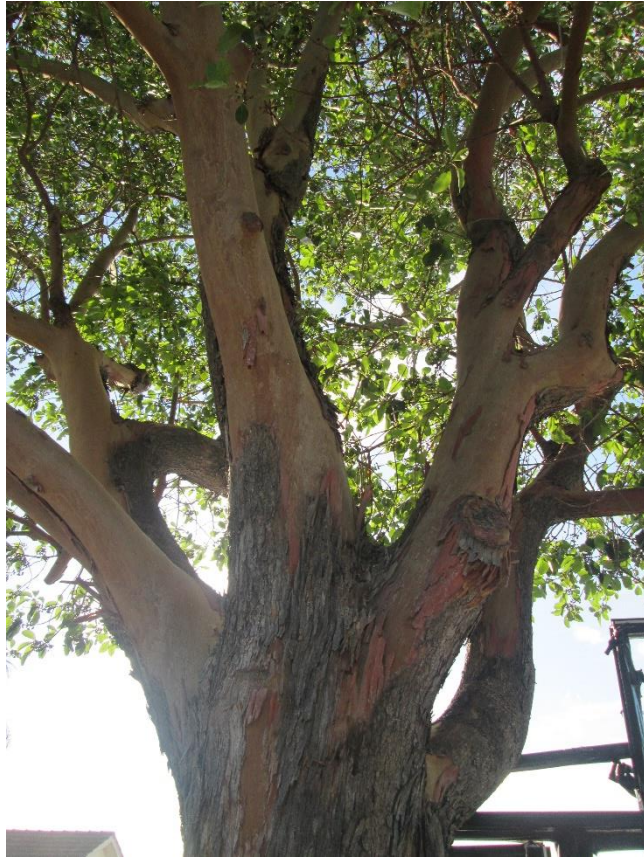
- 4.1. The trunk of this tree was found to be leaning at an angle of approximately 80 degrees in a northerly direction and extends to height of approximately 2.5m where multiple leaders develop to form into the main canopy.
- 4.2. An inspection of the trunk found it to be mechanically and structurally sound with no areas of bark loss, significant decay or cavity formation.
- 4.3. Main lateral limbs were found to be soundly attached with no evidence of cracking, splitting or separation (Figure 4).

Figure 4 Displaying the sound main branch attachments.

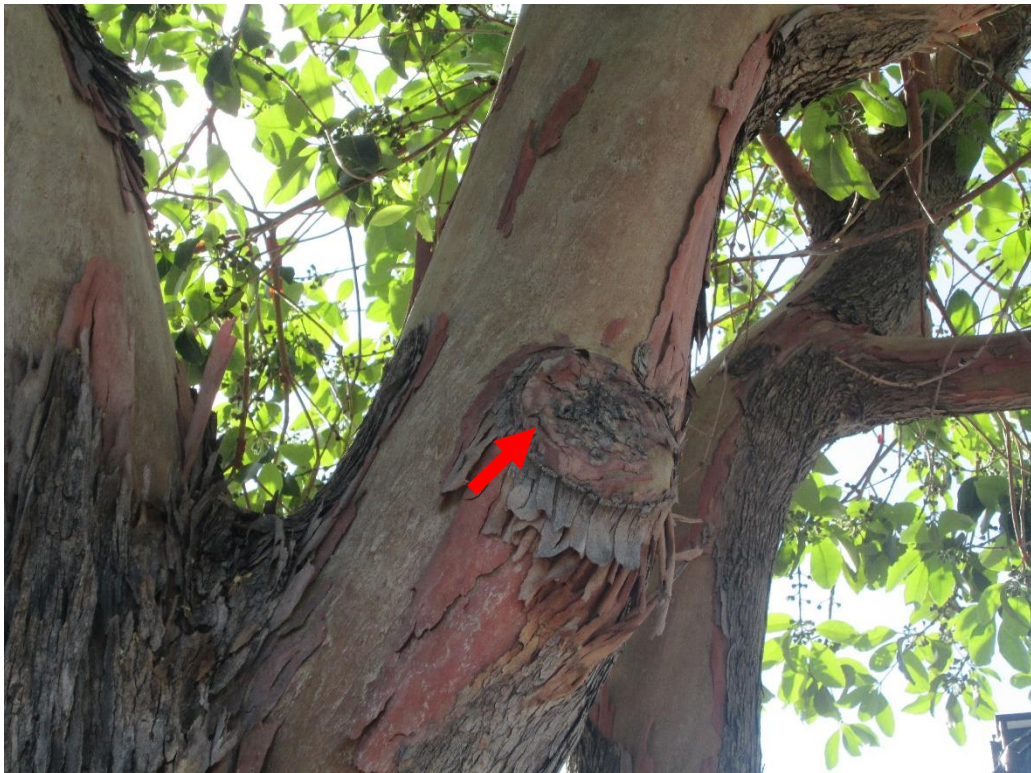
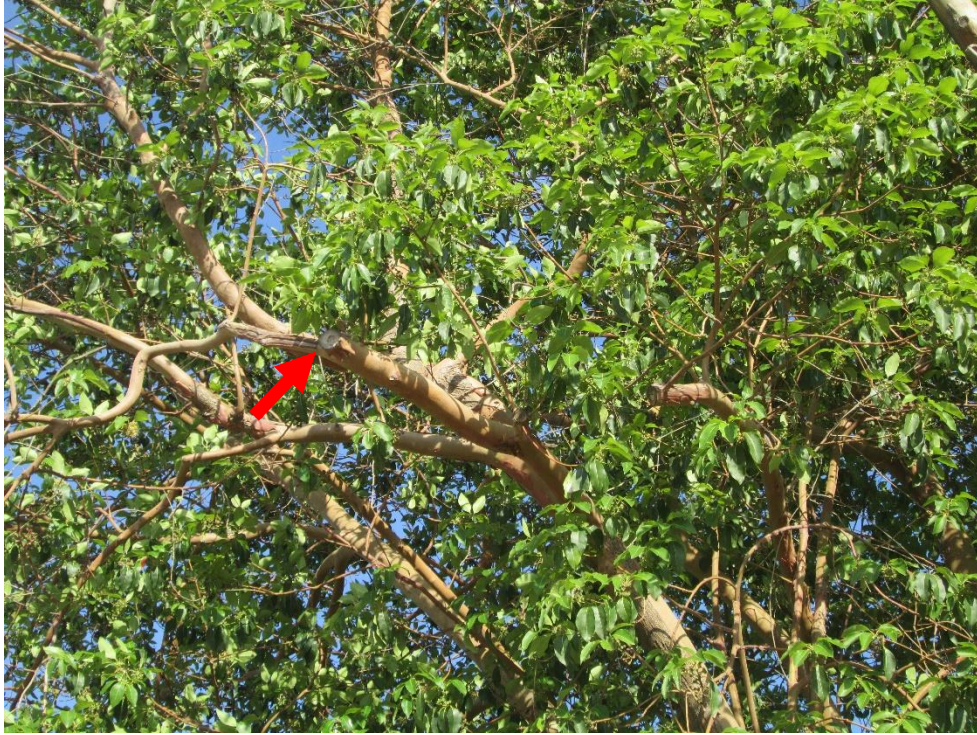
- 5.3. Previous & periodic pruning consisting of the reduction of limbs held over the adjacent property boundary and roadway were visible on the north-western and south-eastern side of the canopy (Figure 5 & 6).

Figures 5 & 6 Indicating the pruning wounds visible on the north-western and south-eastern side of the canopy.

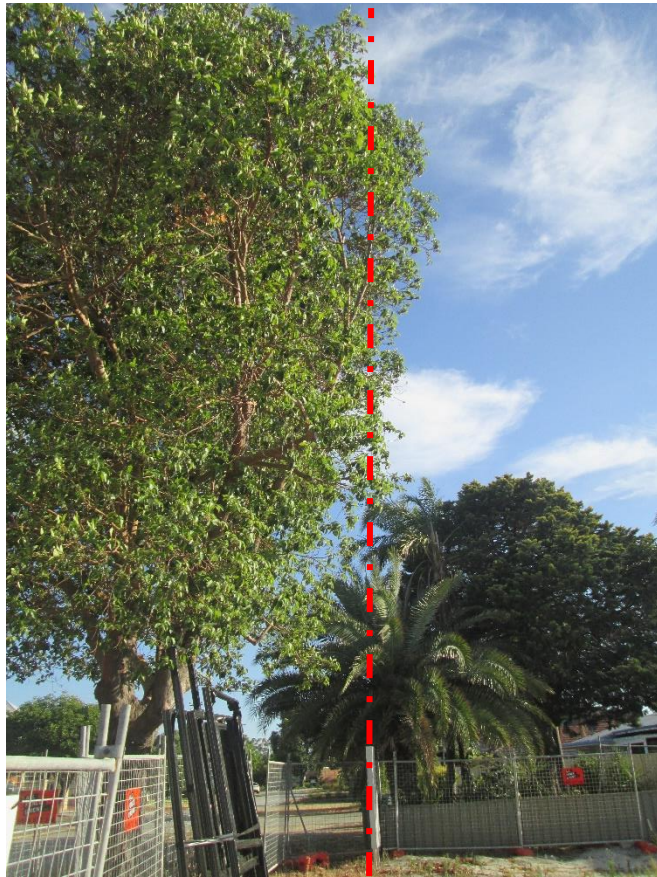
- 5.4. The canopy encroachment over the property boundary is considered minimal at this time, therefore no further pruning is warranted at this time (Figure 7).

Figure 7 Displaying the canopy encroachment over the adjacent property which is considered minimal at this time.

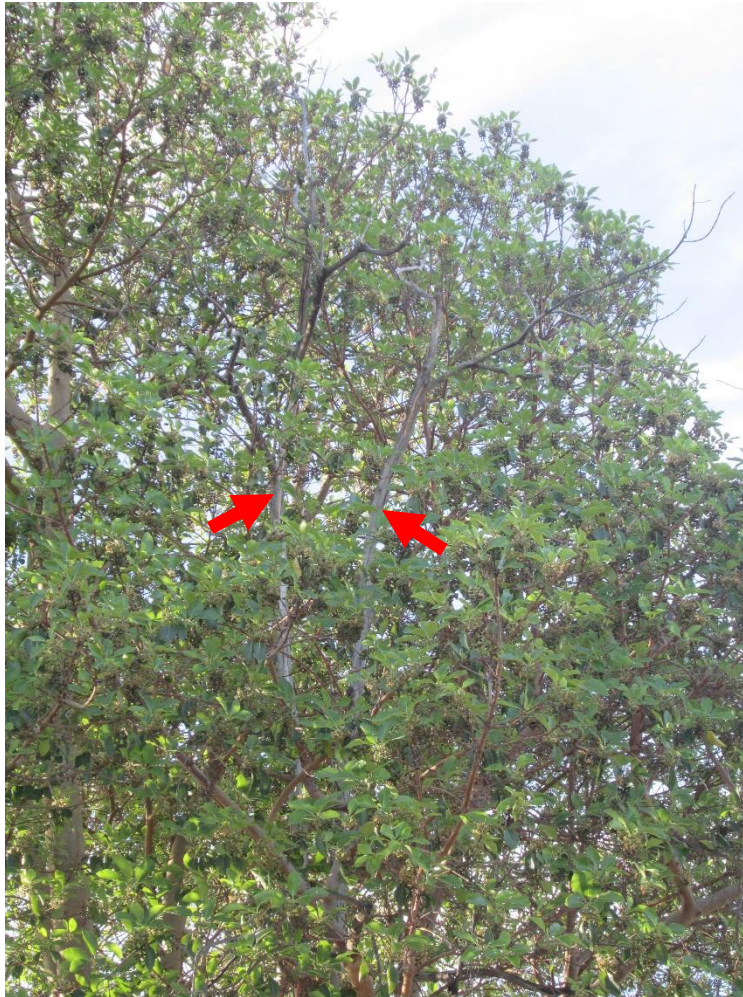
- 5.5. There was no evidence of previous significant limb failure or excessive limb loading at the time of inspection.
- 5.6. The tree holds a small amount of deadwood with an approximate diameter of 60mm on the western side of the crown which is considered a size and weight to represent a hazard to surrounding targets at this time (Figure 8).

Figure 8 Indicating the deadwood to be selectively pruned.

- 9.1. Selectively prune canopy of deadwood (Figure 8).
- 9.2. Ensure the tree is adequately watered weekly during the summer months due to building and works adjacent the tree. (Minimum of 600 litres per week)
- 9.3. Re-inspect in 12 months.
