Mt Pleasant Bowling Club

Address: 40 Barrisdale Road Ardross

Audit Date: 27 March 2020

Prepared for City of Melville

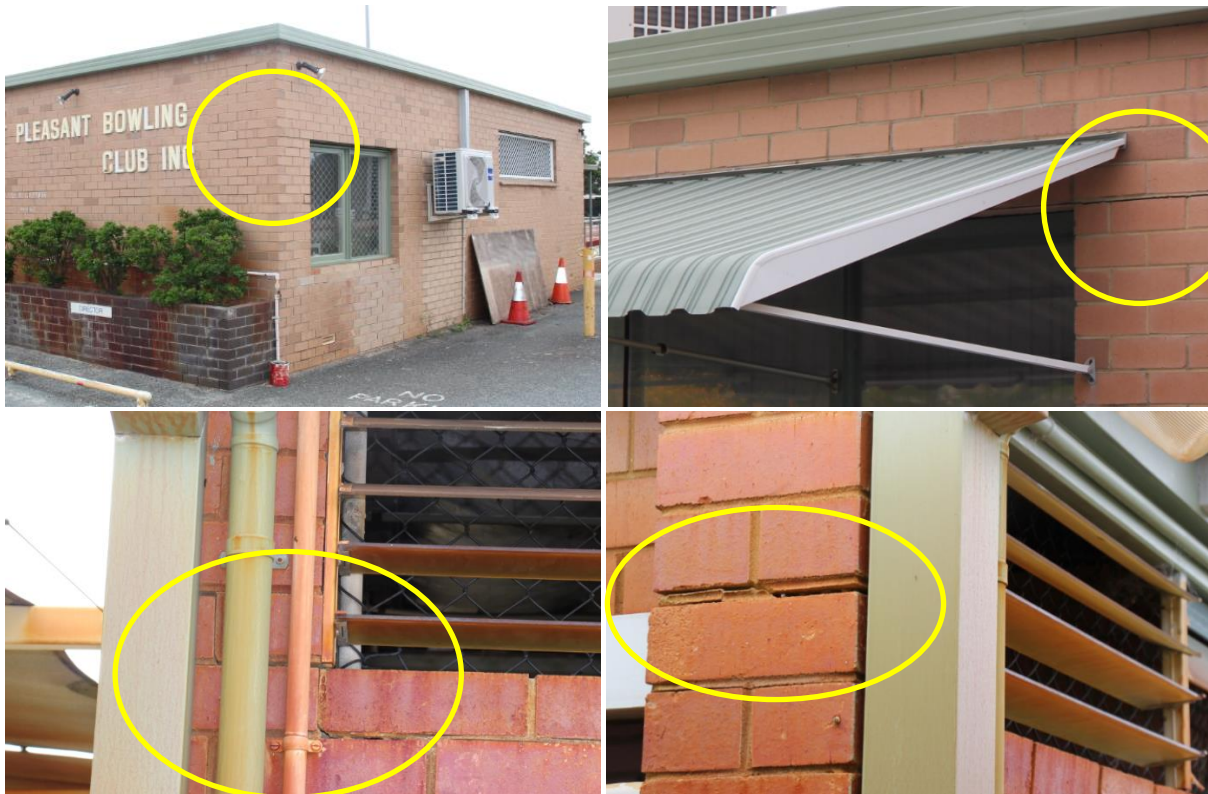
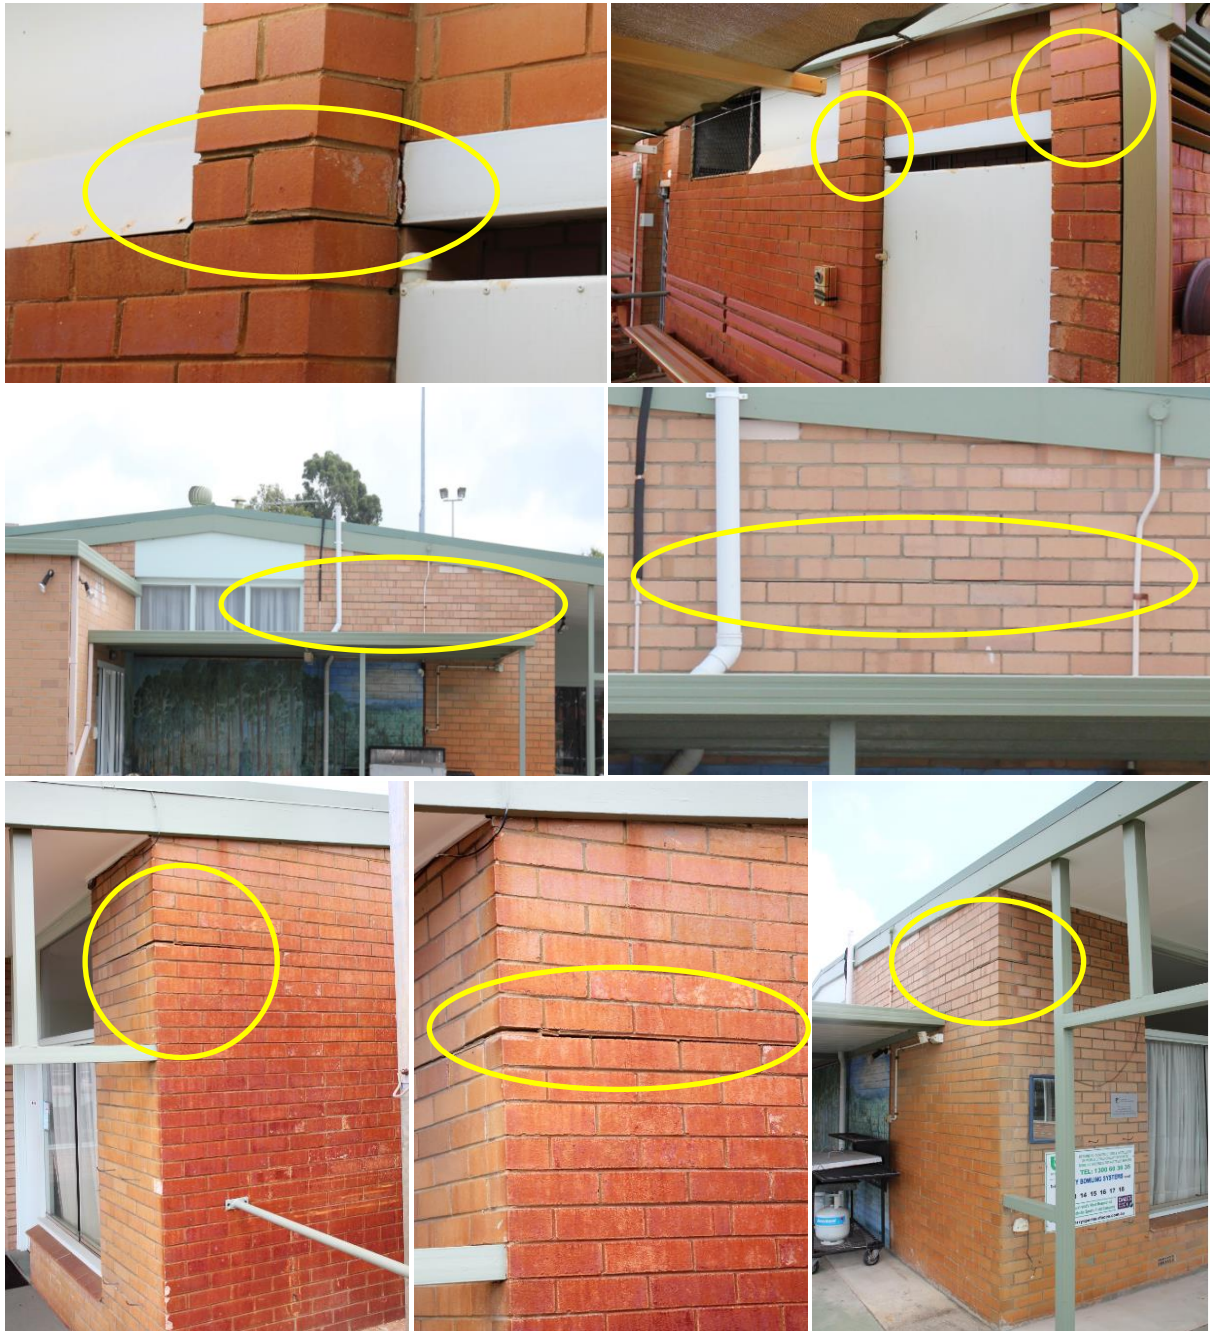
Figure 1: Photo 1, 2, 3, 4, 5, 6, 7, 8, 9, 10 & 11 – Brick walls

Footings for the building appear to be stable with no significant cracking on the lower section of the exterior walls. However, there is evidence of significant cracks to the upper section of the brickwork and the walls are generally in poor condition see Figure 1. The majority of the cracking has occurred in the mortar around the windows. Some cracks may have been caused by corrosion jacking but some cracks occur in the middle of the wall. It is not known what has caused this separation. It is recommended that the walls are inspected by a structural engineer to ensure structural adequacy. It is also recommended that the brick work is repaired.

2.1.1	Foundations and walls	Cracks occur in the middle of the wall	5	5	It is recommended that the walls are inspected by a structural engineer to ensure structural adequacy	1500	2020	The walls still appear stable however should be checked by a structural engineer

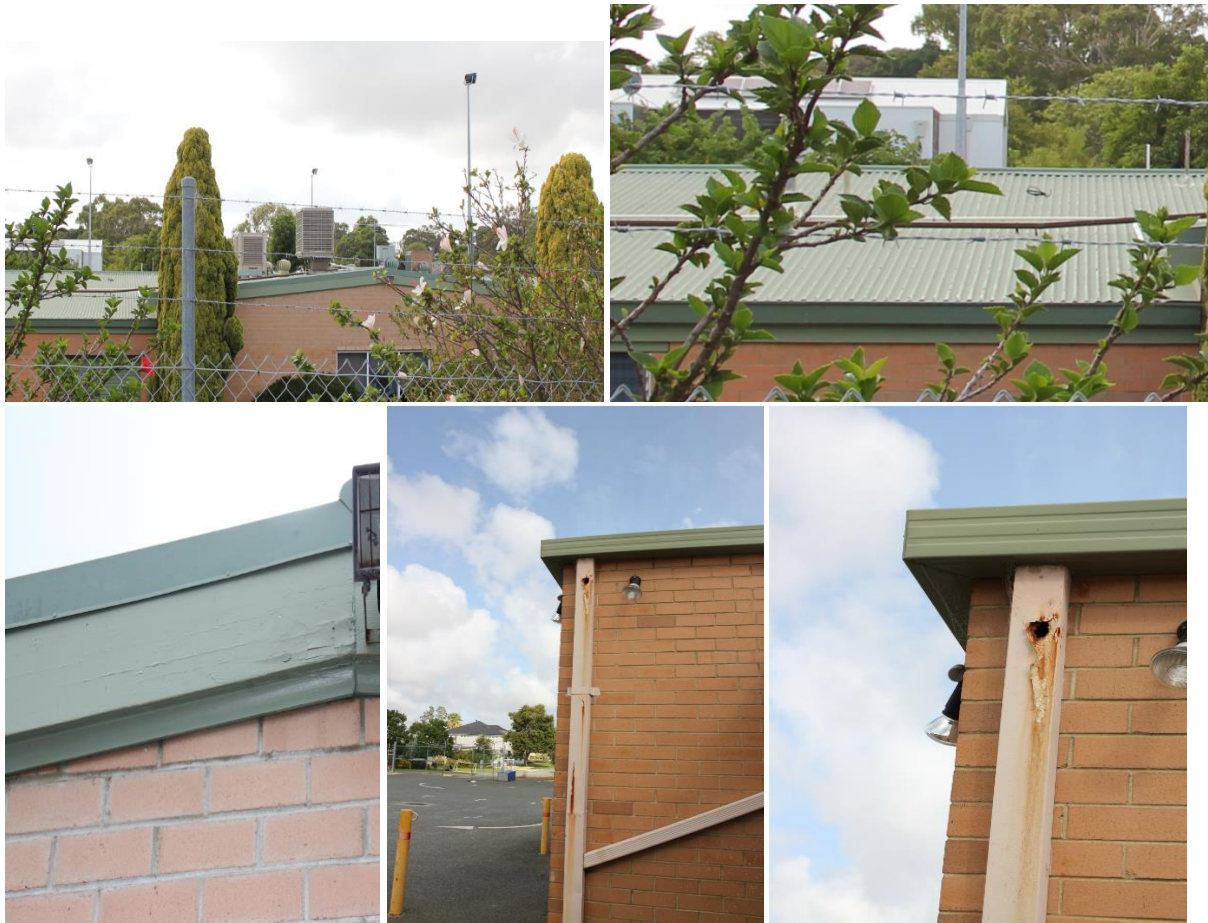
Figure 2: Photo 12, 13, 14, 15 & 16 – Roof cover

The condition of the metal roof is in good condition for its age see Figure 2. However, there are signs of water staining on some ceilings throughout the building. It is recommended that the roof is inspected and repaired if water leaks occur. The staining could have resulted from previous leaks which may have been repaired. The gutters are in good condition for their age. However, some of the downpipes are in poor condition. It is recommended that the damaged down pipes are replaced. The bargeboards are well painted and in good condition for their age. However, a small section of the timber appears to have started to decay beneath the paint. No action is recommended at this time.

2.1.2	Roof	There are signs of water staining on some ceilings throughout the building	4	5	It is recommended that the roof is inspected and repaired if water leaks occur	500	2020	The staining could have resulted from previous leaks which may have been repaired

2.1.2	Roof	Some of the downpipes are in poor condition	5	5	It is recommended that the damaged down pipes are replaced	2000	2020

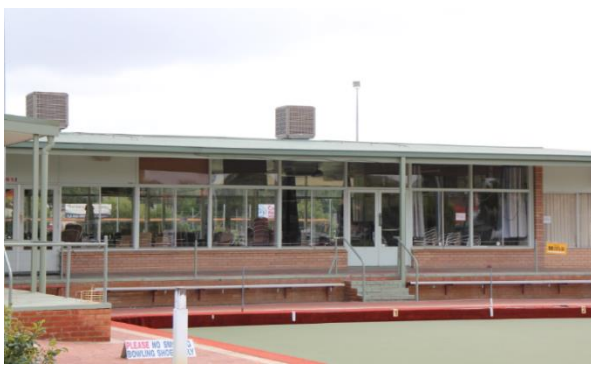
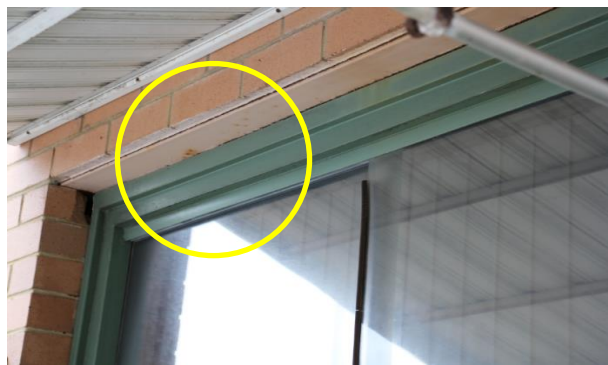
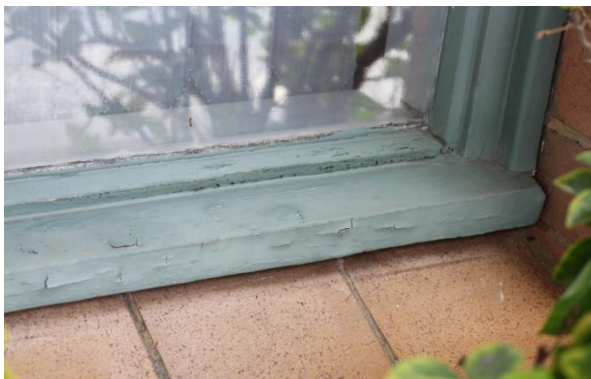
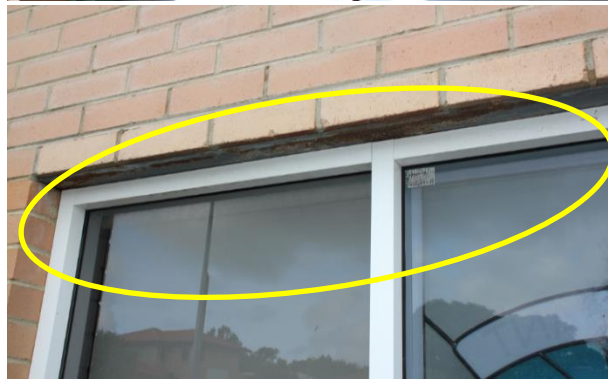
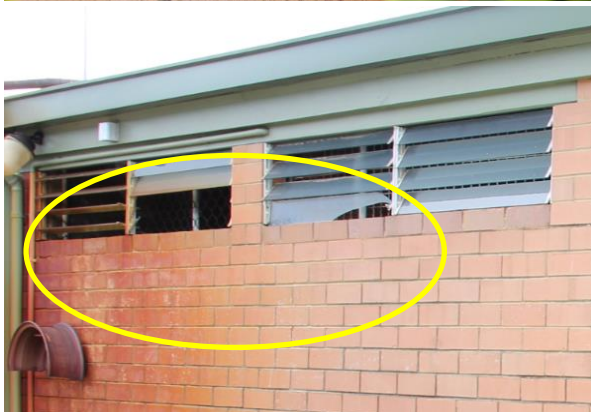
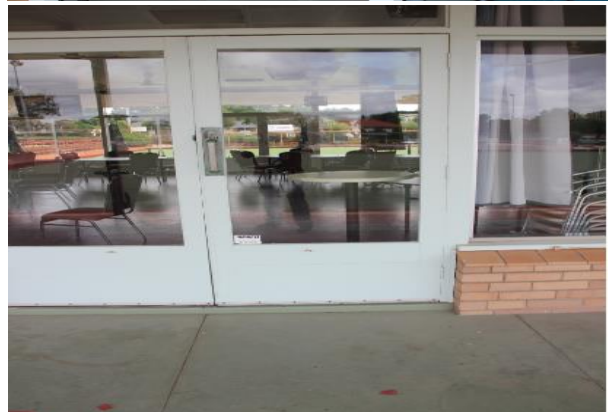
Figure 3: Photo 17, 18, 19, 20, 21, 22, 23 & 24 - Windows and doors

The doors and windows are in good condition for their age see Figure 3. However the paint is starting to flake off on some windows and the paint on the timber doors appears thin. It is recommended that the paint on the windows is removed and timber repainted. The south facing double doors are also in average condition. The bottom timber panel of the joinery has started to split. It is recommended that the doors are repaired and painted.

The steel lintels are in poor condition. The steel is rusting and in some cases causing corrosion jacking which has damaged the structural integrity of the brick walls. It is recommended that the lintels are replaced and brickwork is repaired.

The aluminium windows are in good condition. There are only a few windows with security screens fitted to the windows. There is also glass louver windows with broken glass. It is recommended that the glass is replaced. In general the windows and doors require a lot of maintenance and repairs. No further action is recommended.

2.1.3	Doors and windows	the paint is starting to flake off on some windows and the paint on the timber doors appears thin	3	4	It is recommended that the paint on the windows is removed and timber repainted	2000	2021

2.1.3	Doors and windows	The south facing double doors are in average condition. The bottom timber panel of the joinery has started to split	4	4	It is recommended that the doors are repaired and painted	500	2021

2.1.3	Doors and windows	The steel is rusting and in some cases causing corrosion jacking	4	4	It is recommended that the lintels are replaced and brickwork is repaired	4000	2022

2.1.3	Doors and windows	The glass louver windows have broken glass	5	5	It is recommended that the glass is replaced	800	2020	In general the windows and doors require a lot of maintenance and repairs

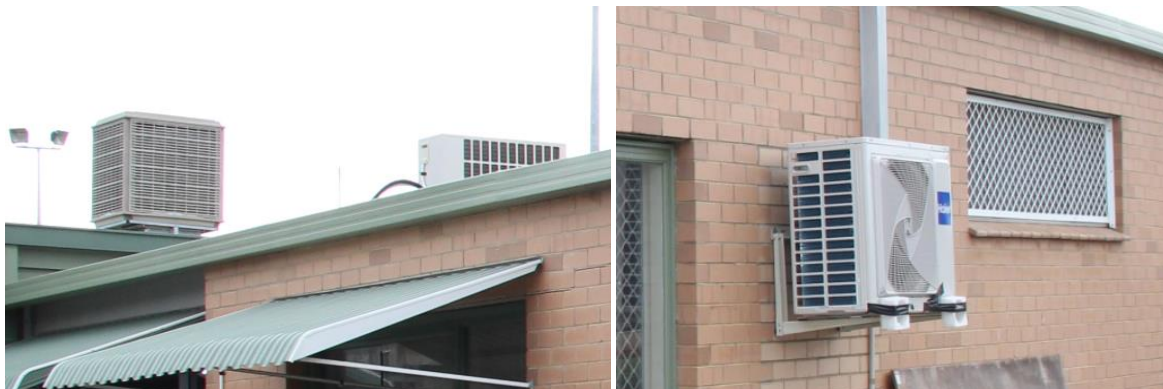
Figure 4: Photo 25 & 26 – Air conditioners

There are a number of air conditioners fitted to the roof and walls of the building see Figure 4. The air conditioners all appear to be in good working condition. The hot water systems are generally located internally and supply the bathrooms and kitchen. The building is connected to natural gas. The bathrooms are connected to the deep sewer main and appears to be in good working order.

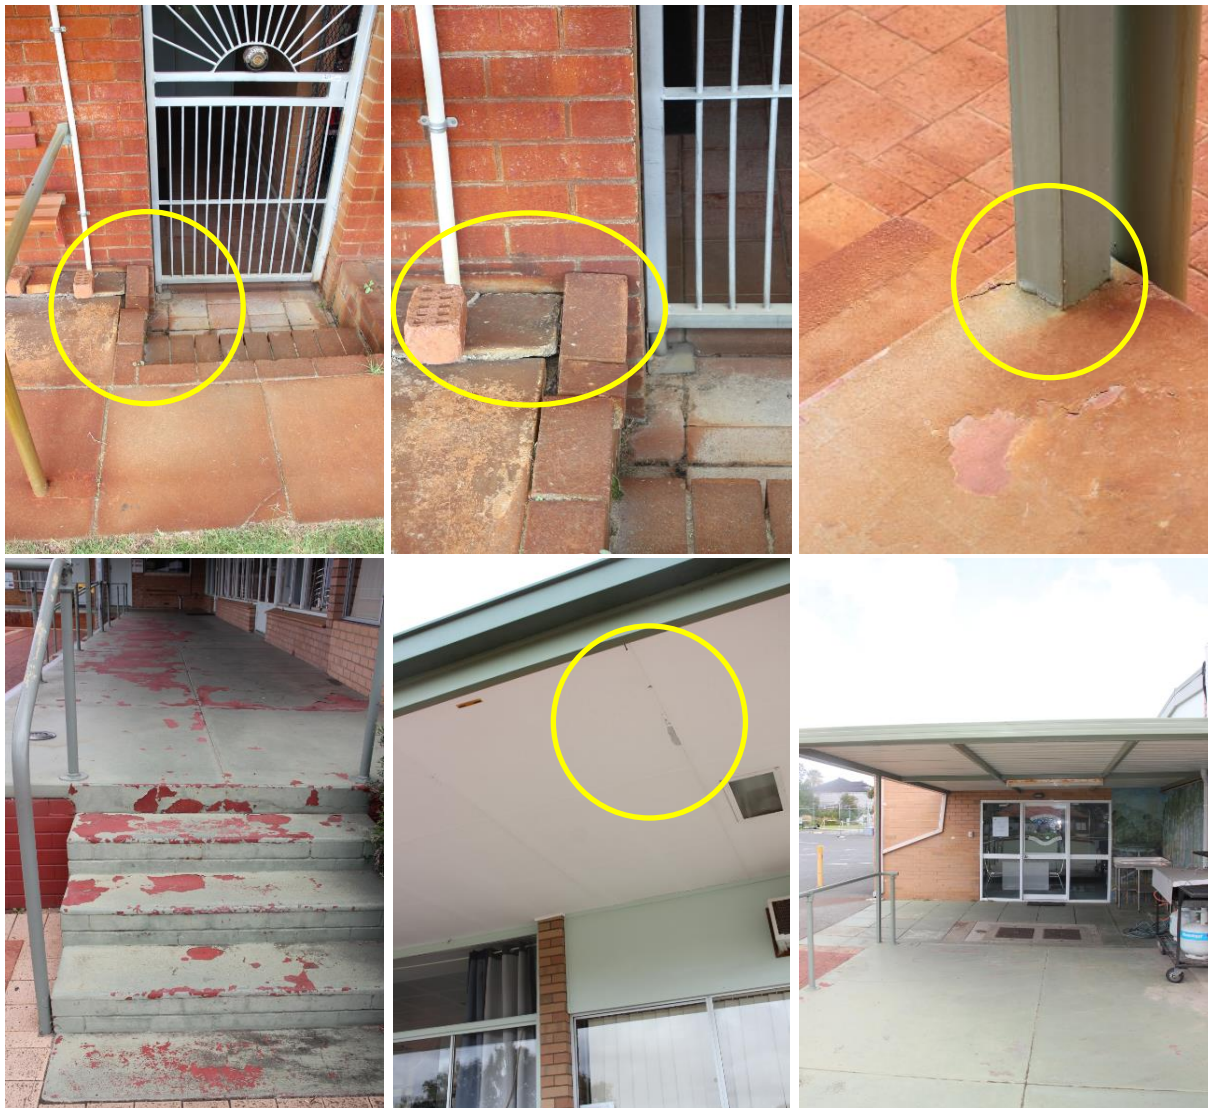
Figure 5: Photo 27, 28, 29, 30, 31 & 32 – Verandah and eaves lining

The verandah is in poor condition see Figure 5. The verandahs support poles are starting to corrode. The concrete path in which the post sits has also cracked due to the pressure. The bricks at the side of the rear step to the male bathrooms appear loose. The concrete has also cracked. It is recommended that the posts, brickwork and concrete is repaired. The concrete verandah floor is structurally sound. However, the paint has flaked off and looks visually terrible. It is recommended that the concrete is repainted. The asbestos ceiling lining to the verandahs is well labelled and in good condition. However, there is a little bit of flaking paint to the north side of the building. The flaking paint will be a health concern as it is laced with asbestos. It is recommended that the ceiling is repainted to prevent flaking paint. The asbestos eaves sheeting appears to be in good condition. The south facing steel patio appears to be in good condition. No further action is recommended.

2.1.5	Verandah's and paths	The verandahs support poles are starting to corrode	4	3	It is recommended that the posts and concrete are repaired	5000	2023	The concrete path in which the post sits has also cracked due to the pressure

2.1.5	Verandah's and paths	The bricks at the side of the rear step to the male bathrooms appear loose	5	5	It is recommended that the brickwork is repaired	500	2020

2.1.5	Verandah's and paths	The paint on the verandah concrete floor is flaking off	4	4	It is recommended that the concrete is repainted	3000	2021	
2.1.5	Verandah's and paths	The verandah asbestos ceiling lining has a little bit of flaking paint to the north side of the building.	5	5	It is recommended that the ceiling is repainted to prevent flaking paint	500	2020	The flaking paint will be a health concern as it is laced with asbestos

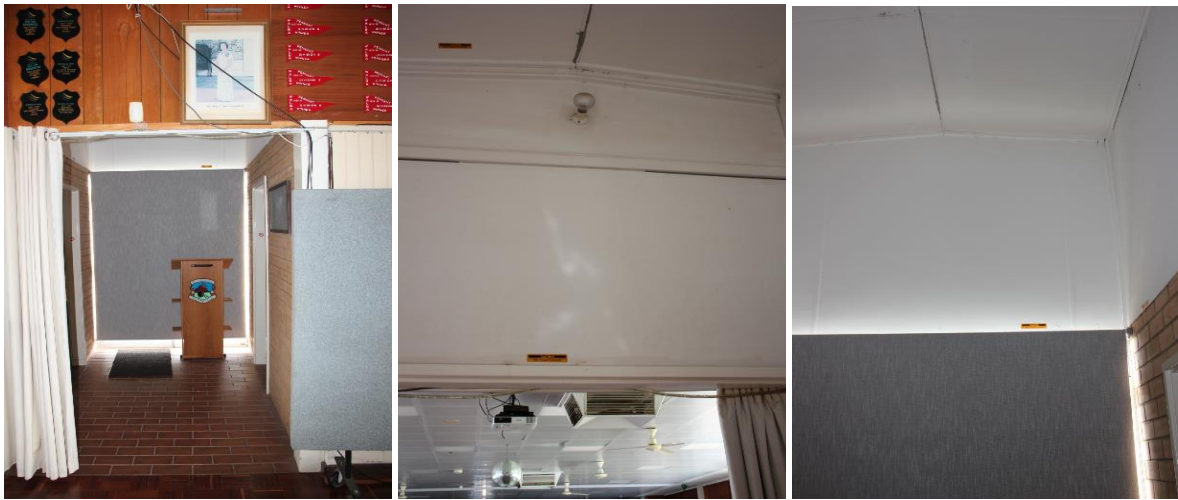
Figure 6: Photo 33, 34 & 35 – Entry foyer

The entry to the main hall is in good condition for its age see Figure 6. The face brick walls are in good condition. The asbestos wall and ceiling lining is in good condition. It does appear that there is some staining along the centre join of the sheet. It is recommended that the ceiling is repainted. The tiled floor is also in good condition. No further action is recommended.

2.2.1	Entry foyer	There is some staining along the centre join of the ceiling sheet	3	3	It is recommended that the ceiling is repainted	500	2022	
2.2.4	Main hall	There are a few ceiling panels that are not sitting correctly in the frame	3	5	It is recommended that the panels are moved back into position	100	2020

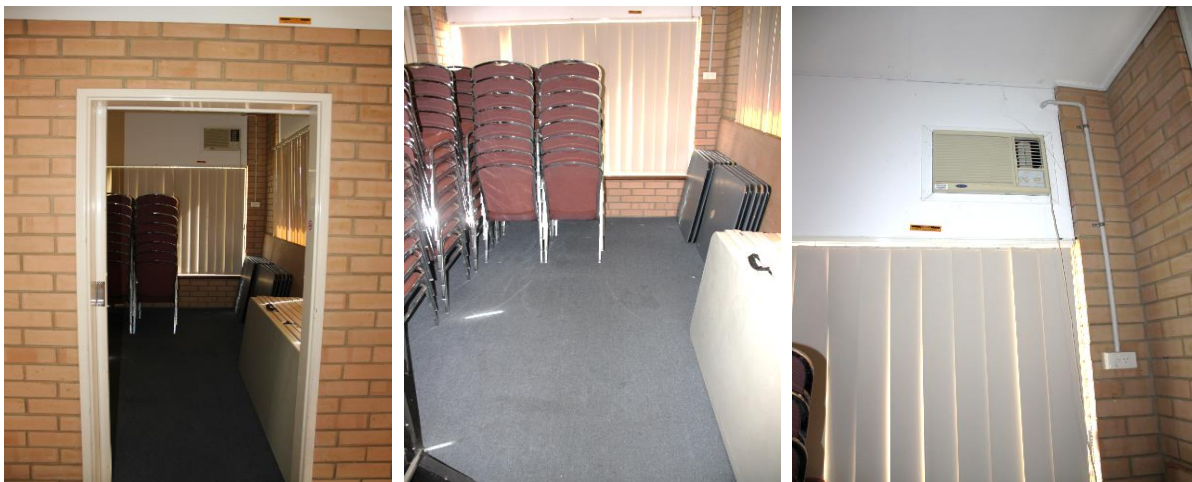
Figure 7: Photo 36, 37 & 38 – Office 1

The office is in good condition for its age see Figure 8. The face brick walls are in good condition. The asbestos wall and ceiling lining is in good condition. The door and frame is well painted and is in good condition. The carpet floor cover appears old and lightly stained but is fit for purpose. No action is recommended.

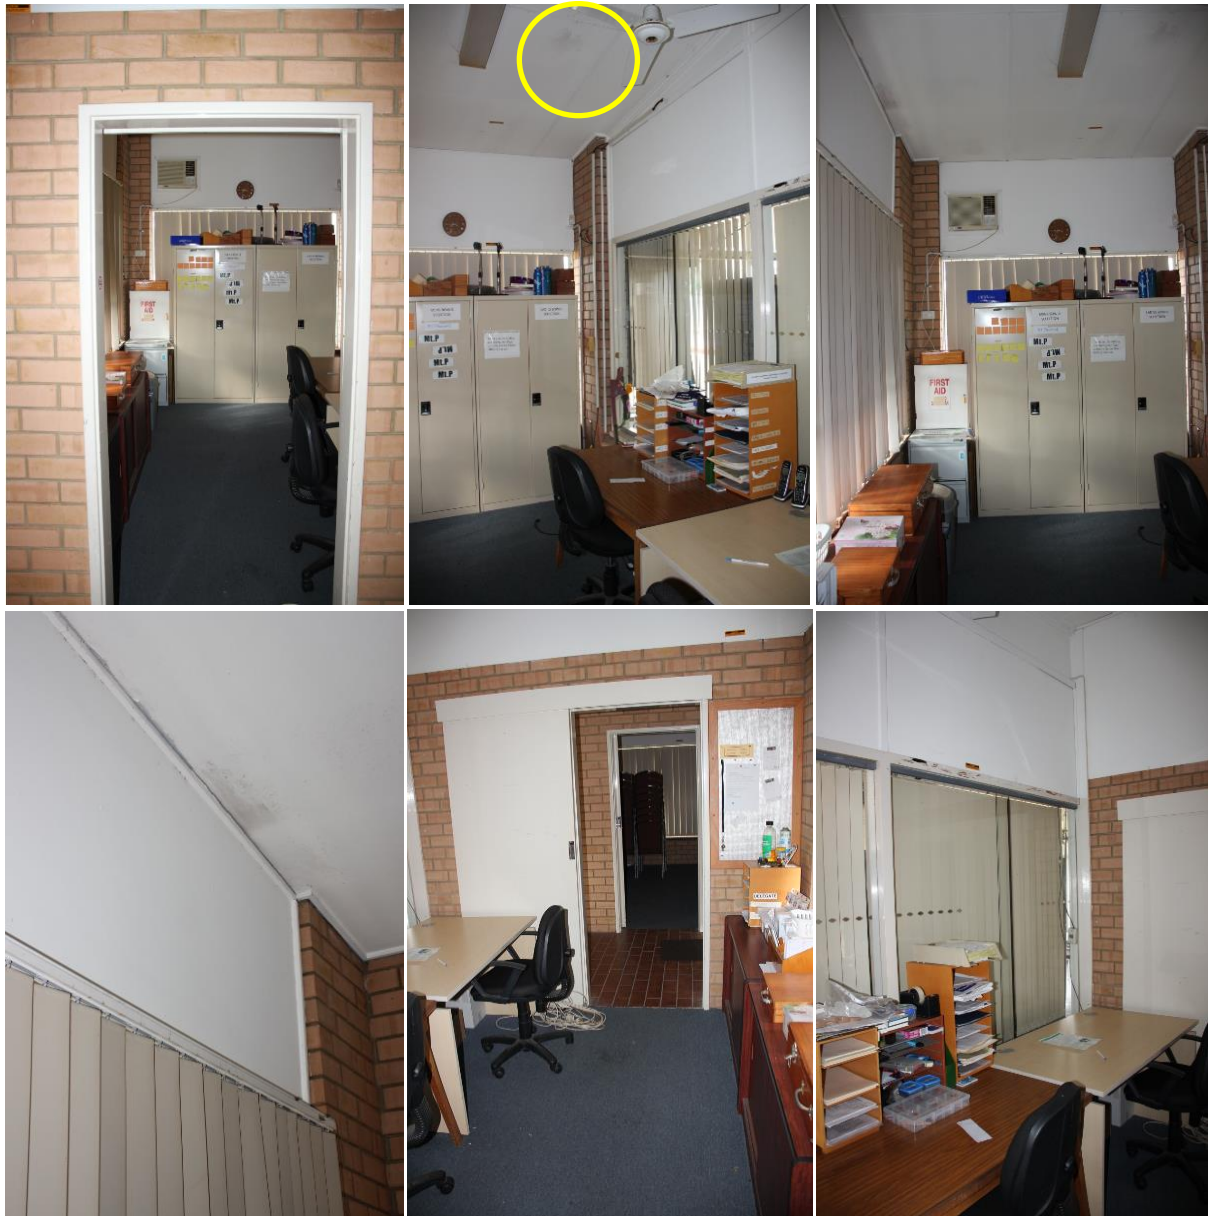
Figure 8: Photo 39, 40, 41, 42, 43 & 44 – Office 2

The office is in good condition for its age see Figure 8. The face brick walls are in good condition. The asbestos wall lining is in good condition. The asbestos ceiling is in good condition but it is a little water stained. The door and frame is well painted and is in good condition. The carpet floor cover appears old and lightly stained but is fit for purpose. No action is recommended.

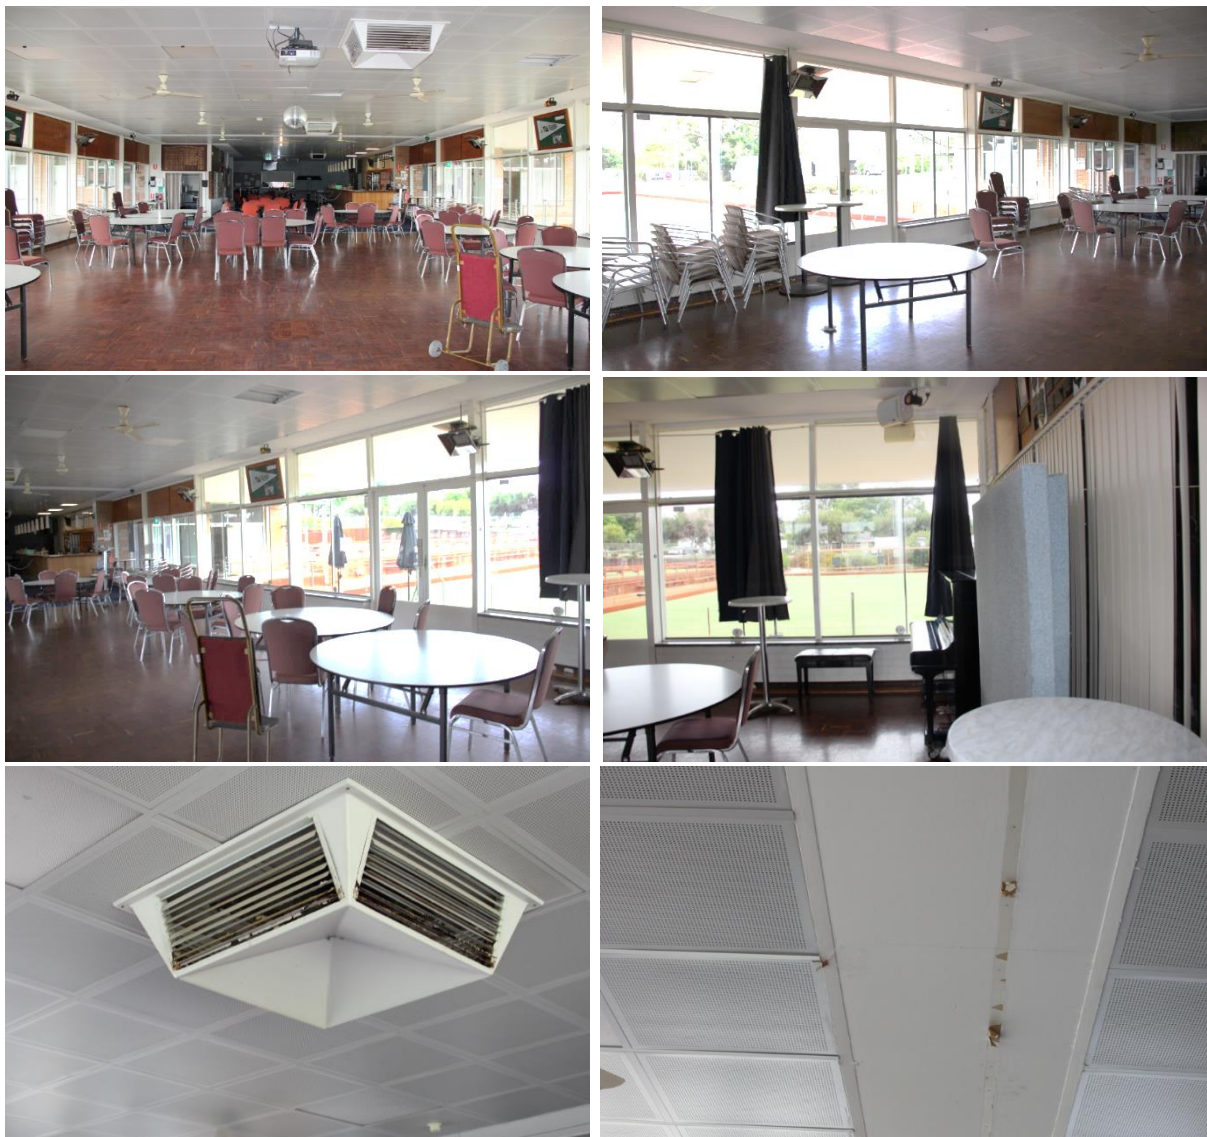
Figure 9: Photo 45, 46, 47, 48, 49 & 50 – Main hall

The Main hall is in good condition for its age see Figure 9. The timber floor cover is in good condition for its age. The ceiling panels are also in good condition. However, there are a few panels that are not sitting correctly in the frame. It is recommended that the panels are moved back into position. The paper face from the gyprock ceiling panel across the centre of the room is torn. It is recommended that the ceiling is patched and painted.

The brick walls and windows are in good condition for their age. As mentioned in 2.1.3 Doors and windows, it was recommended that the south facing double doors need to be repaired and repainted.

The air conditioner duct cover is in poor condition, The fingers on the vents are corroding and the paint is flaking off. It is recommended that the vents are replaced.

2.2.4	Main hall	The paper face from the gyprock ceiling panel across the centre of the room is torn	4	4	It is recommended that the ceiling is patched and painted	1000	2021	It appears that there may have been a door track that was removed

2.2.4	Main hall	The fingers on the air conditioner vents are corroding and the paint is flaking off	4	4	It is recommended that the vents are replaced	300	2022

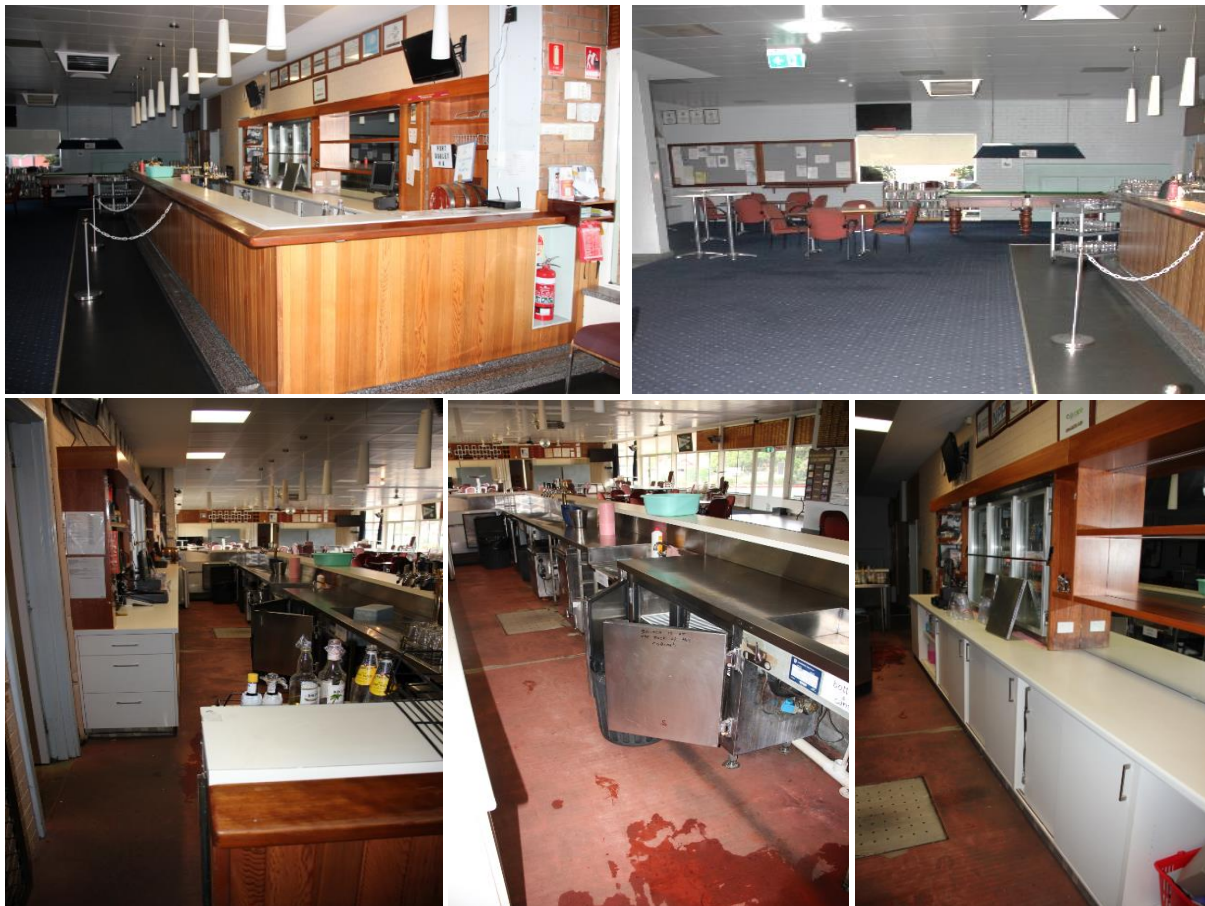
Figure 10: Photo 51, 52, 53, 54 & 55 – Bar area

The bar area is in good condition see Figure 11. The carpet and vinyl floor cover is in good condition. The bar cabinets and equipment also appear to be in good condition. The floor behind the bar was painted and was in good condition for its age. However, it was noticed that there were no rubber matting on the floor this may have been due to the fact that the bowling club was closing down due to covid-19. It is recommended that the bar area is fitted with removable rubber matting to prevent staff slipping.

2.2.5	Bar area	No rubber matting on the bar floor	5	5	It is recommended that the bar area is fitted with removable rubber matting to prevent staff slipping	2000	2020	This may have been due to the fact that the bowling club was closing down due to covid-19

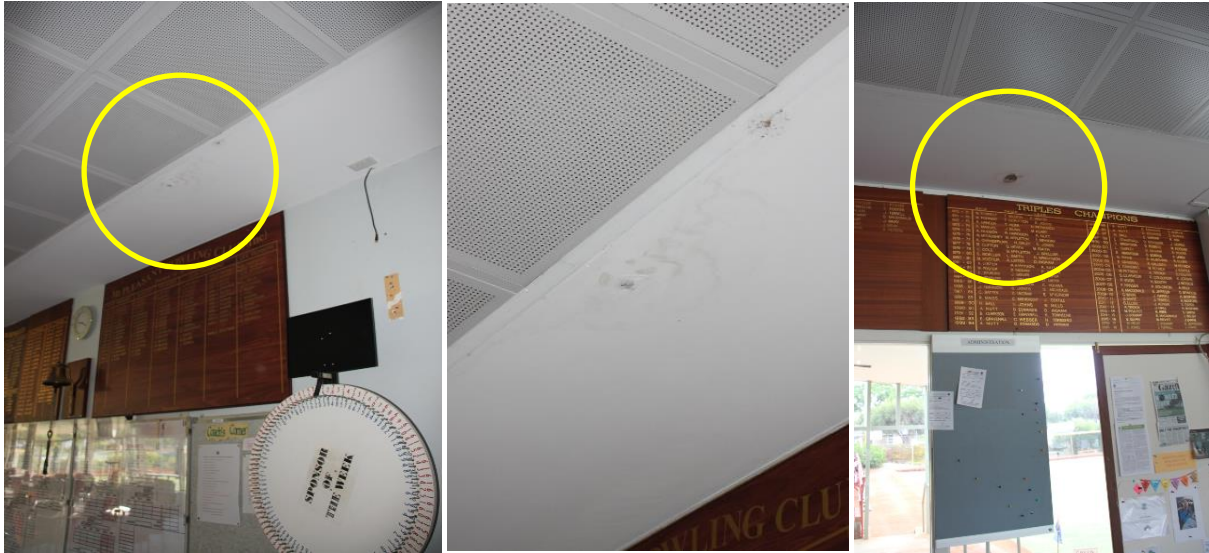
Figure 11: Photo 56, 57 & 58 – Bar area ceiling

The bar area ceiling was in average condition see Figure 11. There is water staining on the ceiling in a few spots. It appears that mould is growing in one section. It is recommended that roof is inspected for leaks, It is also recommended that the damaged section is removed and replaced.

2.2.5	Bar area	There is water staining on the ceiling in a few spots. It appears that mould is growing in one section	5	5	It is recommended that roof is inspected for leaks	500	2020

2.2.5	Bar area	Bar room ceiling has staining and possible mould	5	5	It is recommended that the damaged section is removed and replaced	1000	2020	
2.2.6	Office 3	The concrete floor paint and is worn out	4	4	It is recommended that the floor is repainted	800	2021

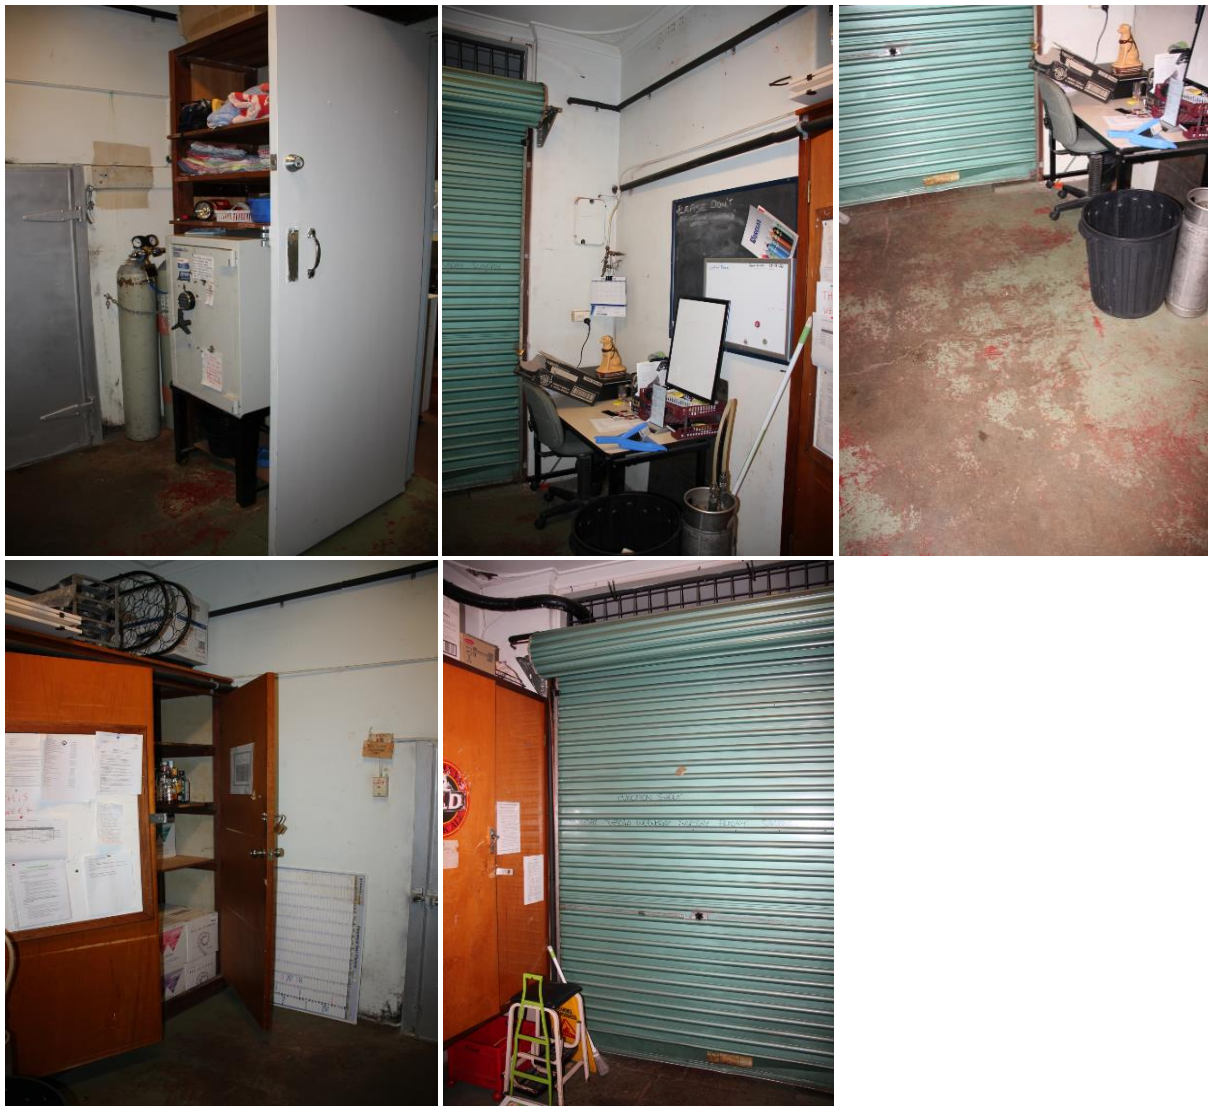
Figure 12: Photo 59, 60, 61, 62 & 63 – Office 3

The office is located behind the bar area and is in average condition for its age see Figure 12. The floor is bare concrete and is in average condition. The concrete floor paint and is worn out. It is recommended that the floor is repainted. The walls and ceiling are in good condition for their age and are fit for purpose. This office gives access to the cool room used for the bar. The cool room was locked. However, it appears to be in good working condition.

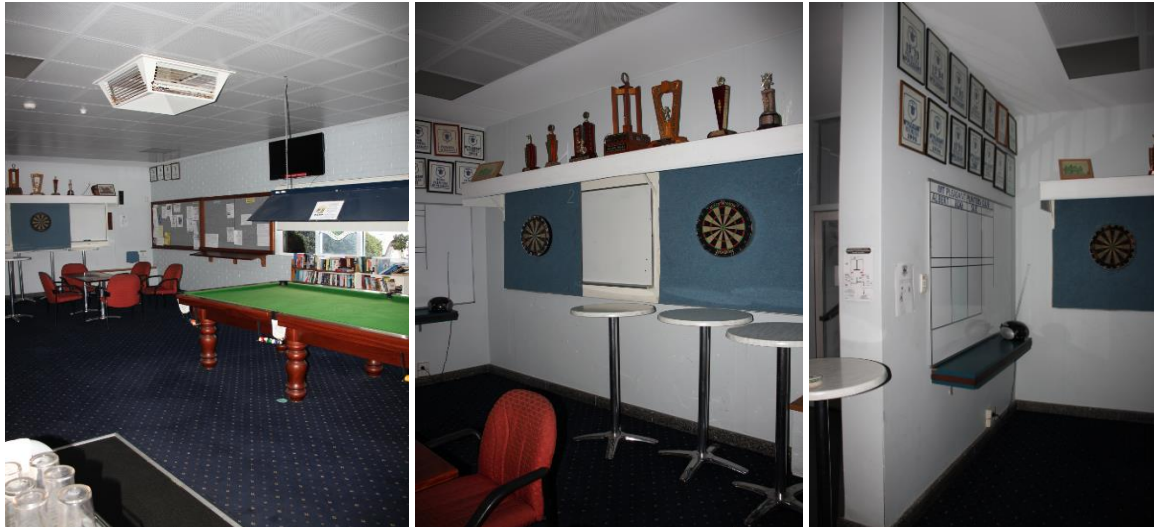
Figure 13: Photo 64, 65 & 66 – Pool and darts room

The pool and darts room is in good condition see Figure 13. The walls and ceiling are well painted and are in good condition. The carpet floor cover is also in good condition. The air conditioner duct cover is in poor condition, The fingers on the vents are corroding and the paint is flaking off. It is recommended that the vents are replaced.

2.2.7	Pool table and darts room	The fingers on the air conditioner vents are corroding and the paint is flaking off	4	4	It is recommended that the vents are replaced	300	2022

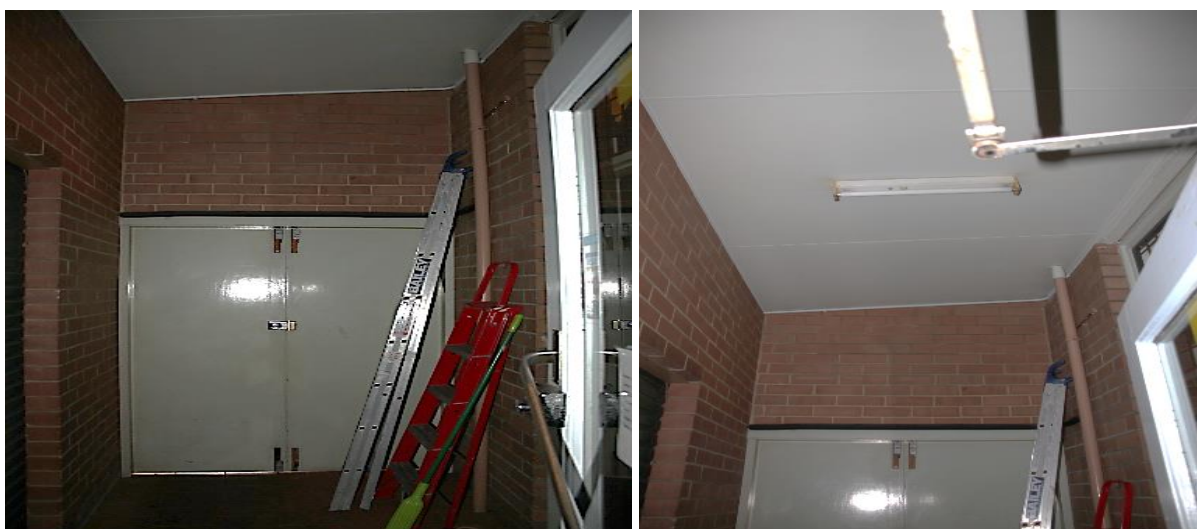
Figure 14: Photo 67 & 68 – Hallway 1

The hallway is in good condition see Figure 14. The external door and frame is in good condition. The face brickwork is in good condition. The asbestos ceiling is well painted and in good condition. The floor is in good condition. No action is recommended.

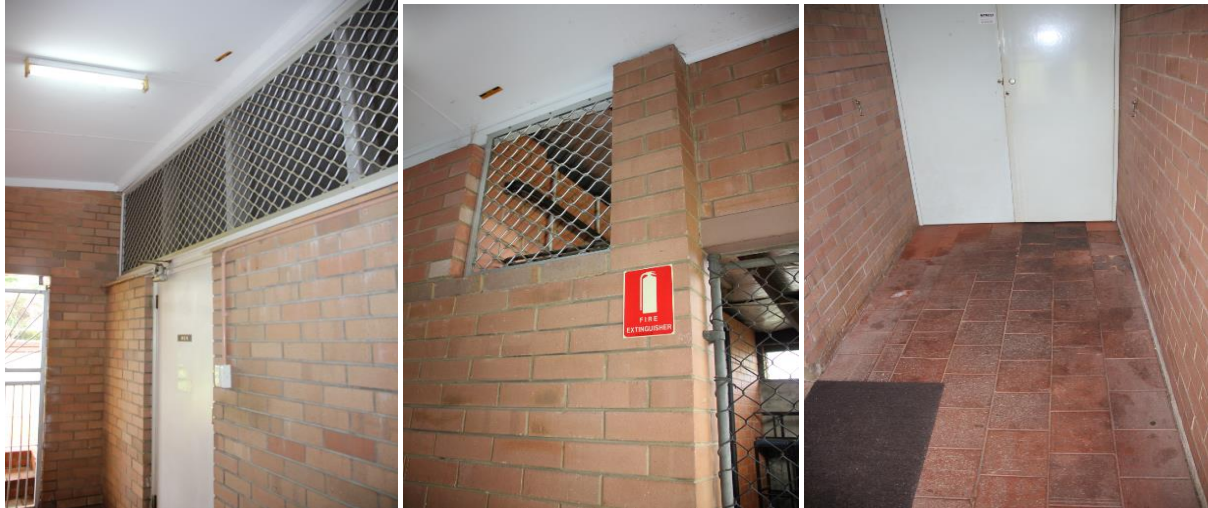
Figure 15: Photo 69, 70 & 71 – Male toilets

The hallway is in good condition see Figure 15. The external door and frame is in good condition. The external metal gate and wire gate to the services area are all in good condition for their age. The face brickwork is in good condition. The asbestos ceiling is well painted and in good condition. The clay paving to the floor is in good condition. There is no fire extinguisher located below the sign. It is possible that the extinguisher is placed behind the locked gate in the services area. However, it could not be located. It is recommended that a location sign is installed or if there is not a fire extinguisher located in the area, the sign is removed.

2.2.9	Hallway 2	The extinguisher could not be located below the sign	5	5	It is recommended that a location sign is installed or if there is not a fire extinguisher located in the area, the sign is removed	300	2020

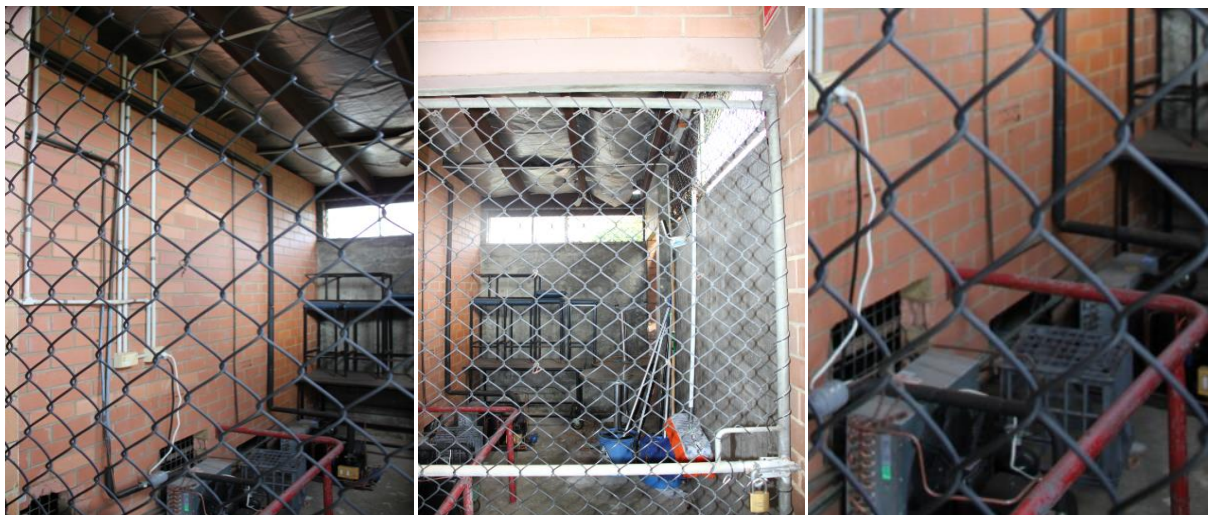
Figure 16: Photo 72, 73 & 74 – Service area

The services area is in average condition see Figure 16. The floor is bare concrete and is fit for purpose. The brick walls are in good condition for their age. The exposed roof rafters are in good condition and there is no ceiling to this room. As mentioned in 2.1.3 Doors and windows, the louver window glass is broken and was recommended that the glass is replaced. No further action is recommended.

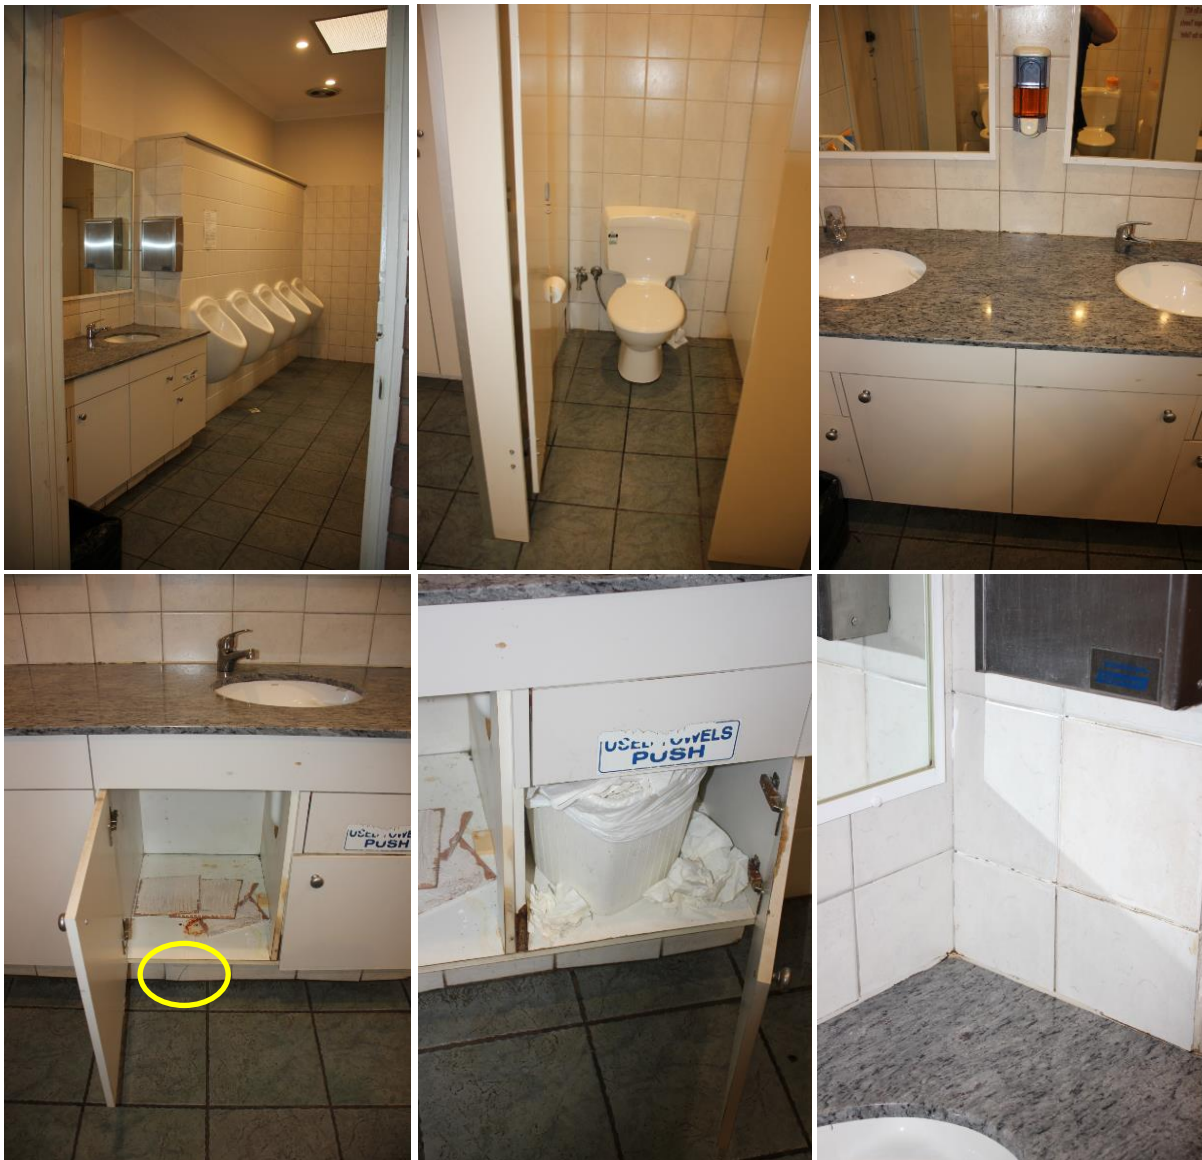
Figure 17: Photo 75, 76, 77, 78, 79 & 80 – Men's bathroom

The bathroom is in good condition see Figure 17. The walls and ceiling are in good condition and show no signs of movement or cracking. The vanity cabinet is old and is in poor condition. The vanity has water staining and panels have swollen due to water damage. It is recommended that the vanity is replaced. Silicon between the bench top and splashback tiles have started to come off. It is recommended that the silicon is removed and replaced with new. The vanity kickboard tile has cracked. It is recommended that the kickboard tiles are replaced. The plumbing was inspected and no leaks were found. The toilet cubicle panels are in good condition. The floor and wall tiles are in good condition. The urinals, toilets and basins are in very good condition. No further action is recommended.

2.2.11	Men's bathroom	The vanity has water staining and panels have	4	4	It is recommended that the vanity is replaced	1500	2021

swollen due to water damage						
2.2.11	Men's bathroom	Silicon between the bench top and splashback tiles have started to come off	5	5	It is recommended that the silicon is removed and replaced with new	200	2020

2.2.11	Men's bathroom	The vanity kickboard tile has cracked	5	5	It is recommended that the kickboard tiles are replaced	200	2020	
2.2.11	Men's bathroom	There is slight cracking to the internal corner and below the cornice above the door	3	4	It is recommended that these minor cracks are repaired and painted when the room is next painted	100	2023
