Mt Pleasant Bowling Club

Address: 40 Barrisdale Road Ardross

Audit Date: 27 March 2020

Prepared for City of Melville

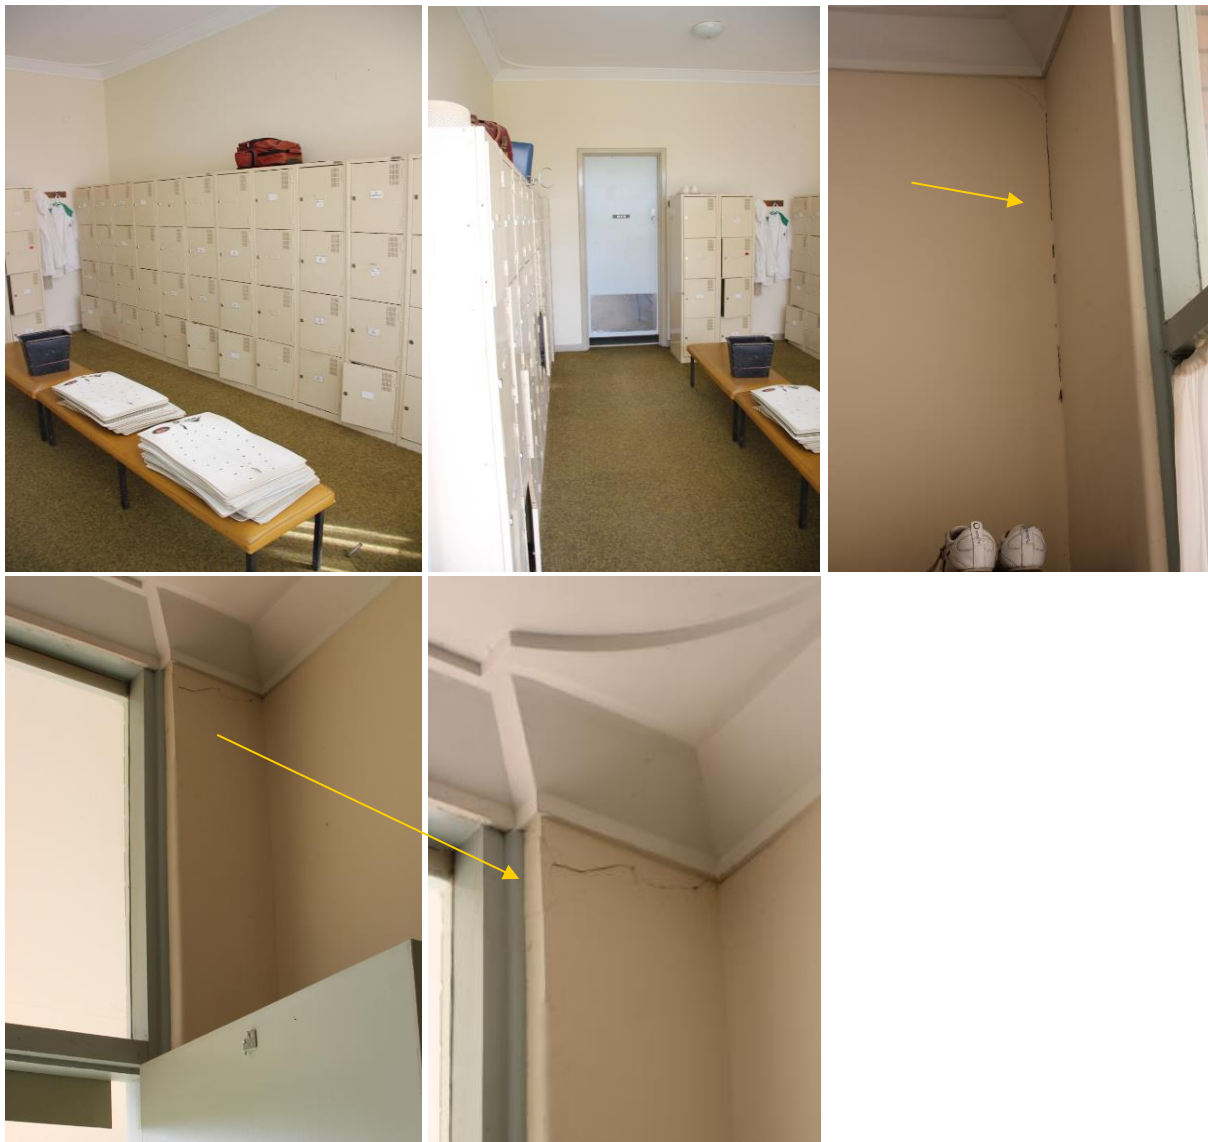
Figure 18: Photo 81, 82, 83, 84 & 85 – Men's changeroom

The changeroom is in good condition see Figure 18. The ceiling was well painted and is in good condition. The walls are also in good condition. However, there is slight cracking to the internal corner and below the cornice above the door. It is recommended that these minor cracks are repaired and painted when the room is next painted. The carpet appears old but is in good condition for its age. The doors and door frames are also in good condition. No further action is recommended.

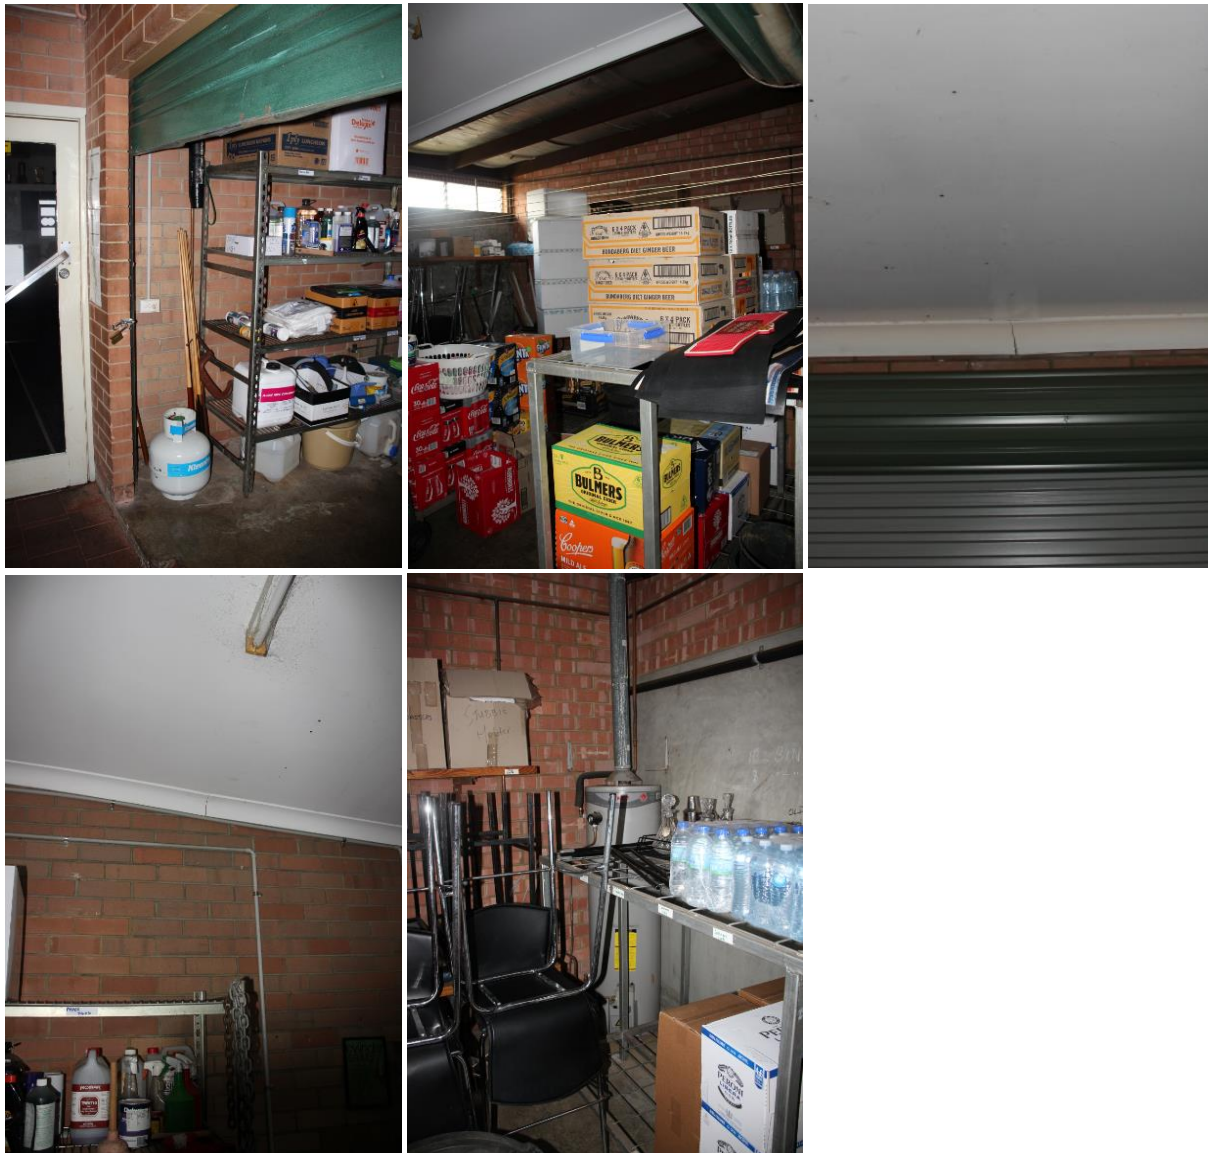
Figure 19: Photo 86, 87, 89, 90, 91– Delivery room

The delivery room is in good condition see Figure 19. The ceiling appeared to be in average condition. However, the cornice has cracked in a couple of places and the ceiling has been re-fixed to the supporting framework. It is recommended that the ceiling and cornice is filled and painted. The face brick walls are also in good condition. The floor is bare concrete and is fit for purpose. The roller door is functioning correctly and is in good condition. The storage hot water system appears new and is in good working condition. No further action is recommended.

2.2.13	Delivery room	The cornice has cracked in a couple of places and the ceiling has been re-fixed to the supporting framework	4	4	It is recommended that the ceiling and cornice is filled and painted	1000	2022

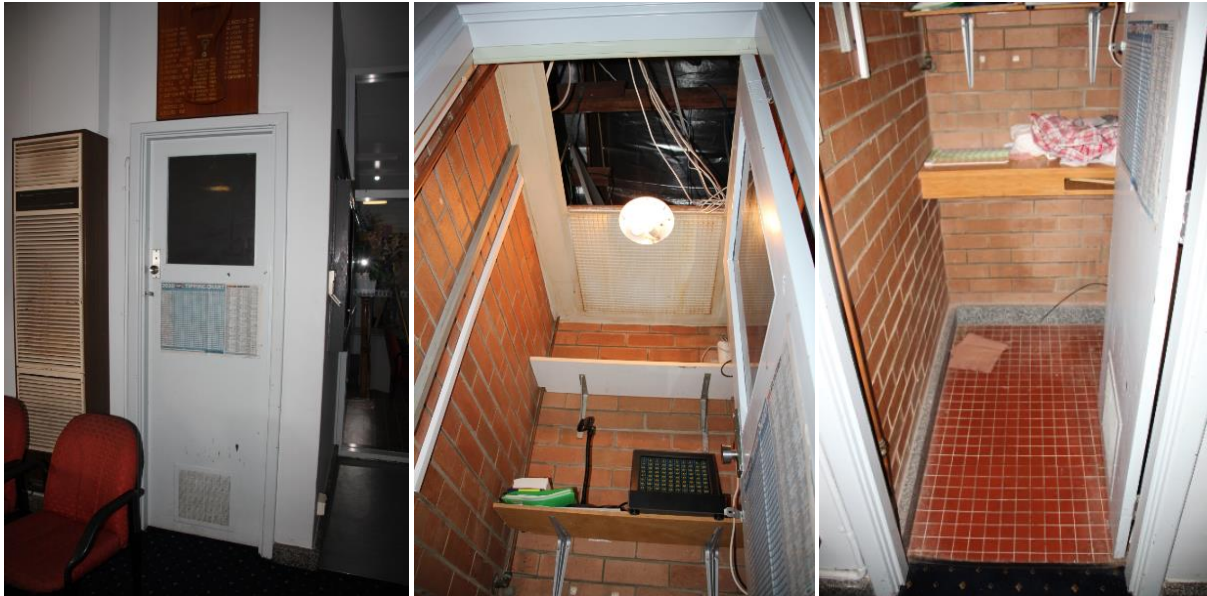
Figure 20: Photo 92, 93 & 94 – Electronics room

The electronics room is fit for purpose see Figure 20. The ceiling panel was missing and the paint is in poor condition. It is recommended that the ceiling panel is replaced and repainted. The face brick walls are also in good condition. The tiled floor is in good condition for its age. The entry door and door frame is well painted and is in good condition. No further action is recommended.

2.2.14	Electronics room	The ceiling panel was missing and the paint is in poor condition	5	5	It is recommended that the ceiling panel is replaced and repainted	500	2020

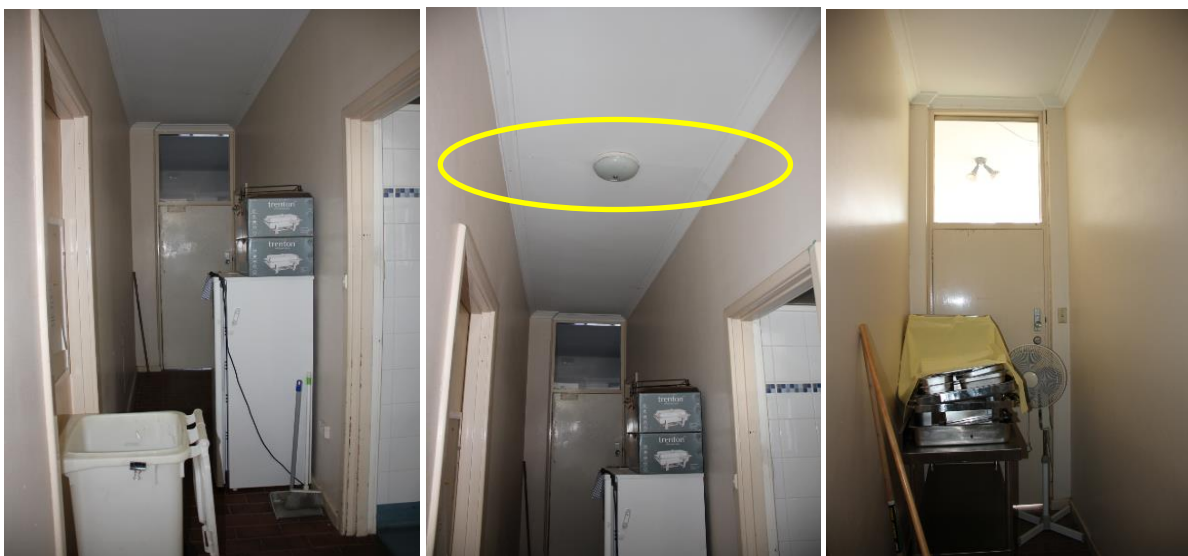
Figure 23: Photo 103, 104, & 105 - Hallway

The hallway is in good condition see Figure 23. The walls and ceiling are well painted and are in good condition. However, there is a slight crack through the ceiling where the light is fixed. It is recommended that the ceiling is repaired and painted. The doors and door frames are well painted and are in good condition. The tiled floor is in good condition for its age. No further action is recommended.

2.2.17	Hallway 3	There is a slight crack through the ceiling where the light is fixed	4	4	It is recommended that the ceiling is repaired and painted	500	2021

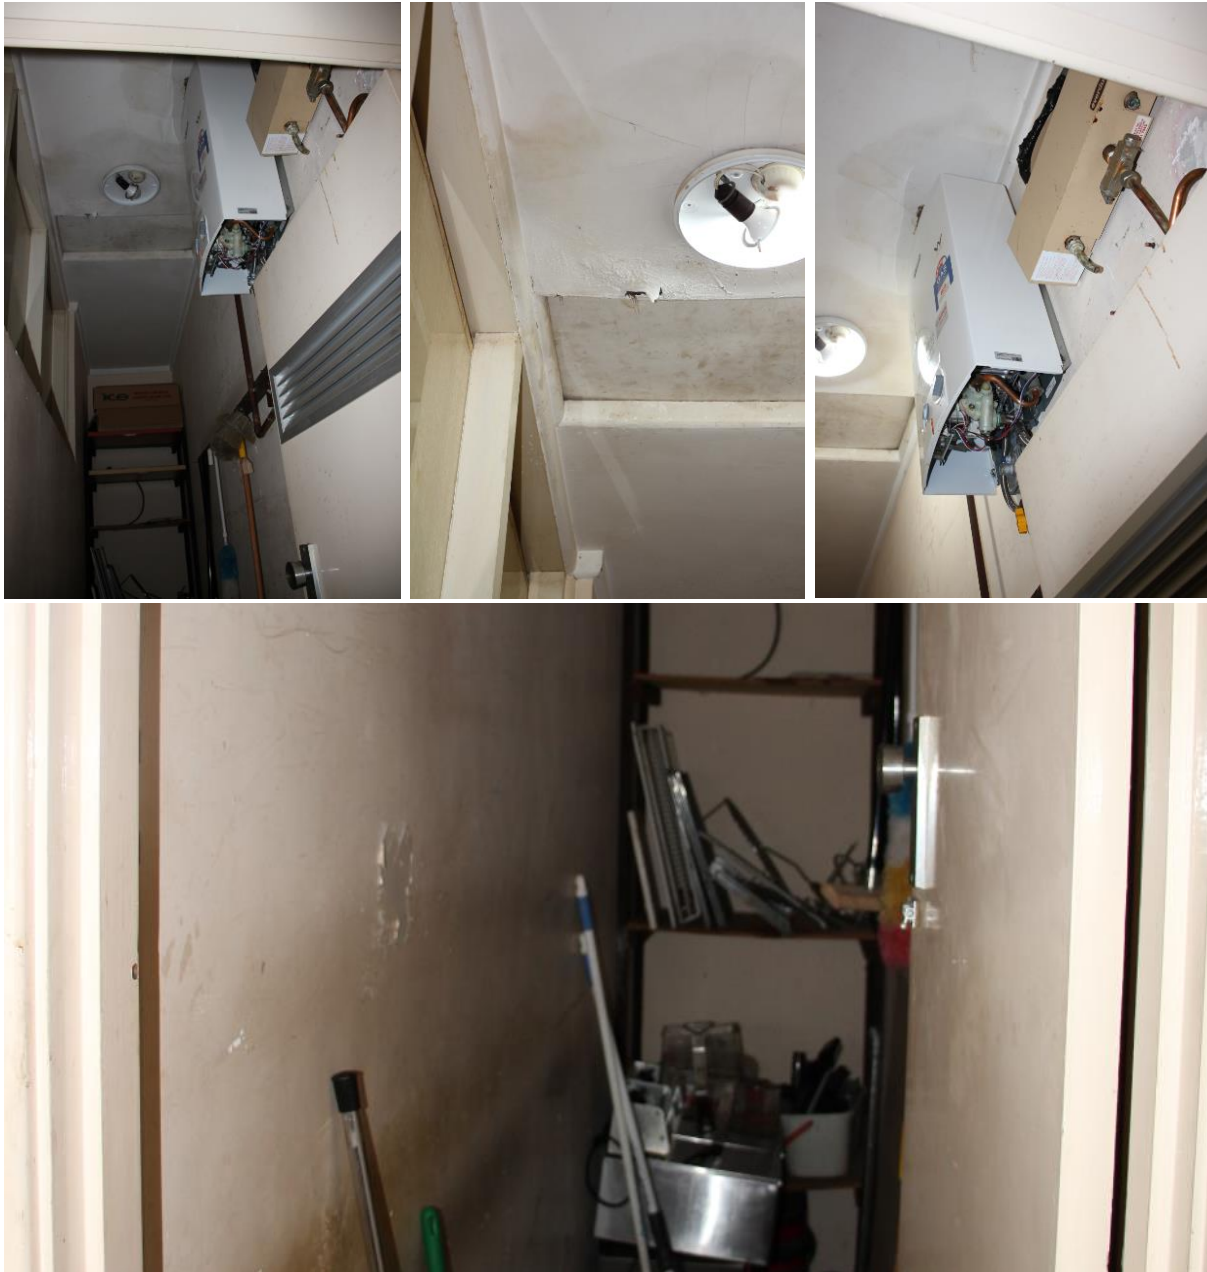
Figure 24: Photo 106, 107, 108 & 109 – Service duct

The service duct is in average condition see Figure 24. The walls are in average condition for their age. The walls are chipped and the paint is flaking. It is recommended that the walls are patched and repainted. The ceiling appears water stained and is in poor condition. It is recommended that the ceiling is repaired and painted. The bare concrete floor is fit for purpose. The two hot water systems appear to be in good working condition.

2.2.18	Service duct	The walls are chipped and the paint is flaking	4	4	It is recommended that the walls are patched and repainted	500	2021	
2.2.18	Service duct	The ceiling appears water stained and is in poor condition	4	4	It is recommended that the ceiling is repaired and painted	500	2021

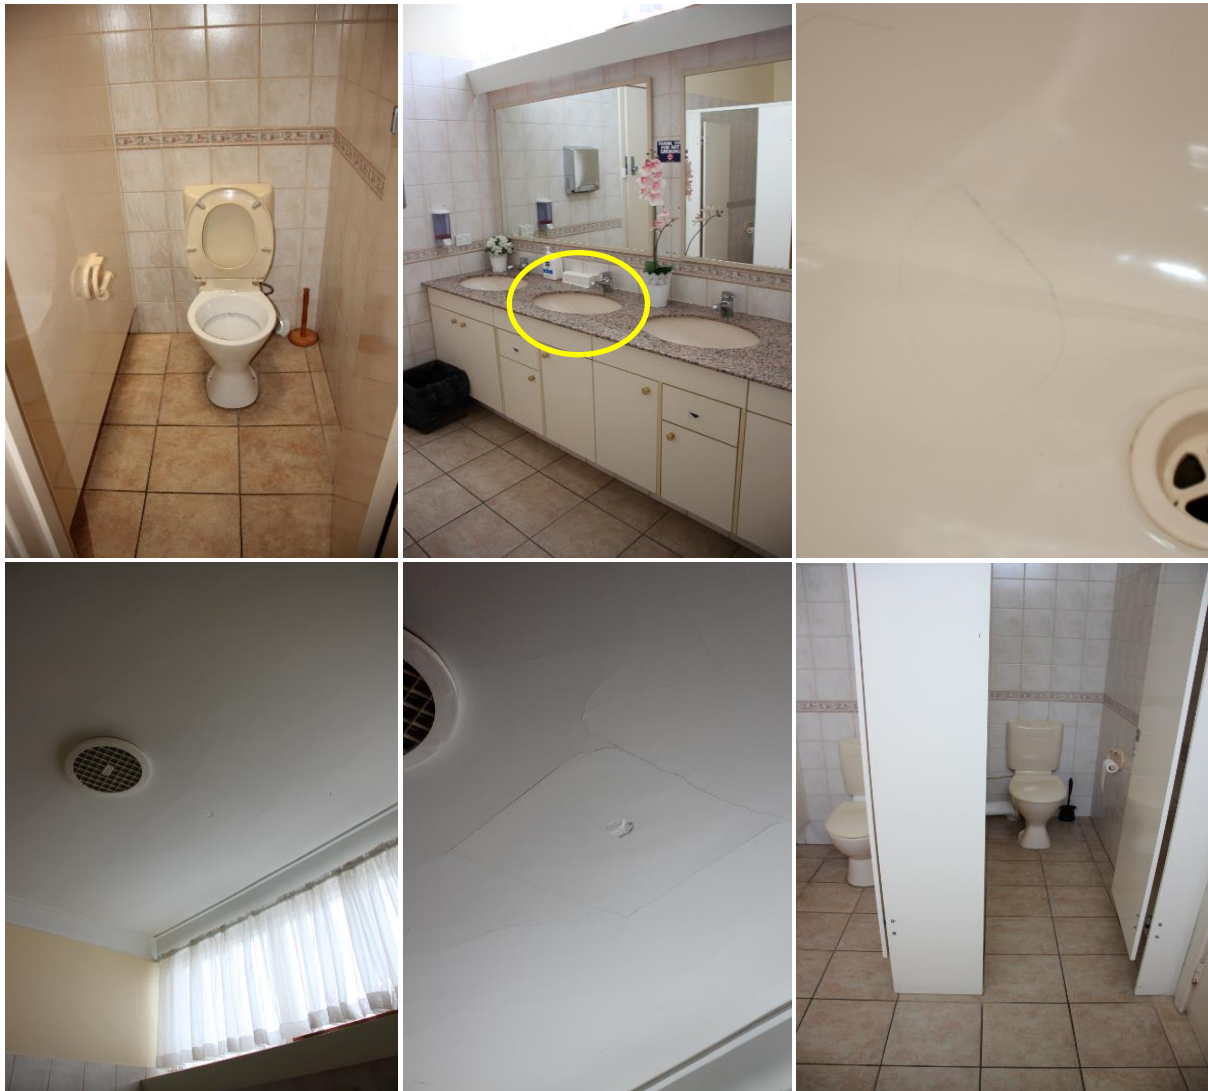
Figure 27: Photo 120, 121, 122, 123, 124 & 125 – Ladies bathroom

The bathroom is in good condition see Figure 27. The tiled walls are in good condition. The toilet doors and walls are well painted and are in good condition. The tiled floor cover appears to be in good condition. The vanity cabinet is in good condition for its age. However, the centre basin is cracked. There is no water leaking from the basin. However, it is recommended that the basin is replaced. The ceiling is in average condition. There is cracking in the ceiling lining. It is recommended that the damaged section is repaired and painted.

2.2.21	Ladies bathroom	The centre basin is cracked	4	5	It is recommended that the basin is replaced	400	2020	There is no water leaking from the basin
2.2.21	Ladies bathroom	There is cracking in the ceiling lining	4	4	It is recommended that the damaged section is repaired and painted	500	2021

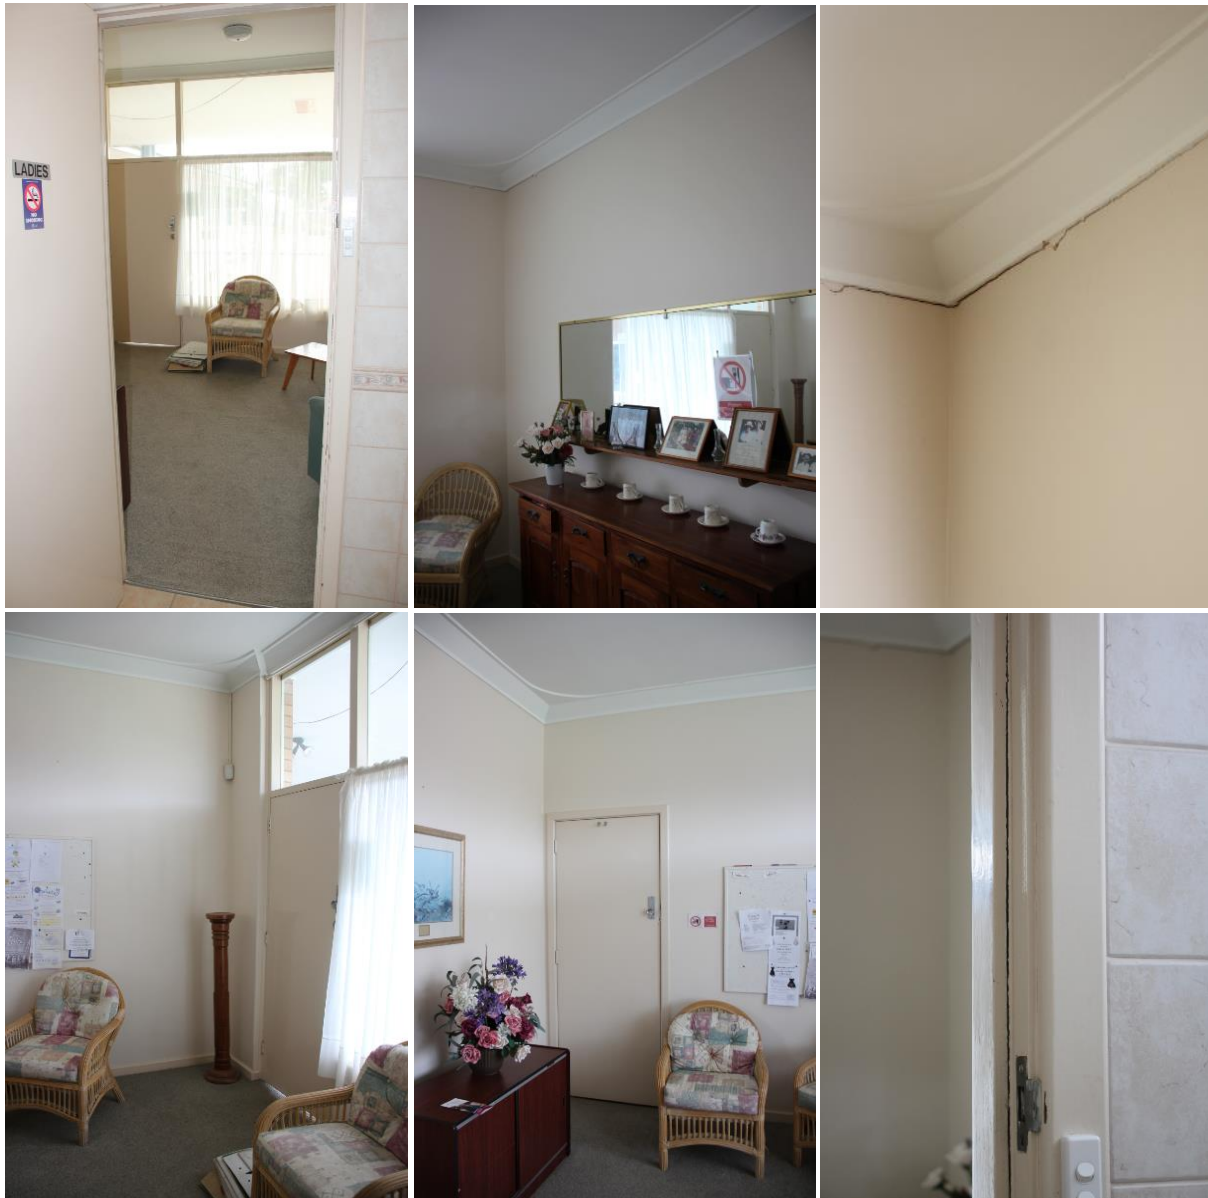
Figure 28: Photo 126, 127, 128, 129, 130 & 131 – Ladies sitting room

The sitting room is in good condition see Figure 28. The walls and ceiling are well painted and are in good condition. However there is a slight crack between the white set plaster and the cornice. It is recommended that the crack is filled and painted. The doors and door frames are well painted and are in good condition. However, the planted door stop has come away from the door jamb which leads to the bathroom. It is recommended that the door stop is re-fixed to the jamb. The carpet floor cover is also in good condition. No further action is recommended.

2.2.21	Ladies bathroom	There is a slight crack between the white set plaster and the cornice	4	4	It is recommended that the crack is filled and painted	100	2021

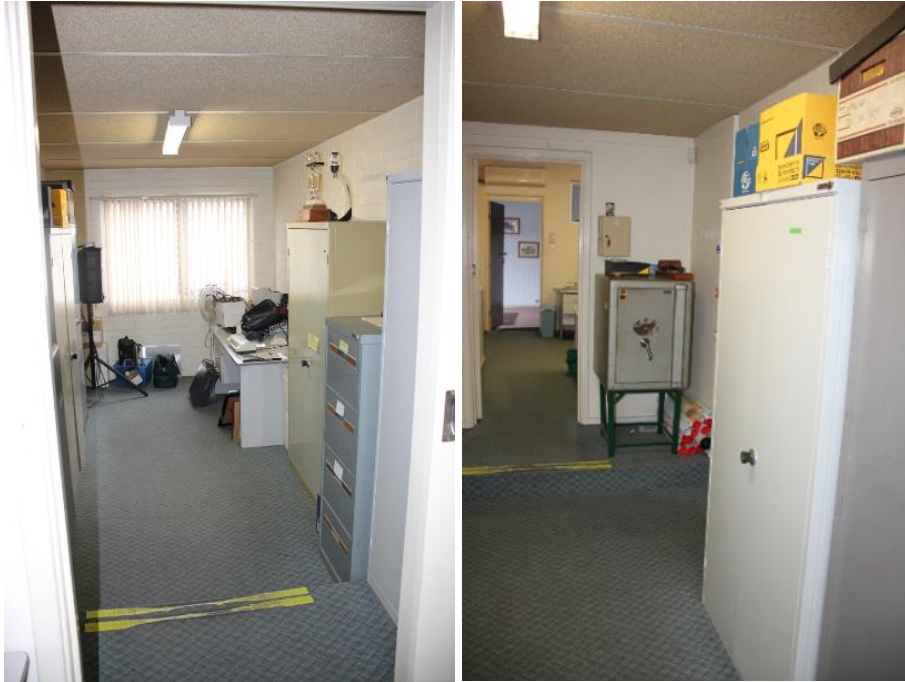
Figure 31: Photo 142 & 143 – Front office 2

The office is in good condition for its age see Figure 31. The walls are well painted and are in good condition. The ceiling is very old but is in good condition for its age. The carpet floor cover is in good condition. The safety strips on the floor, warning of the step are worn. It is recommended that the strips are replaced.

2.2.25	Front office 2	The safety strips on the floor, warning of the step are worn	5	5	It is recommended that the strips are replaced.	200	2020	
2.2.26	Boardroom	The ceiling has water staining	5	5	It is recommended that the roof is inspected for leaks	500	2020

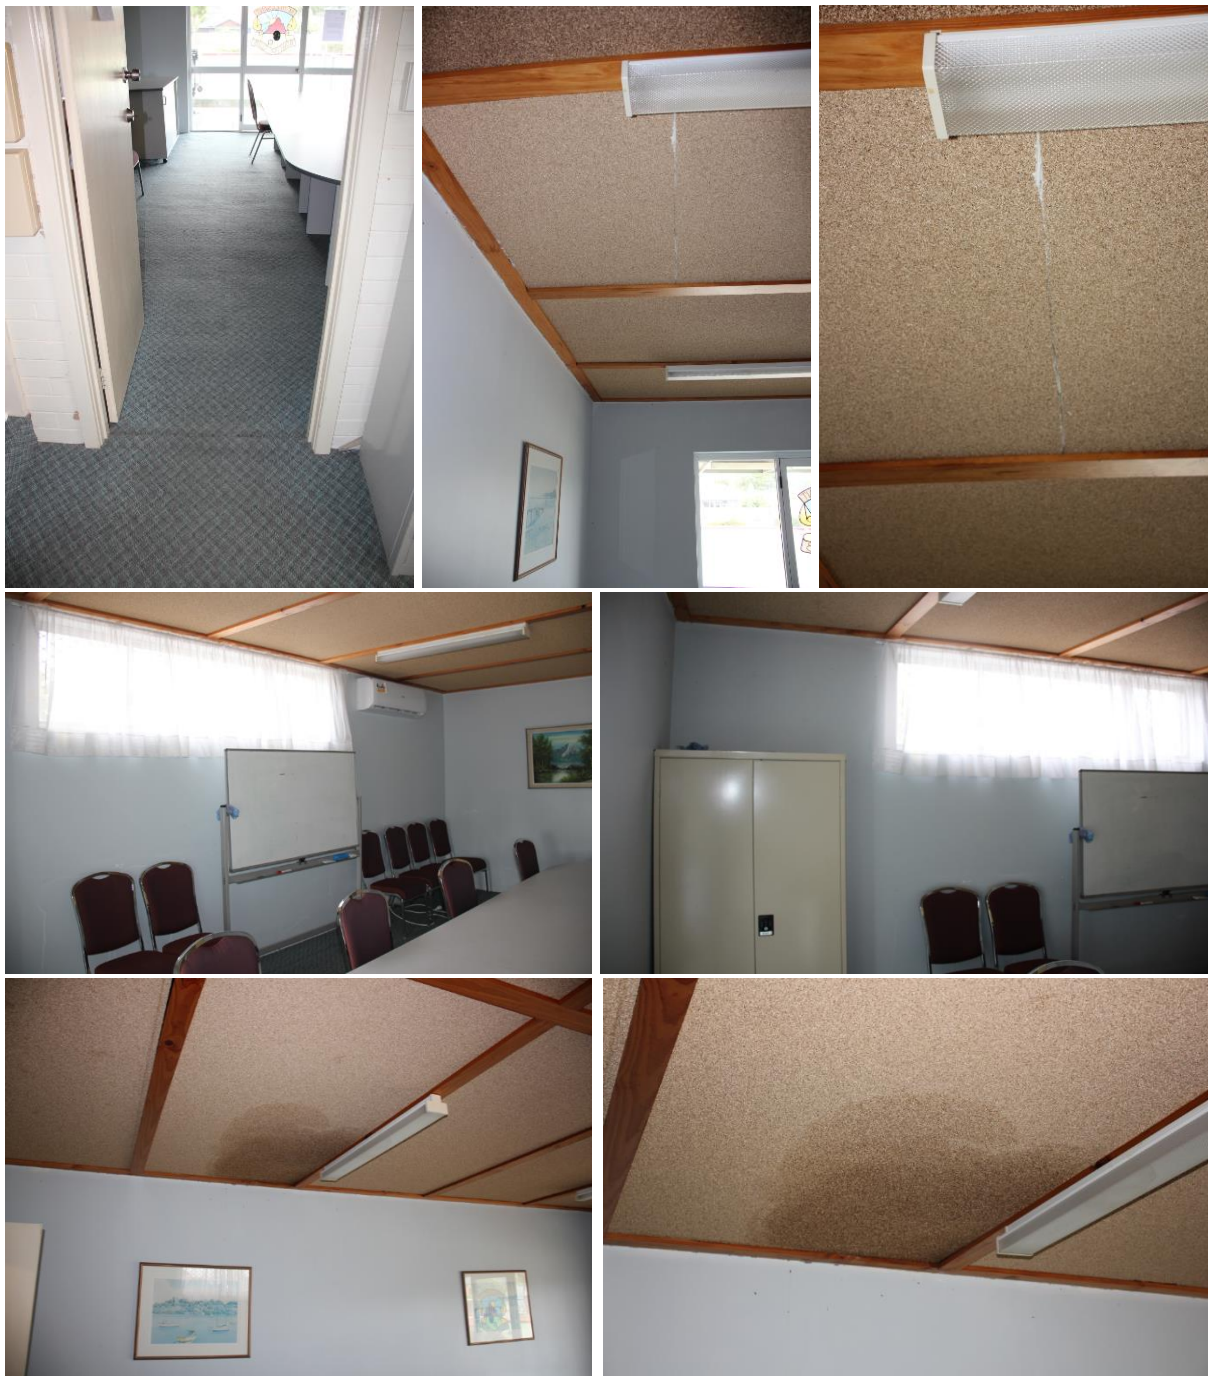
Figure 32: Photo 144, 145, 146, 147, 148, 149, 150 & 151 - Boardroom

The office is in average condition for its age see Figure 32. The walls are well painted and are in good condition. The ceiling is very old. The ceiling has cracked and there is water staining. It is recommended that the roof is inspected for leaks. It is also recommended that the ceiling lining is replaced. The doors and door frames are well painted and are in good condition. The carpet floor cover is in good condition. The airconditioner is in good working condition. No further action is recommended.

2.2.26	Boardroom	There is cracking and water staining to the ceiling	5	5	It is recommended that the ceiling lining is replaced	4000	2020	
4.1.4	Life safety	Emergency egress also needs to be addressed. The type of locking system does not allow easy exit out of the double doors.	5	5	A panic bar or a handle with a single downward motion to open the alternative access door would ease the emergency egress problem	2000	2020	Appropriate door furniture should be installed immediately. Precise requirements should be reviewed by a fire consultant prior to installation

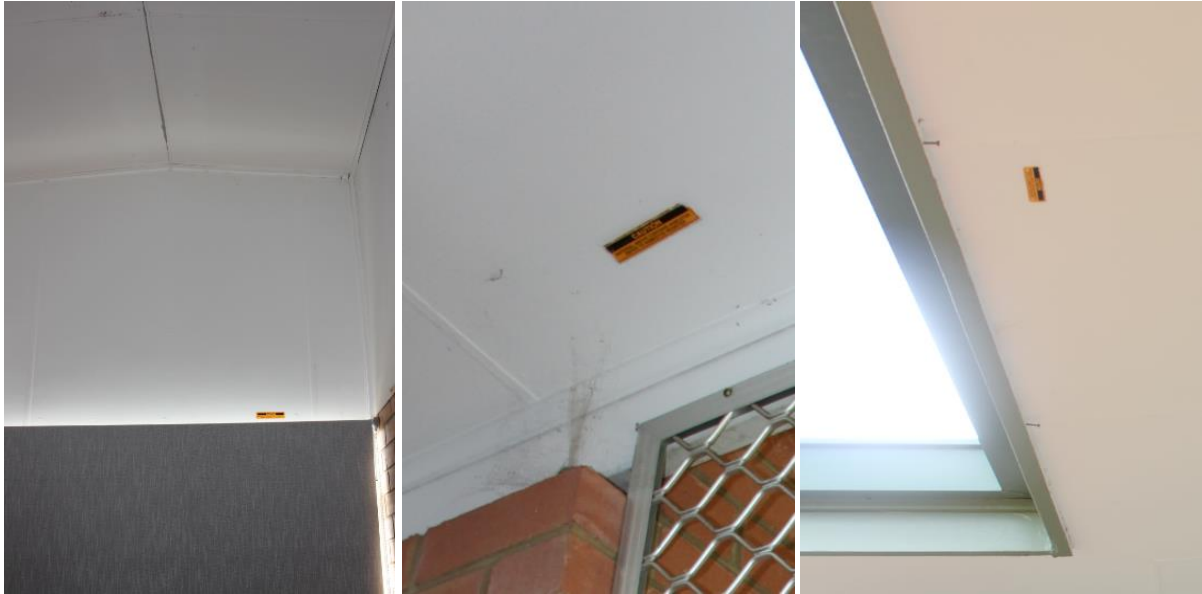
Figure 33: Photo 152, 153 & 154 – Asbestos

The building is predominantly brick with a metal roof cover. A large amount of asbestos could be found on the walls, ceilings and eaves lining throughout the building see Figure 33. Most of the asbestos is in good condition for its age.
