RE: ARBORICULTURAL REPORT – 3A Bolas Court, Myaree

Arboricultural Inspection Report for City of Melville

Date inspected: 24th March 2021
Location: 3A Bolas Court, Myaree
Tree species: *Agonis flexuosa* (Weeping Peppermint)

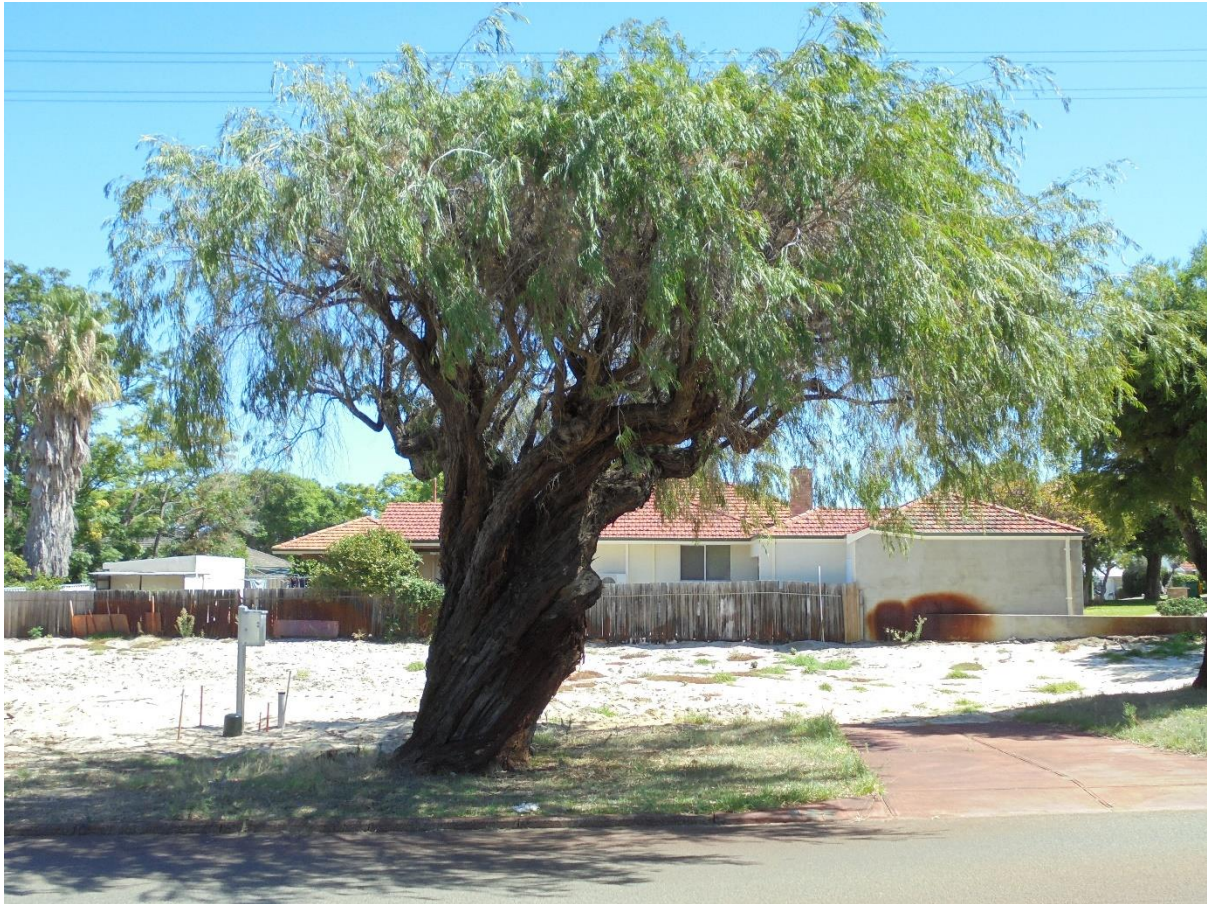
- 2.1. This late mature *Agonis flexuosa* (Weeping Peppermint) is located under low voltage power lines and has a clinometer height reading of 6.1m, with a canopy spread of 7.5m north/south & 8.5m east/west and a trunk diameter of 141cm measured at a height of 1.4m above ground level (Figure 1).
- 2.2. The base of the tree is 2.0m from the roadway and approximately 1.8m from the boundary of the adjacent property.

Figure 1 Displaying the late-mature *Agonis flexuosa* within the verge adjacent no. 3A Bolas Court, Myaree.

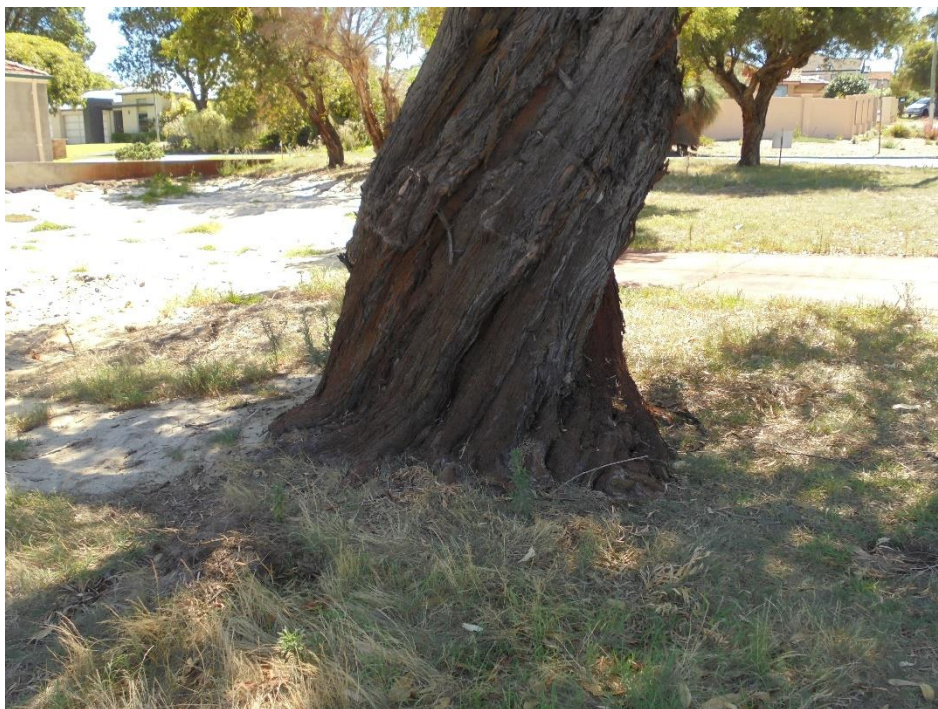
- 3.1. An examination at ground level found the base of this tree to remain predominantly sound with no evidence of significant decay or the development of cavities (Figure 2).
- 3.2. There was no evidence of soil lifting or displacement at the base of the tree and no evidence of bark loss indicative of root decay.
- 3.3. Surface roots were not visible and there was no evidence of damage to adjacent hard infrastructure.

Figure 2 Displaying the base of the tree viewed from the south eastern side.

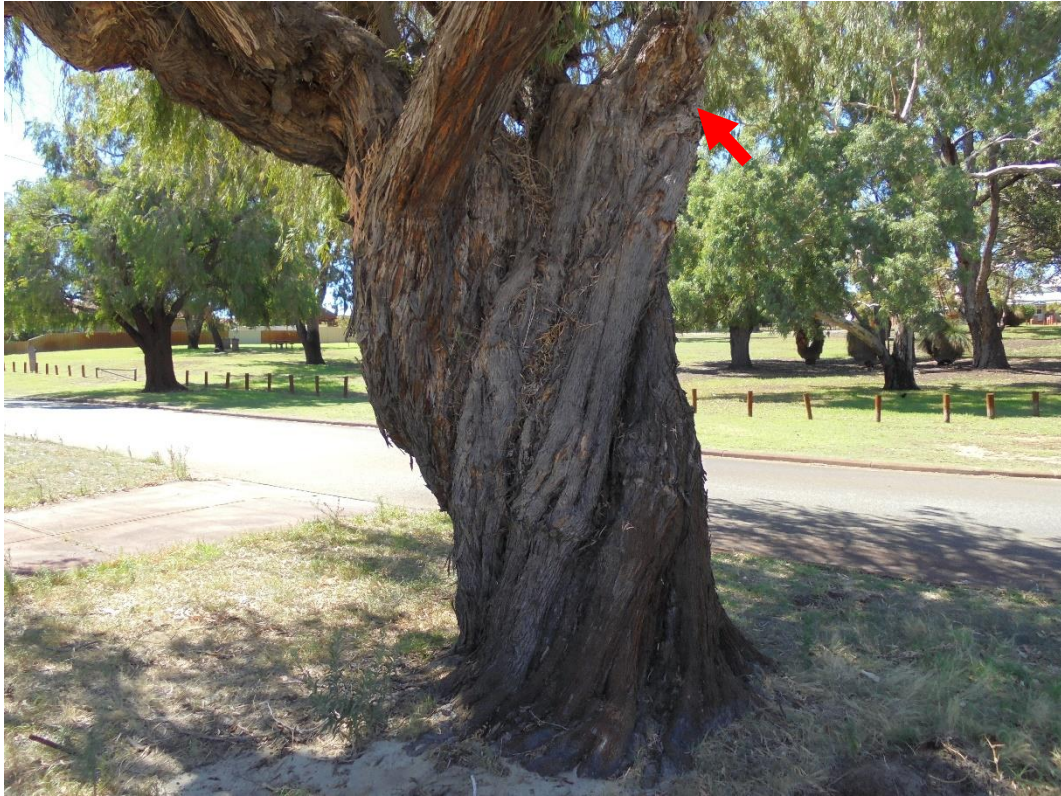
- 4.1. This tree displays a splayed, multi-stemmed form supporting upper limbs and epicormic re-growth in response to periodic pruning typical of mature trees of the species located under power lines (Figures 3 & 4).

- 5.3. Major limbs appeared soundly attached with no evidence of splitting or separation while previous limb failure from the south western side appears due to a mid-stem break and consistent with storm damage.

Figure 3 Displaying the trunk and attachment of main limbs viewed from the south west side and indicating evidence of previous limb failure.

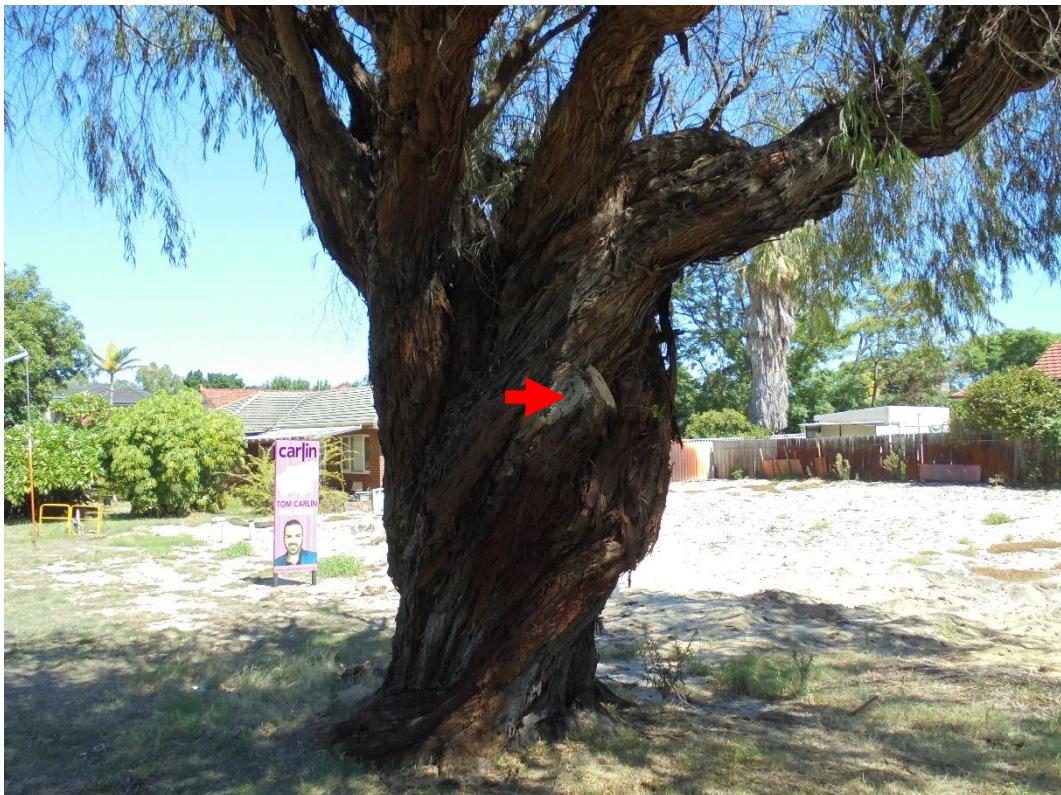
- 4.5. The stub of lower lateral limb previously removed from the north eastern displays visible decay.
- 4.6. Fungal fruiting bodies were not evident and there was no evidence of previous or current termite activity within the supporting stem structure or major limbs.

Figure 4 Displaying the trunk and attachment of main limbs viewed from the south west side and indicating evidence of previous lower limb removal.

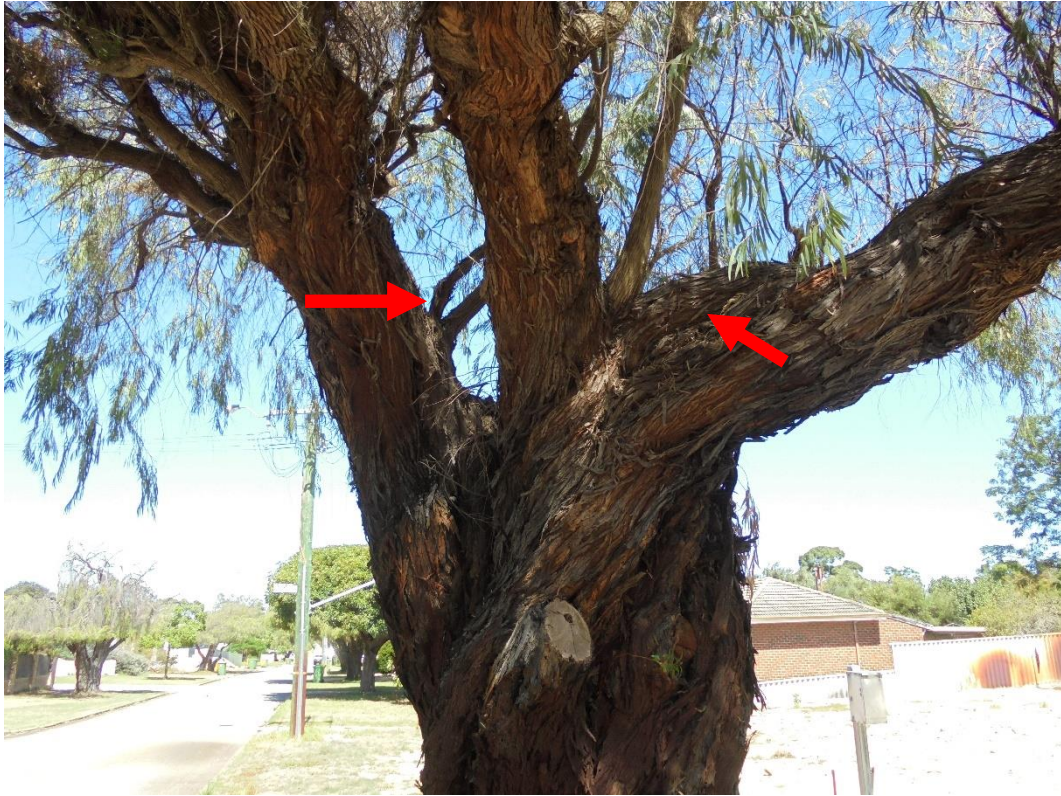
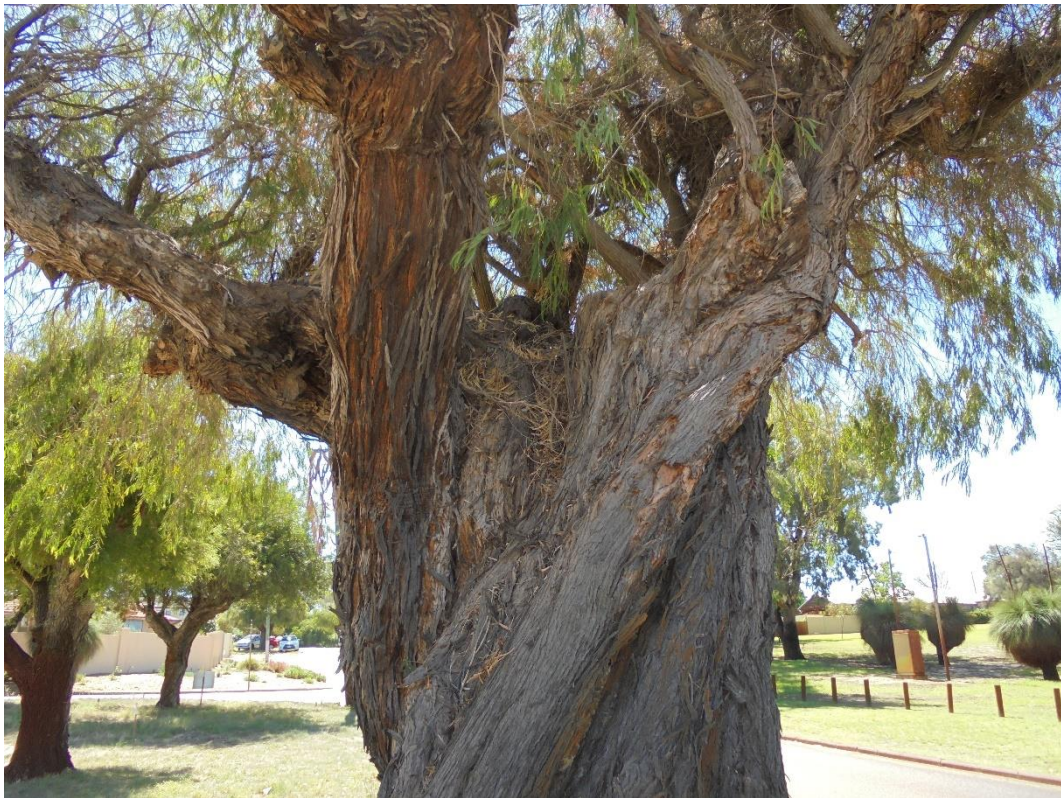
- 5.1. The crown of this tree displays a reduced epicormic form due to maintenance pruning under LV powerlines and a suitable cover of healthy foliage consistent with the form and age of the tree (Figures 5 – 7).

Figures 5 & 6 Displaying the crown structure viewed from the both the northern (above) and southern sides (below) with prominent active secondary growth supporting the trunk and major limbs and predominantly minor epicormic re-growth forming the canopy.

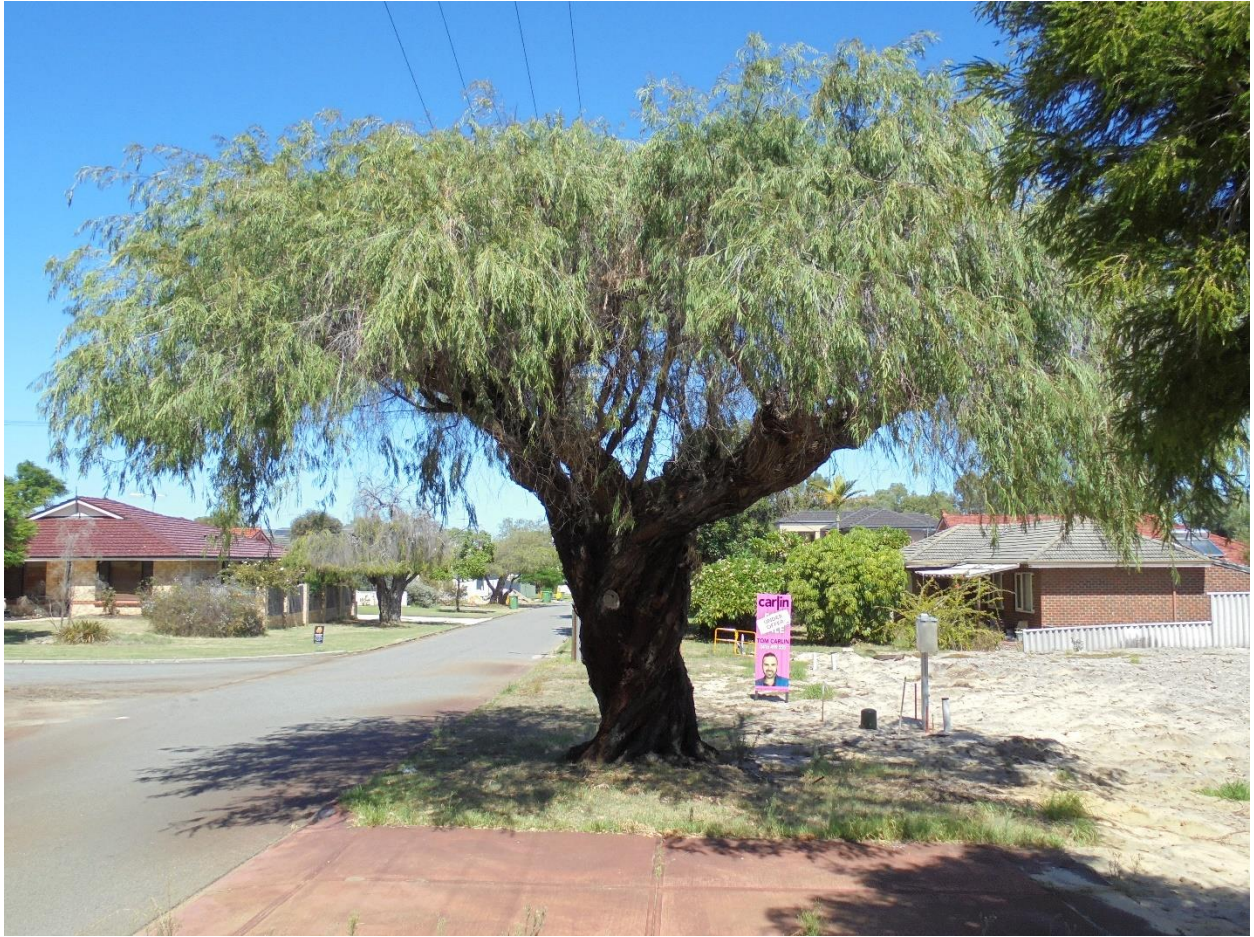
Figure 7 Displaying the crown of the tree viewed from the northern side
