## TREE REPORT

**Client:** City of Melville  
**Contact:** Janine Ahola – Act. Manager Natural Areas & Parks  
**Site:** 63 Ardross Street - Applecross

6 January 2020

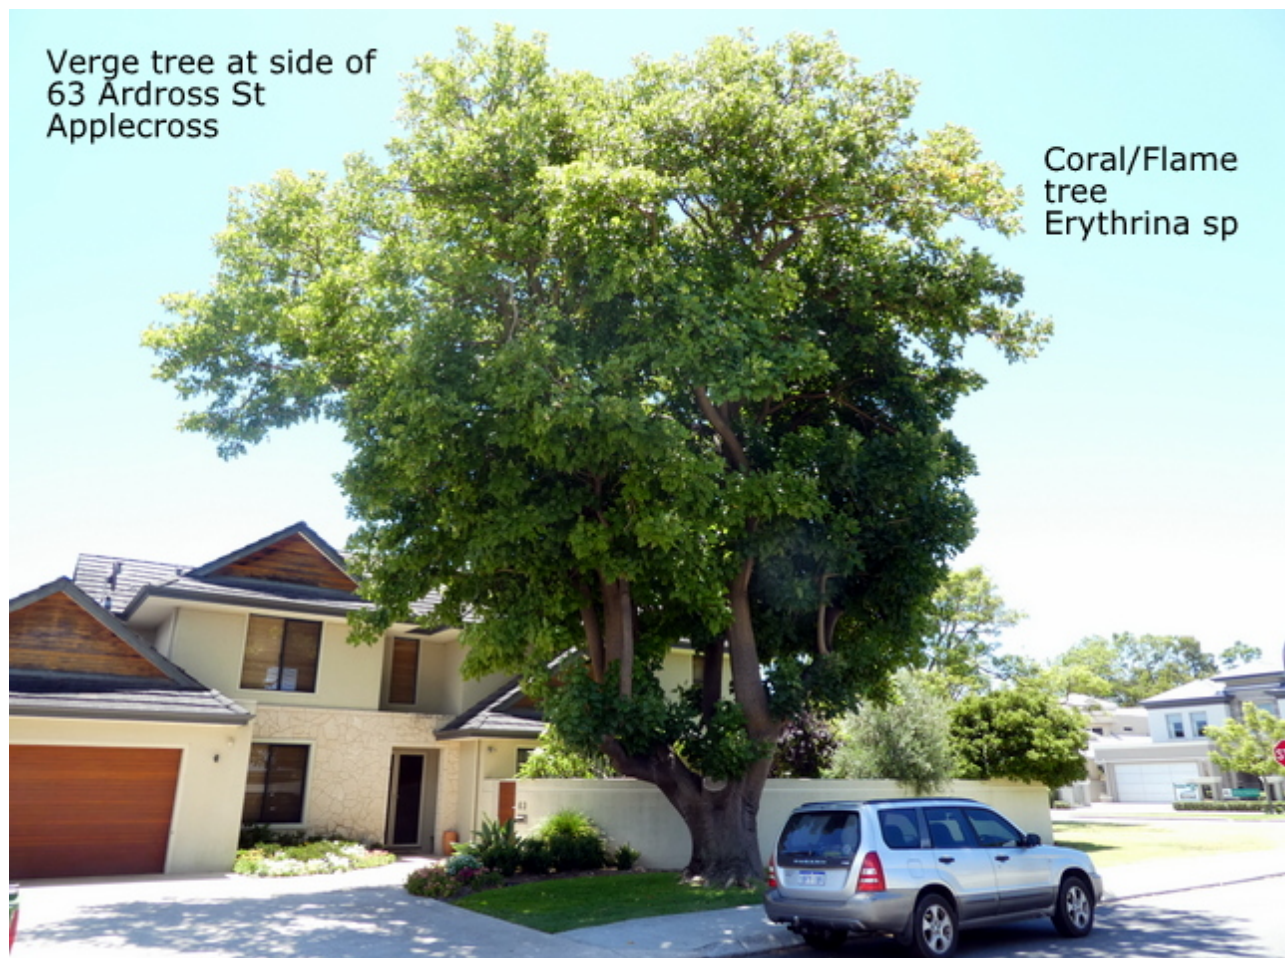
The subject tree is a Coral or Flame tree – *Erythrina* sp – see image below

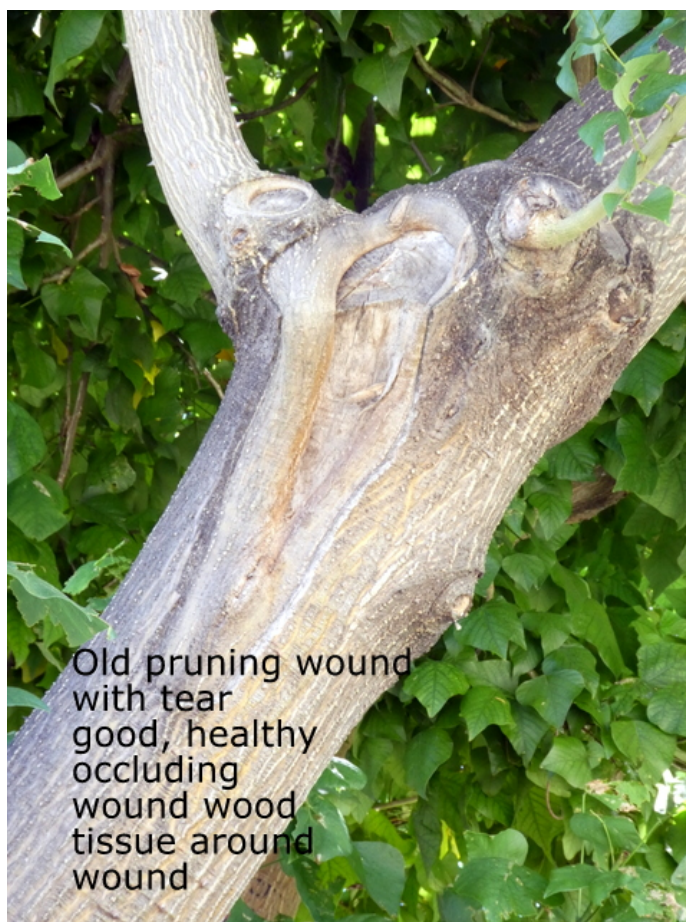
The stem divides at 1.7m agl into three leaders or separate upright stems. At the union of these three leaders is evidence of a former branch removal wound around 400mm in diameter. The exposed wood appears sound. Behind this wound on the property side is a partially lopped branch that has most of its bark missing. The exposed wood appears sound.

The tree has a slight lean to the north. The tree has a history of lopping and/or topping that has taken place at around 2.5 – 3m agl – above ground level. The regrowth appears sound and healthy. There is evidence of an old branch failure wound at around 6.5m agl on the road side. The wound wood tissue surrounding this wound appears healthy and there is no evidence of decay in this area. There is a branch removal wound with a tear in the low crown east side near the road – see image below. The exposed wood appears sound. There is evidence of branch removal wounds in the low crown property side. The exposed wood in all of these old wound sites appears sound.

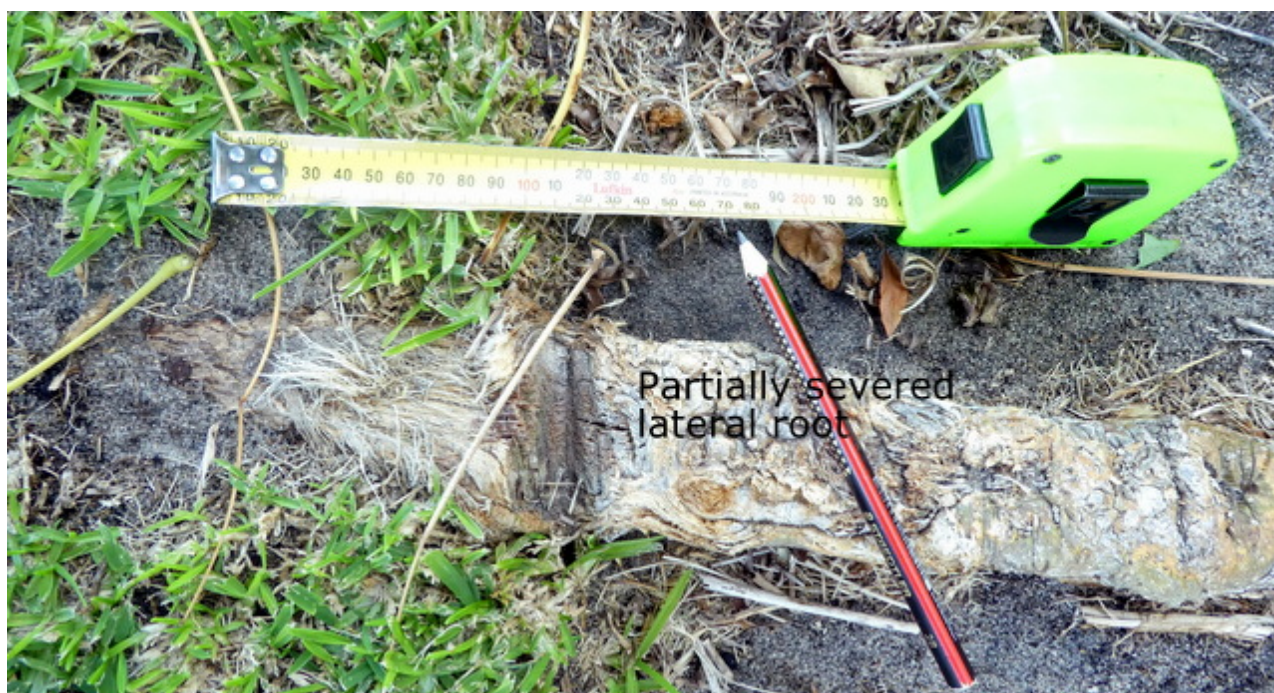
There is evidence of a partially exposed lateral root lying between the grass verge and a garden bed on the property side. The partially cut root is 75mm in diameter – see image below.
