Arboricultural Inspection Advice for City of Melville

Date inspected: 9th January 2020
Location: 63 Ardross Street (Munro Road verge), Applecross.
Tree species: *Erythrina x sykesii* (Coral Tree)

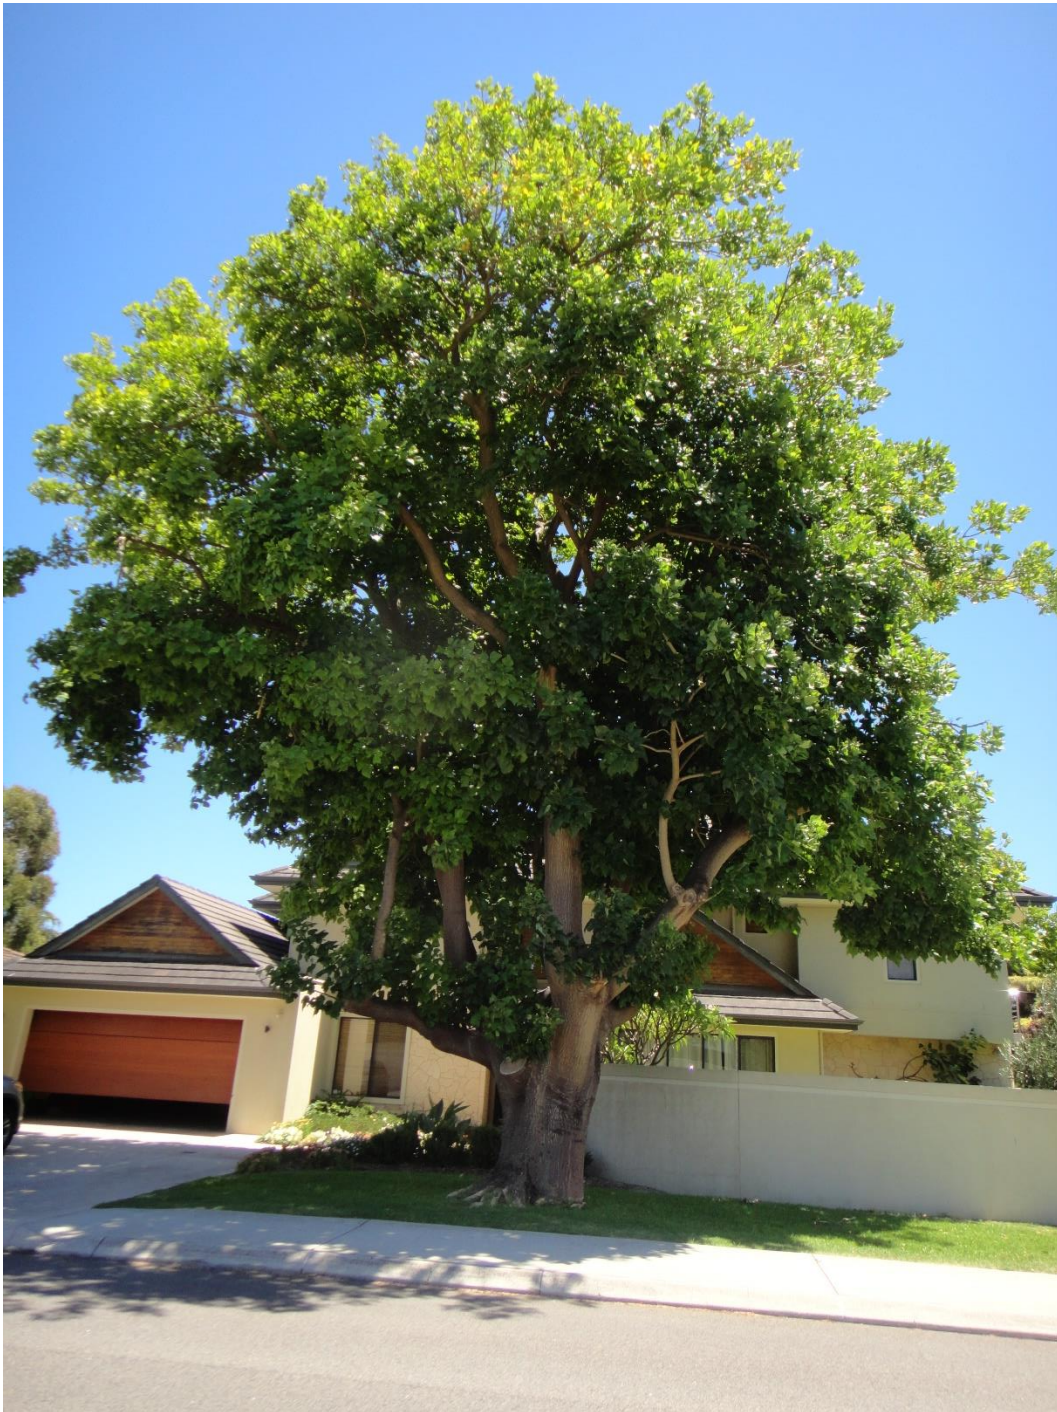
- This mature tree has a clinometer height reading of 16.2m with a canopy spread of approximately 14.0m and 104cm diameter measured at 1.0m above ground level due to the form (Figure 1).

Figure 1 Displaying the *Erythrina x sykesii* (Coral Tree) located within the verge adjacent no. 63 Ardross Street (Munro Road verge), Applecross.

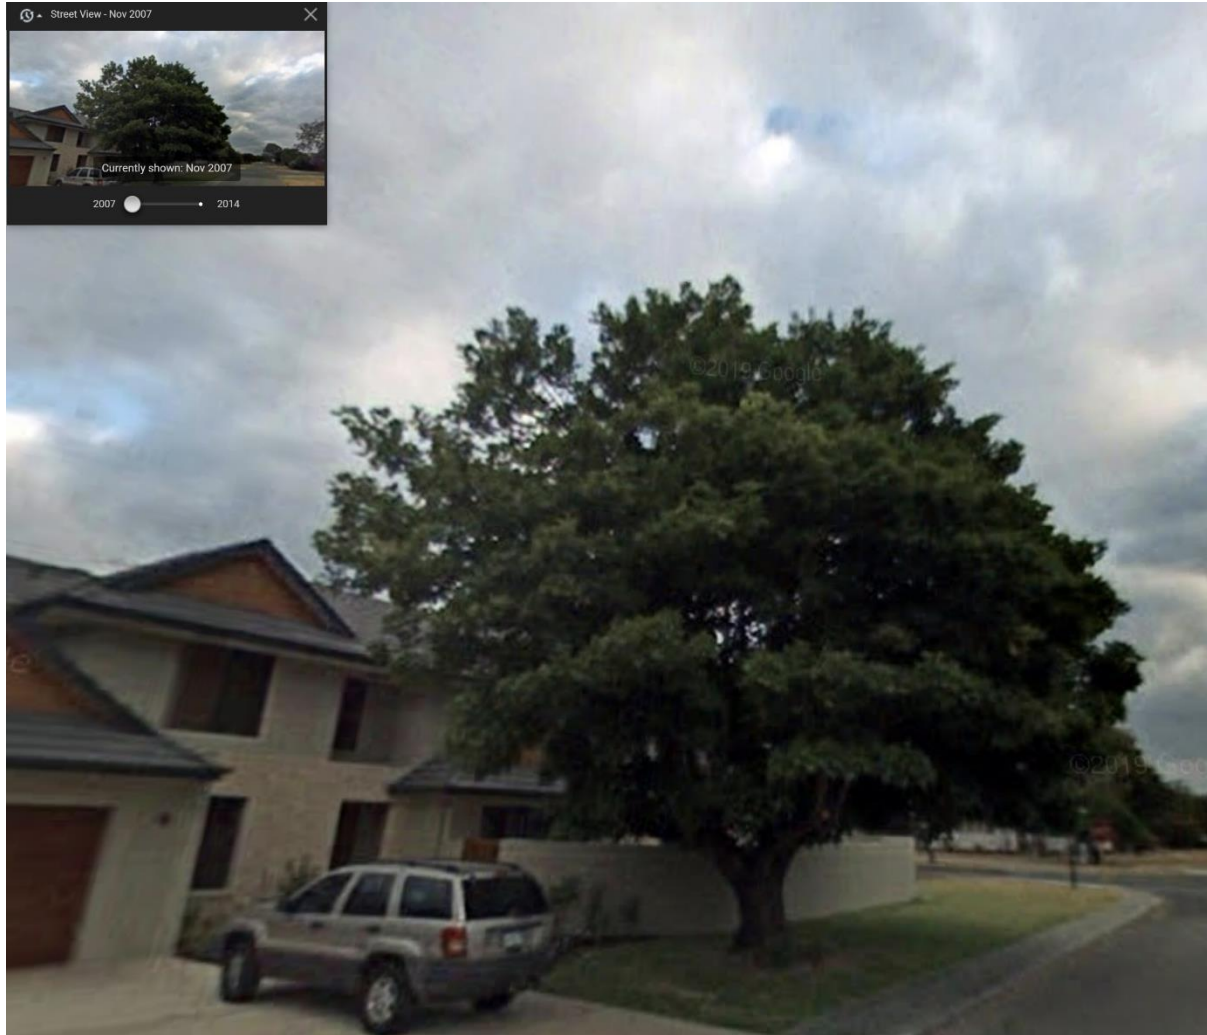
- The tree was found to be in good health and poor structural condition and displays a full canopy of dense foliage.
- Previous lopping of the canopy at a height of 1.5m has encouraged a mature epicormic limb structure. A google Streetview image dated November 2007 displays the tree with a structure indicating that the reduction of limbs occurred prior to this date (Figure 2).

Figure 2 Displays the Google Streetview image of the tree dated November 2007

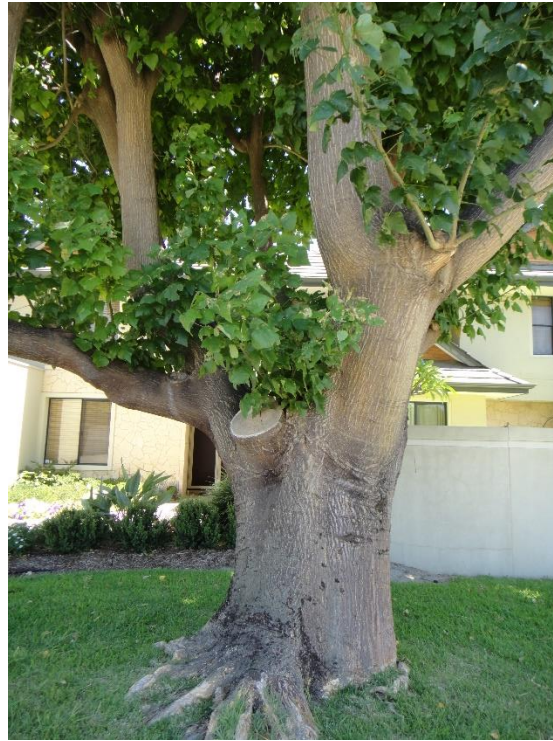
- The base of the tree appears root firm with no visible soil lifting or displacement consistent with root plate movement (Figure 3).
- Exposed root flare displays some mechanical damage consistent with turf maintenance machinery.

Figure 3 Displaying the base of the tree and attachment of major limbs.

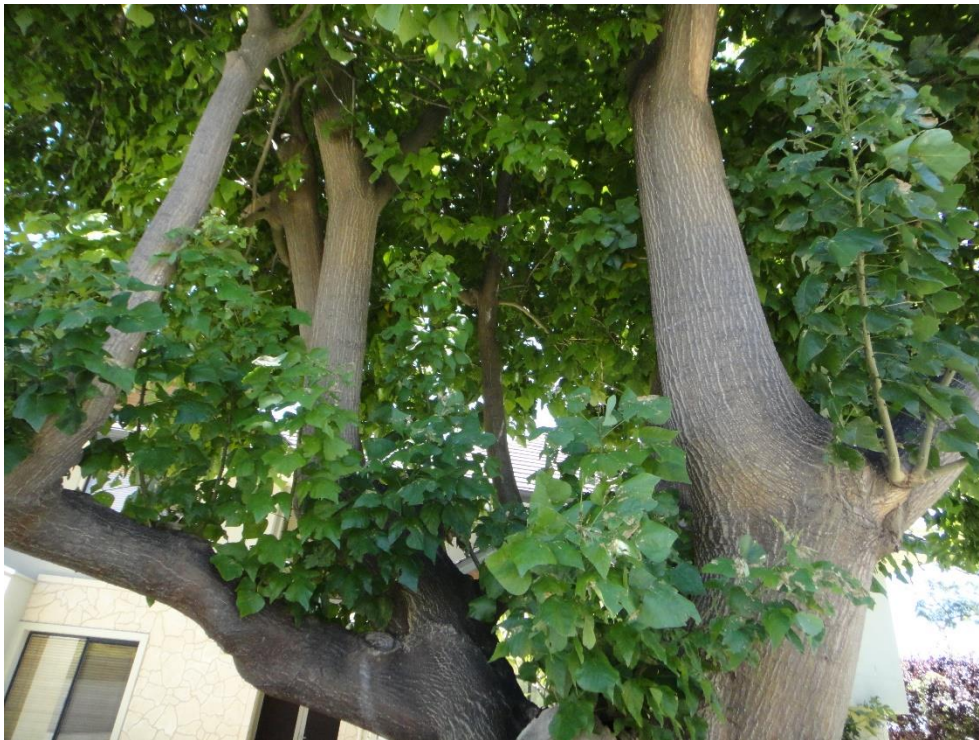
- Major limbs consisting of mature epicormic stems were found to be soundly attached at their point of emergence with no evidence of cracking, splitting or separation visible at this time (Figure 4).

Figure 4 Displaying the extension of the main mature epicormic stems which form into the canopy structure and the attachment of lateral limbs with previous pruning & development of small epicormic growth evident.

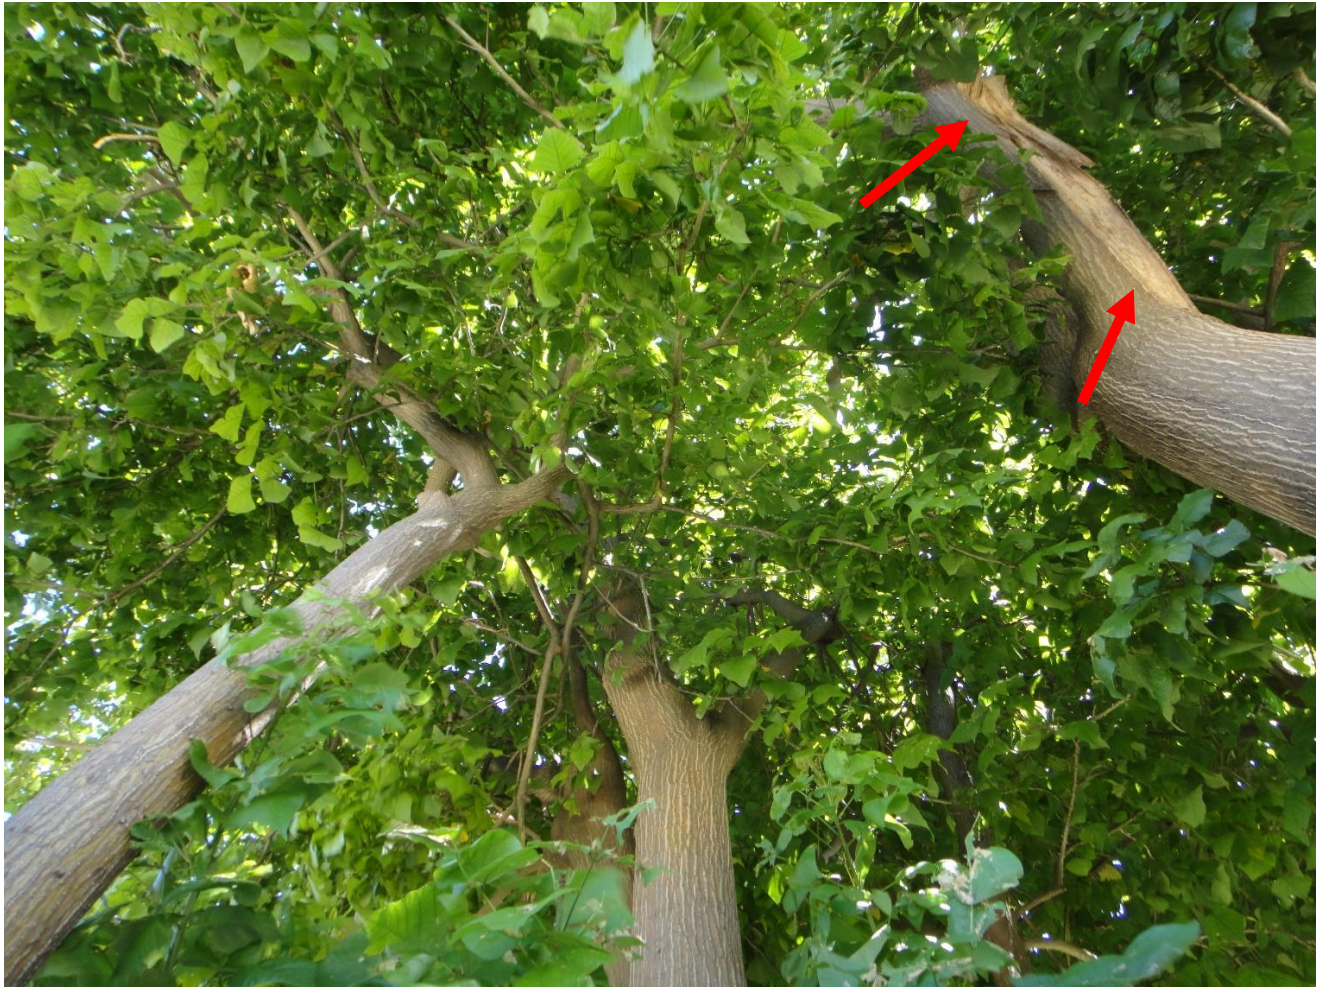
- Pruning wounds throughout the canopy display healthy occlusion indicative of the tree's vitality.
- Clustered epicormic growth throughout the canopy with some crossing and conflicting limbs is a result of previous pruning. Sporadic limbs are held over the property boundary, crossover and verge displaying bending and arching consistent with excessive limb loading.
- A recent significant limb failure was evident over the footpath which has resulted in a longitudinal bark tear.
- Due to the dense foliage coverage much of the upper limb structure is obscured when viewed from ground level (Figure 5).
- The canopy extends approximately 2.0m over the adjacent property but does not overhang the residence (Figure 6).

Figure 5 Displays the congested limb structure and dense foliage. Arrow depicts the recent limb failure resulting in a tear.

- Conduct a property boundary line clearance prune to sound growth points.
- Reduce end load of limbs bending and arching which are held over the verge and crossover.
- Selectively thin crossed and conflicting epicormic limbs from within the canopy without creating open spaces or lion tailing.
- Re-inspect in 12 months.

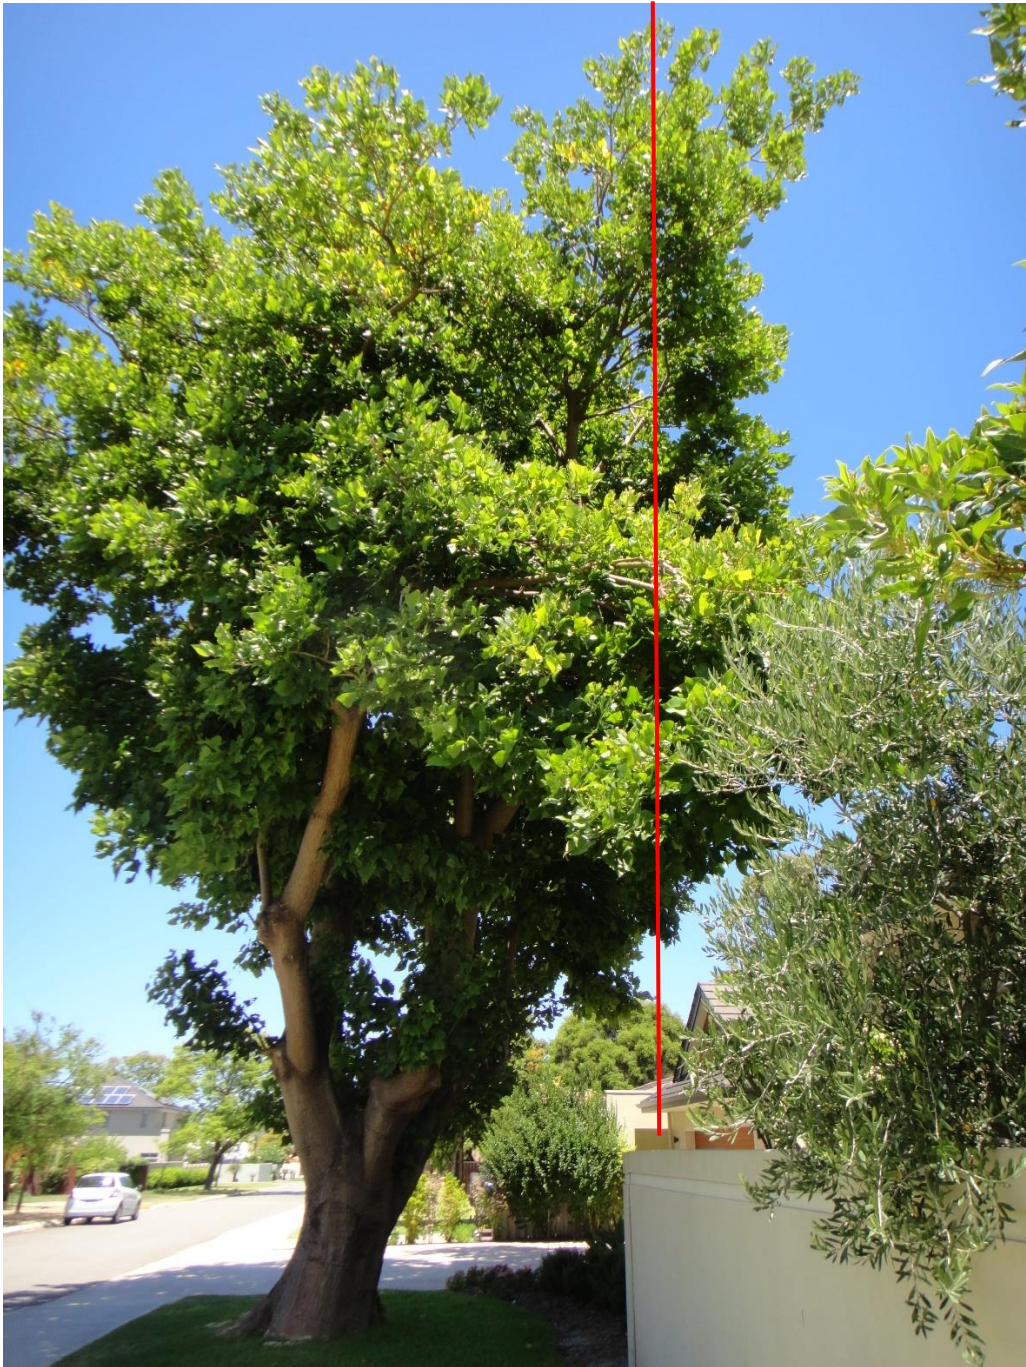
Figure 6 Displaying the amount of foliage held over the property boundary.
