**City of Melville**

**FORESHORE MANAGEMENT PLAN**

**October 2025**  
**For City of Melville**

<b>Report</b>	<b>25001.RPT001</b>			
<b>Version</b>	<b>Date</b>	<b>Prepared by</b>	<b>Review/Approval</b>	<b>Issue Details</b>
1	16.10.25	RT, ME, KT	JS, DW	Draft 1 for comment
2	15.07.2025	RT, ME	JS, DW	Draft 2 for review
3	16.10.2025	RT	JS	Final Document Issue

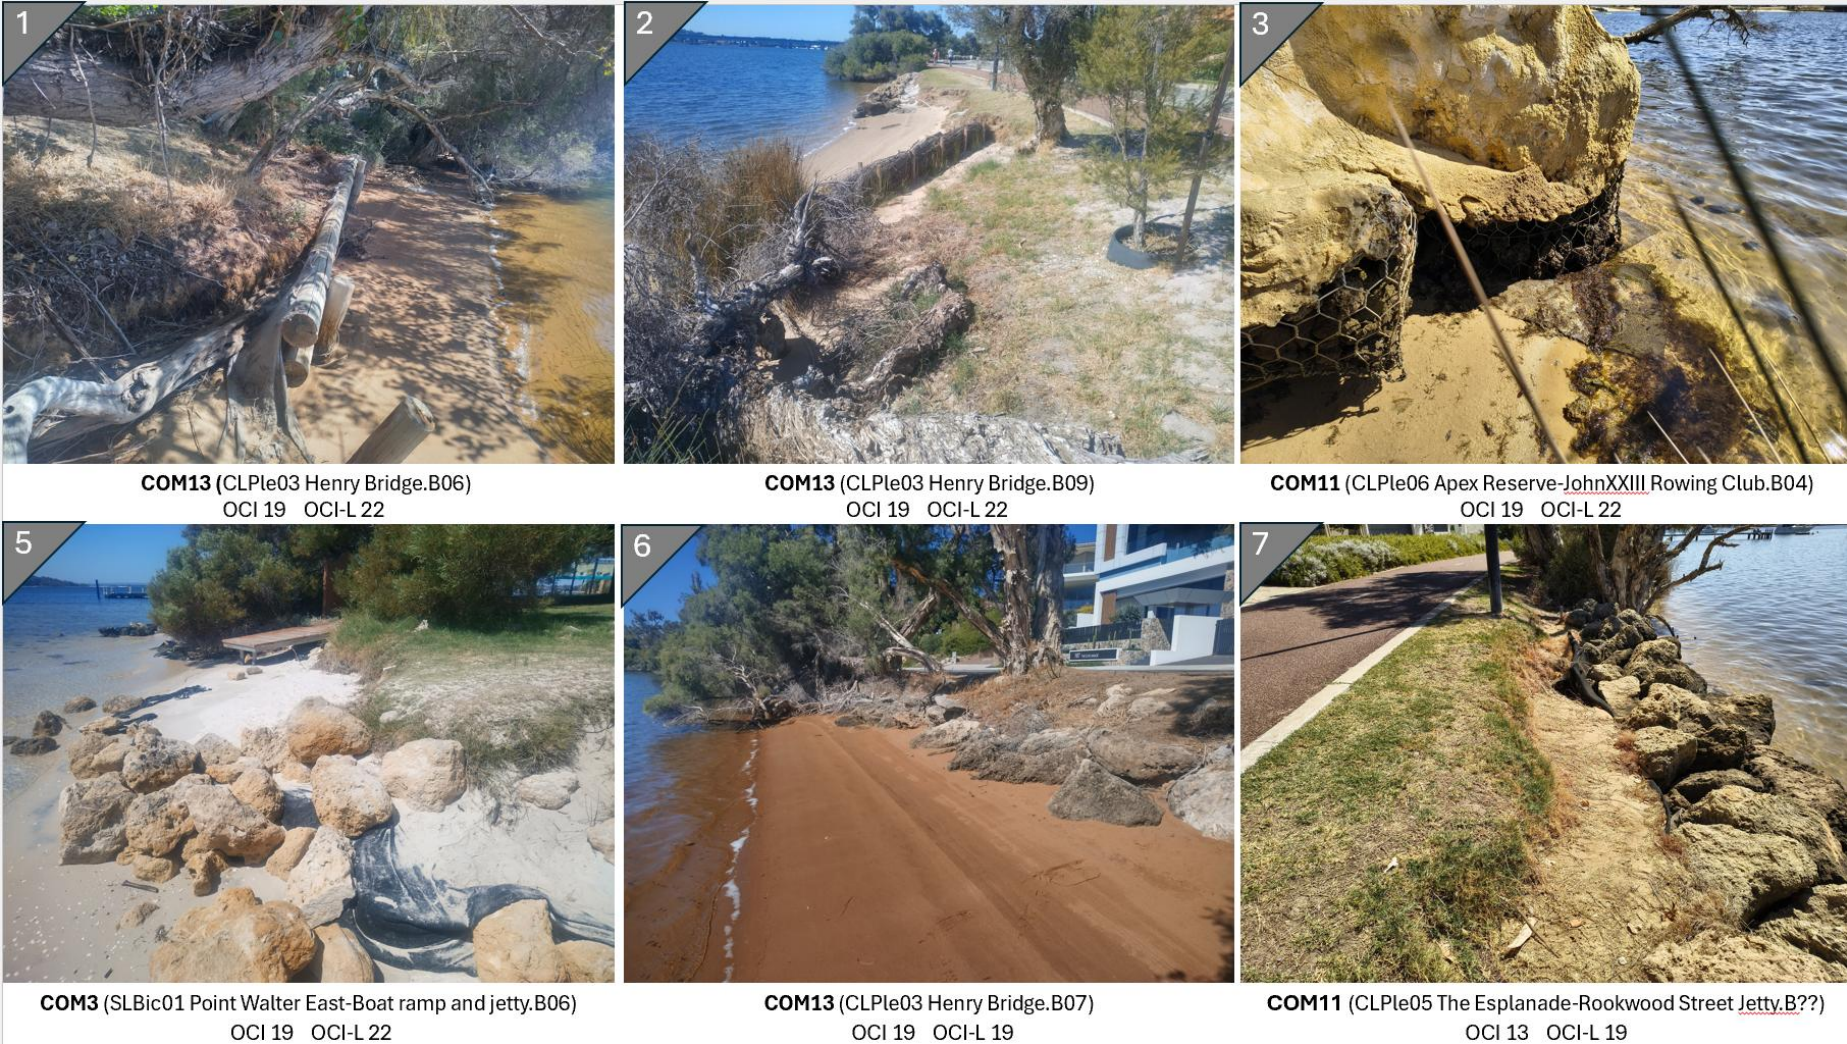
Figure 34. Selected high OCl 'Built' segment location images.

COM	Segment Name (DBCA)	OCI (2019)	OCI (2025)	OCI-L
13	CLPle03 Henry Bridge.B06	13	19	22
13	CLPle03 Henry Bridge.B09	18	19	22
11	CLPle06 Apex Reserve-John XXIII Rowing Club.B04	3 (new)	19	22
3	SLBic01 Point Walter East-Boat ramp and jetty.B06	13	19	22
10	SLApl01 Beach Rd to Coffee Point Reserve.B04	18	19	22
13	CLPle03 Henry Bridge.B07	13	19	19
11	CLPle05 The Esplanade-Rookwood Street Jetty.B??	not assessed	13	19
11	CLPle06 Apex Reserve-John XXIII Rowing Club.B01	13	13	19
10	SLApl01 Beach Rd to Coffee Point Reserve.B05	13	13	19

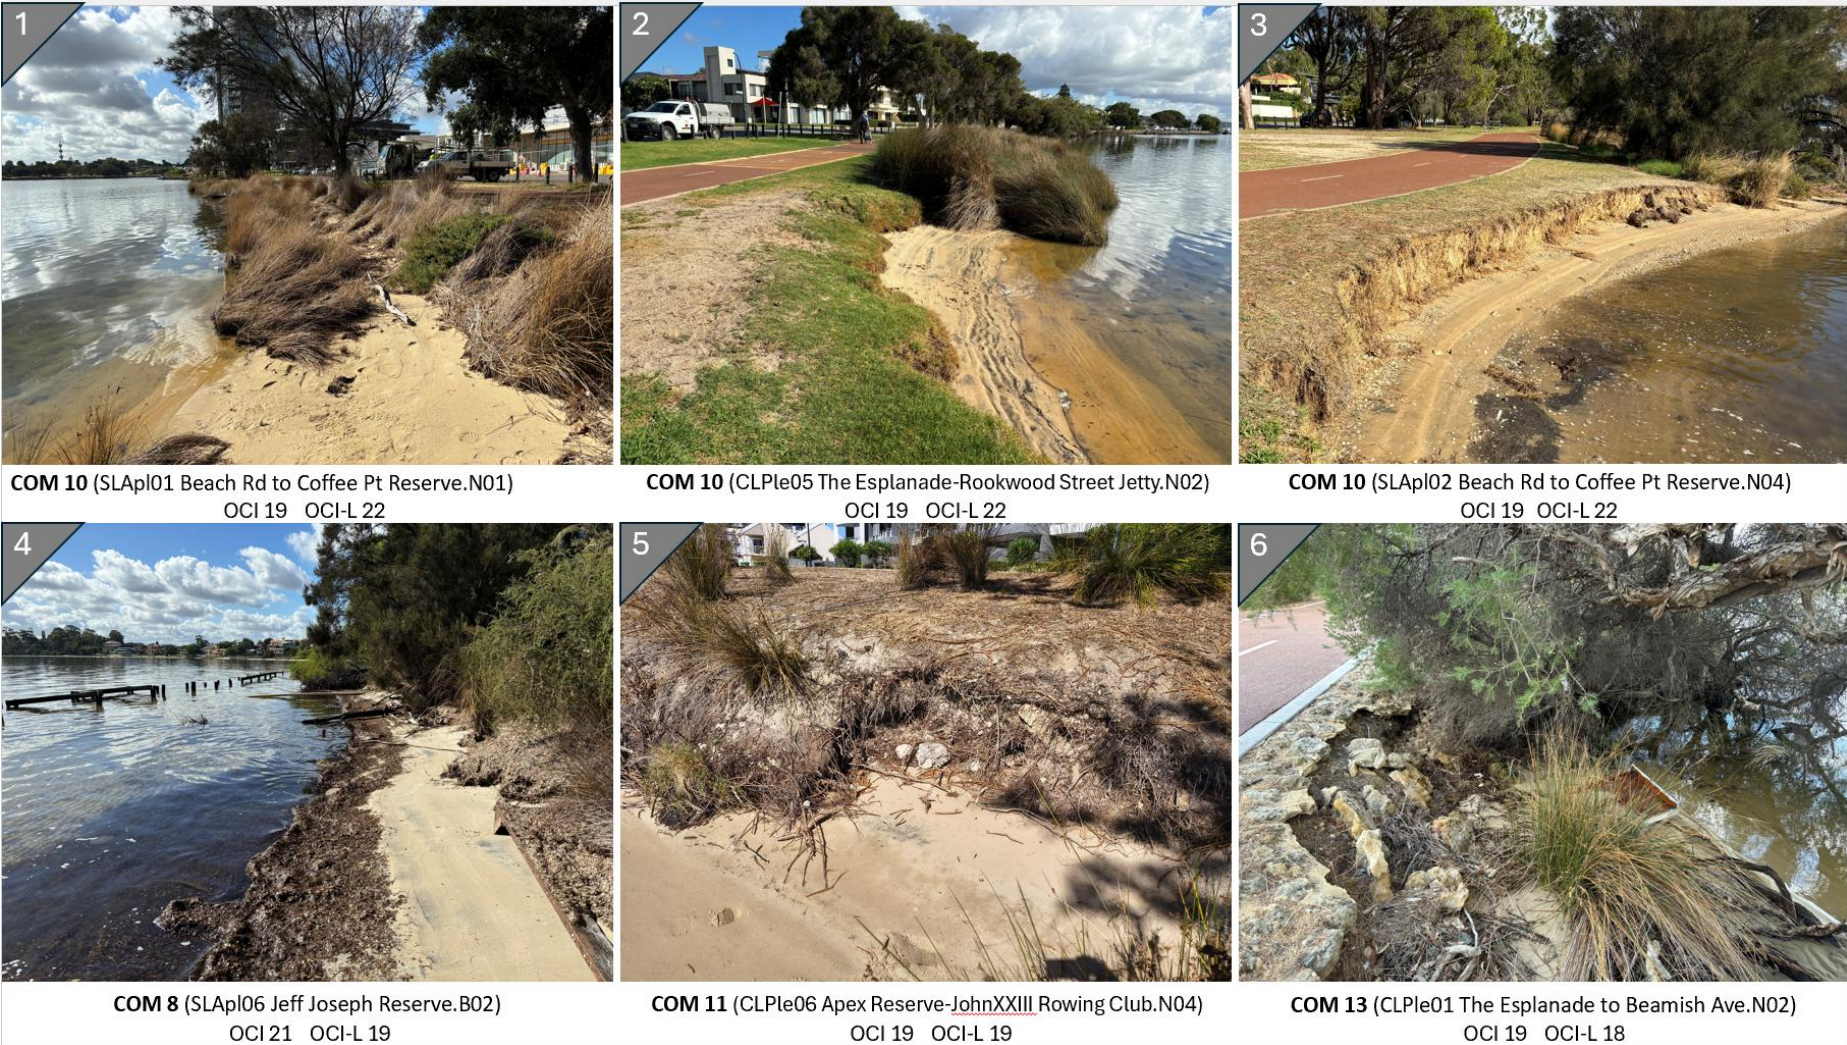
Figure 36. Selected high OCI 'Natural' segment location images (a).

COM	Segment Name (DBCA)	OCI (2019)	OCI (2025)	OCI-L
10	SLApl01 Beach Rd to Coffee Pt Reserve.N01	19	19	22
10	SLApl01 Beach Rd to Coffee Pt Reserve.N02	19	19	22
10	SLApl02 Beach Rd to Coffee Pt Reserve.N04	19	19	22
8	SLApl06 Jeff Joseph Reserve.B02	19	19	21
11	CLPle06 Apex Reserve-John XXIII Rowing Club.N04	19	19	19
13	CLPle01 The Esplanade to Beamish Ave.N02	not assessed	19	18
13	CLPle02 The Esplanade to Regents Wy.N01	not assessed	13	18
11	CLPle05 The Esplanade-Rookwood Street Jetty.N02	21	13	19
11	CLPle05 The Esplanade-Rookwood Street Jetty.N03	20	13	19
11	CLPle06 Apex Reserve to John XXIII Rowing Club.N01	20	13	19
11	CLPle06 Apex Reserve to John XXIII Rowing Club.N02	20	13	19
7	SLApl07 Point Dundas Boardwalk -Jeff Joseph Res.N02	19	13	19

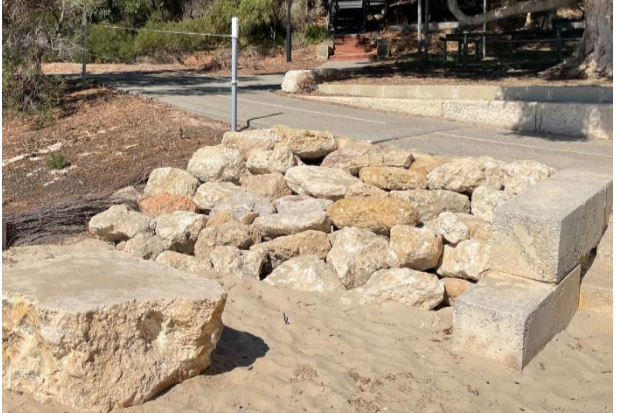
This area has been rehabilitated, however additional areas are showing degradation - Refer to site specific report cards.

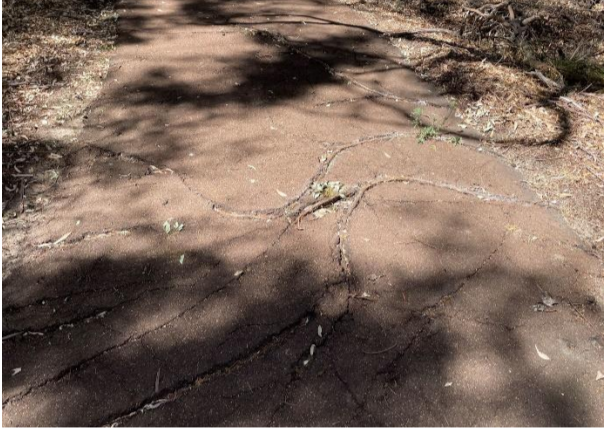
Tree roots are still present and growing through the bitumen path. Path needs repair.
BC3	Repair the damaged drainage outlet located at the path providing access to the river at Spinaway Crescent.	Does not appear to have occurred.	Drain headwall is new however the pipe behind is exposed (not buried fully) and sedges are growing in front of the drain - monitor to check if sedge trimming / removal is required to facilitate stormwater flows.
BC4	Assess usage and access to the boardwalk located within the wetlands at Bateman Park.	Two wooden planks are rotted and need replacement. Most of structure good condition	Four damaged planks, Minor splits and paint loss on handrails and surface corrosion on fixings (GHD, 2024)

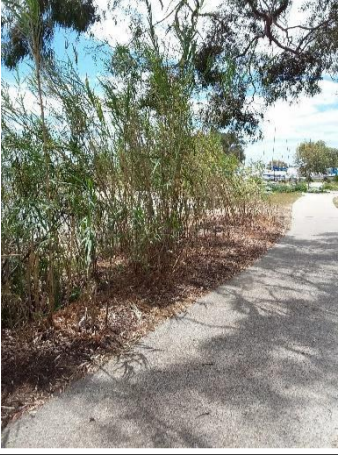
Giant reed was removed (mechanically) and sprayed. There is an ongoing management for regrowth.
<b>PHWB3</b>	Connect vegetation along The Strand and Jeff Joseph Reserve through revegetation	Does not appear to have taken place. Replacement of asset has been undertaken	Additional planting was conducted near Sea scout club, however the area is largely impacted by turf grasses such as Couch.
<b>PHWB4</b>	Maintain weed control within the areas of vegetation in good condition in Jeff Joseph Reserve	Some control work is apparent; however ongoing work is required.	Weed control is ongoing. Some improvements achieved, however further control of turf grasses particularly Couch, mature Canary palm and poplar trees is required.
