City of Melville

FORESHORE MANAGEMENT PLAN

October 2025
For City of Melville

Report	25001.RPT001			
Version	Date	Prepared by	Review/Approval	Issue Details
1	16.10.25	RT, ME, KT	JS, DW	Draft 1 for comment
2	15.07.2025	RT, ME	JS, DW	Draft 2 for review
3	16.10.2025	RT	JS	Final Document Issue

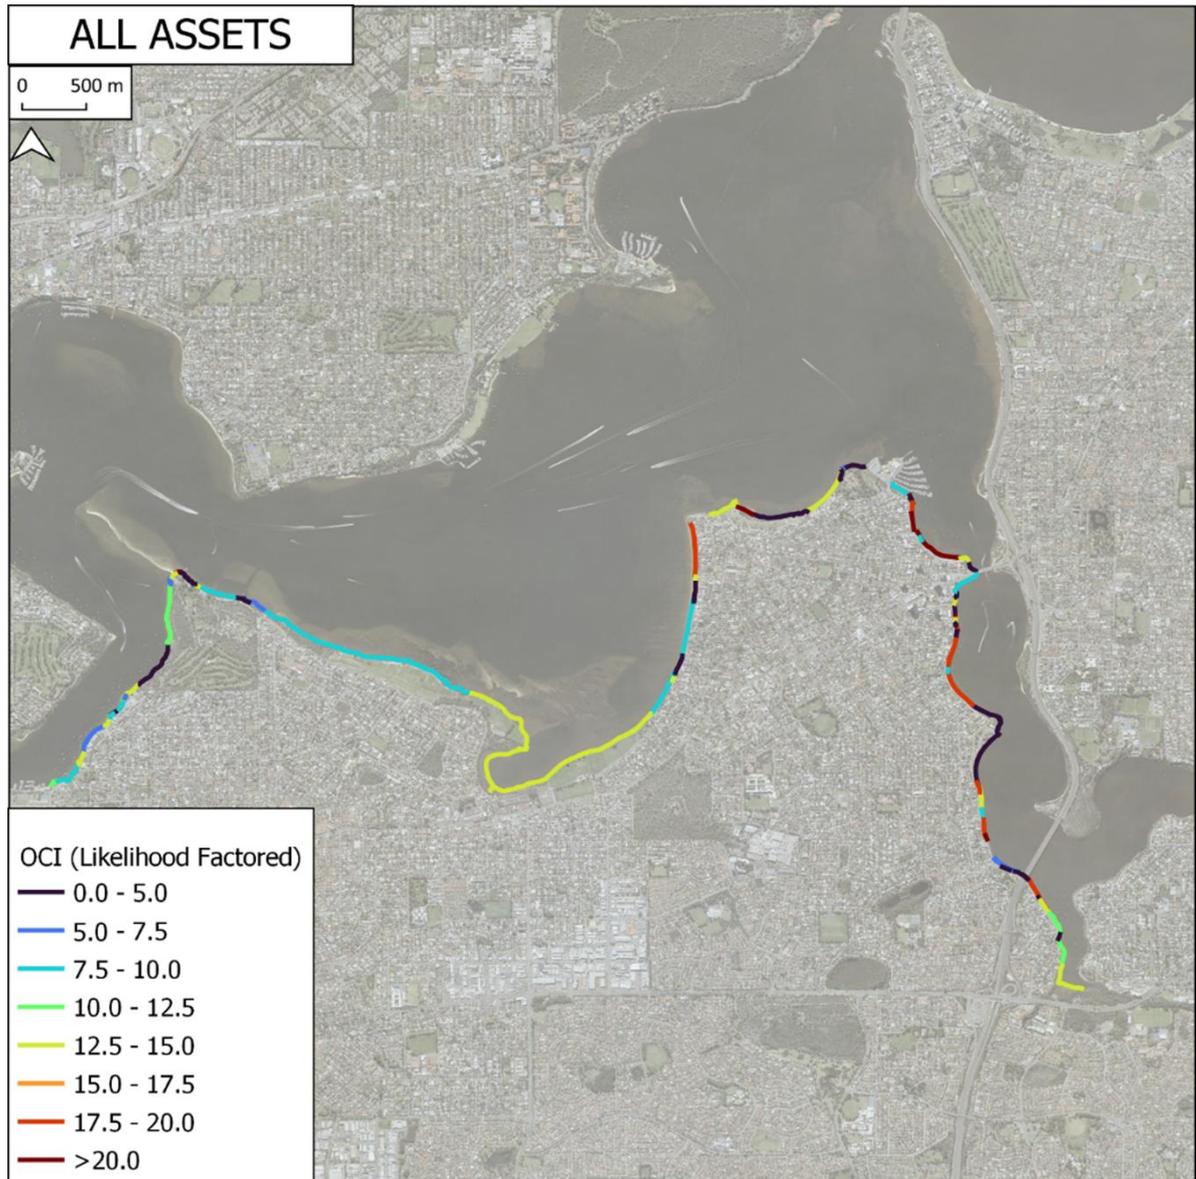
Figure 32. Asset overall condition index, including likelihood.

- Narrow riparian zones along the Canning River foreshore, which typically give higher ratings.
- Erosion in beach areas, with net loss and small scarps.

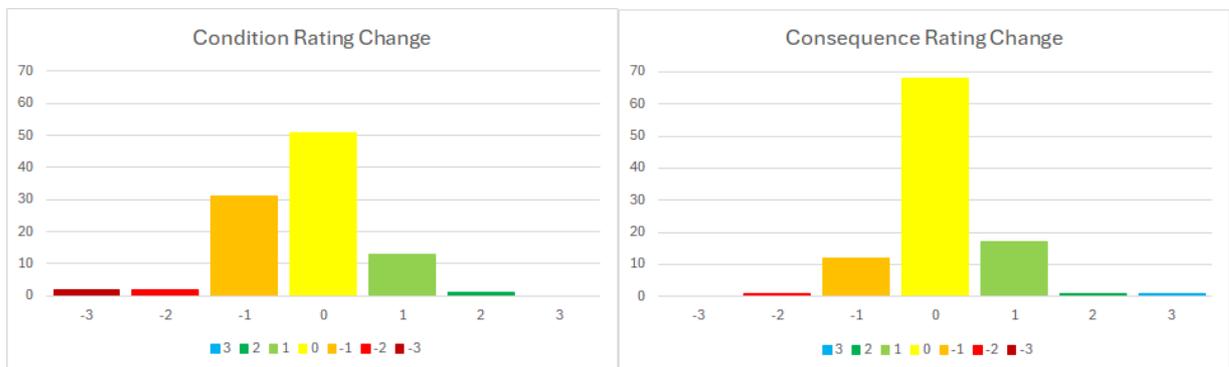
Figure 38. Foreshore asset condition rating differences 2019 to 2025.

A comparison of condition and consequence ratings from GHD (2019b) suggests a slight degradation of foreshore condition, with 35% of assets rated worse than in 2019 and 13% given an improved condition rating. Consequence ratings remained 68% unchanged, with slight variations evidently due to differences in rating schedules. During inspection, it was noted that many areas of Attadale and Canning River foreshore were in better condition than had been observed across multiple site visits over 2020-2024, potentially due to seasonal change, with March having the lowest wave and water level conditions, helping to provide a beach buffer at many sites.

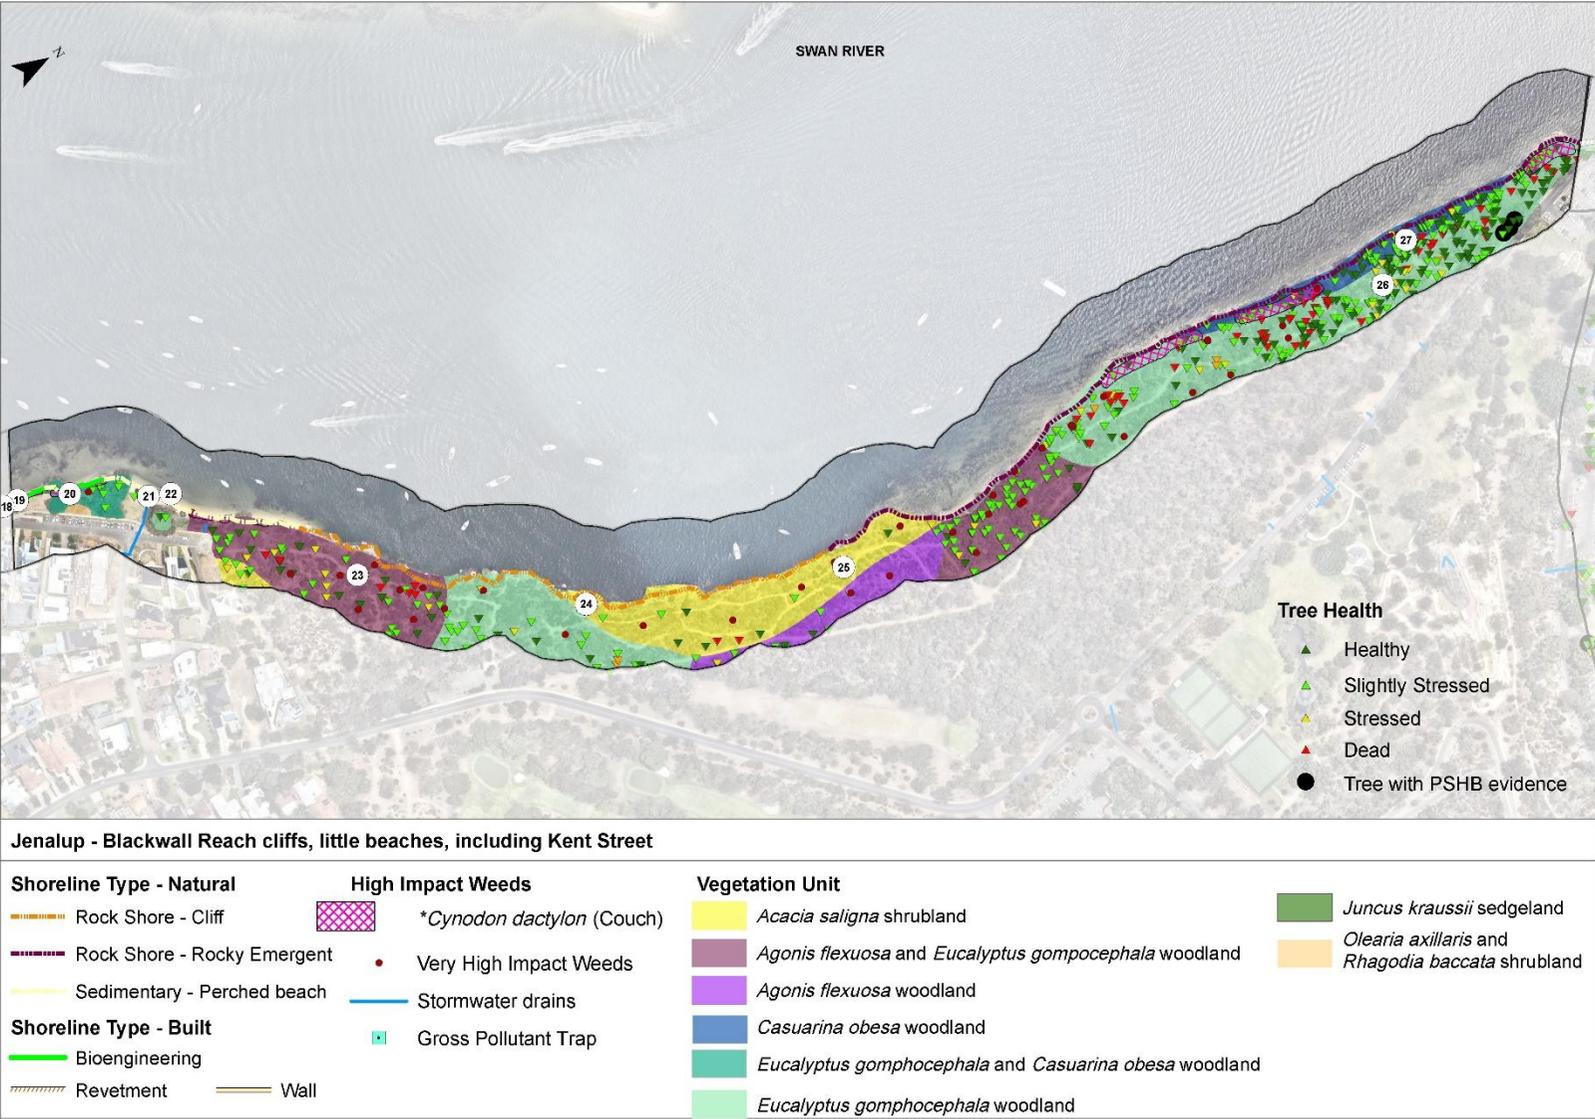
Figure 40. Jenalup - Blackwall Reach cliffs, little beaches, including Kent Street key management action sites

Note: Condition of viewing platforms on the cliffs was not examined beyond visual appearance. The composite decking is in serviceable condition; however, many boards are warping. The inspection and servicing of these platforms is scheduled on a regular basis via the City's asset management system outside of aquatic assets like jetties or boardwalks over water, and hence not elaborated on in the FMP.

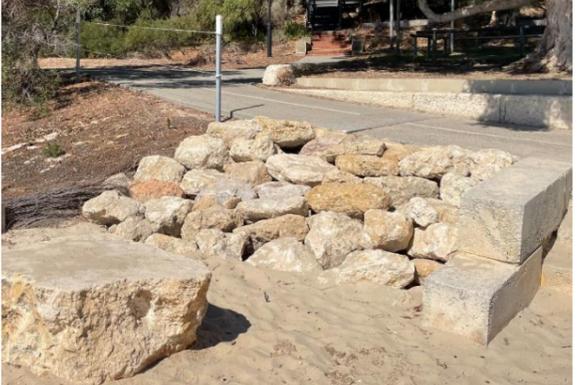
This area has been rehabilitated, however additional areas are showing degradation - Refer to site specific report cards.

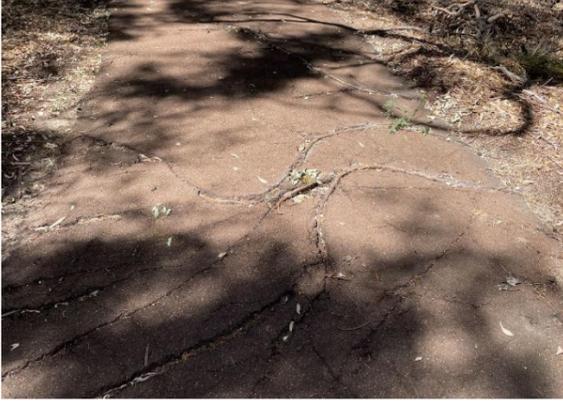
Tree roots are still present and growing through the bitumen path. Path needs repair.

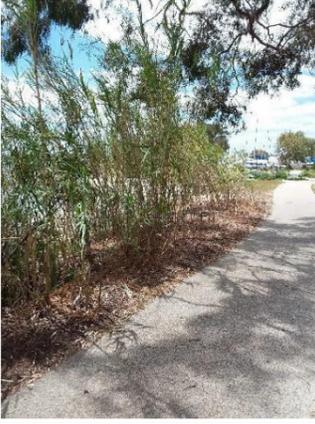
Giant reed was removed (mechanically) and sprayed. There is an ongoing management for regrowth.
PHWB3	Connect vegetation along The Strand and Jeff Joseph Reserve through revegetation	Does not appear to have taken place. Replacement of asset has been undertaken	Additional planting was conducted near Sea scout club, however the area is largely impacted by turf grasses such as Couch.
PHWB4	Maintain weed control within the areas of vegetation in good condition in Jeff Joseph Reserve	Some control work is apparent; however ongoing work is required.	Weed control is ongoing. Some improvements achieved, however further control of turf grasses particularly Couch, mature Canary palm and poplar trees is required.
