# Water and sediment quality in the Bull Creek catchment and City of Melville lakes 2021

Prepared by the South East Regional Centre for Urban Landcare  
for the City of Melville

**DRAFT December 2022**

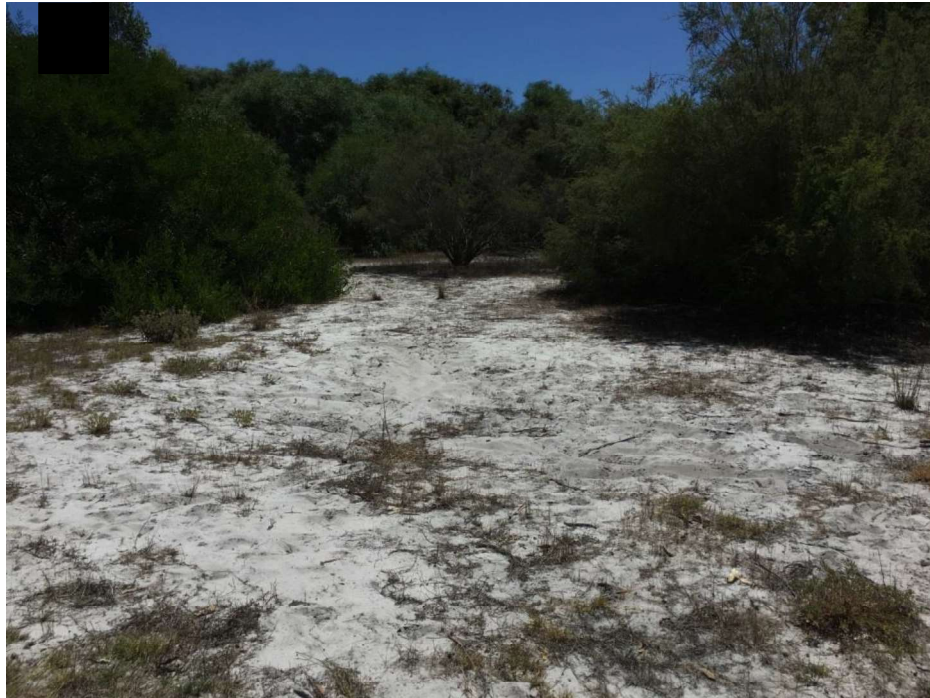
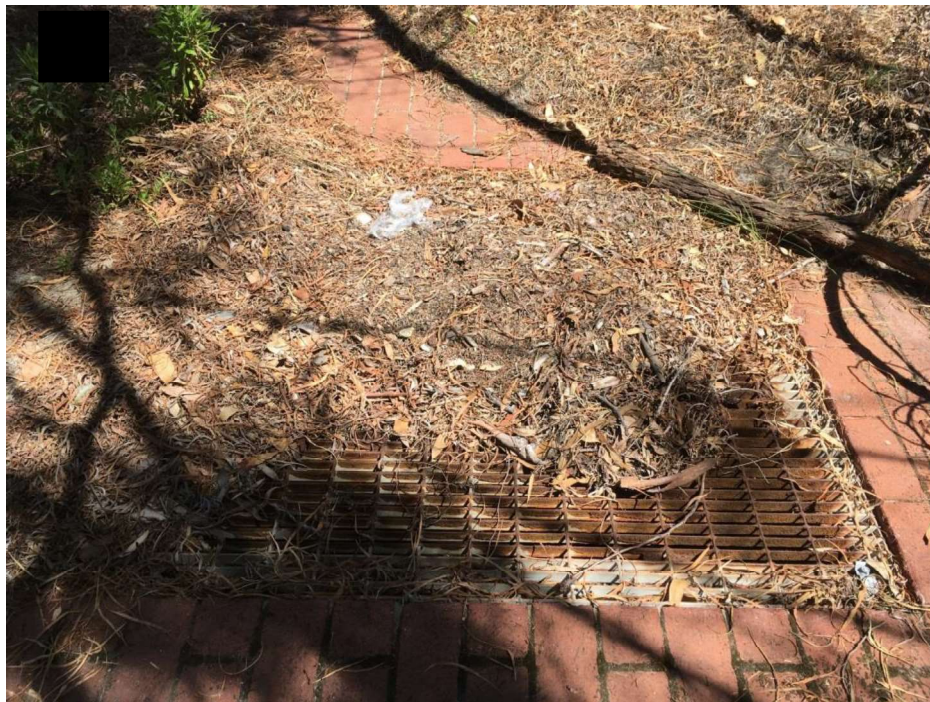
**Figures 218. A) Sandy area in Trevor Gribble Park compensation basin where planting is recommended; B) grate in Trevor Gribble Park compensation basin with leaf litter and sediment sitting on top.**

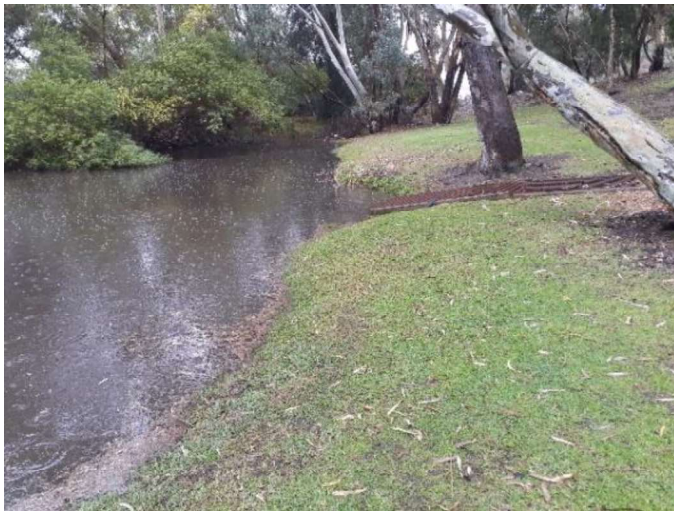
**Figure 219. John Creaney Park Outlet (MELDR-05). The outlet is more open and surrounded by grassy areas. This location is likely to be influenced by fertilisers and urban wastes to a larger extent than more vegetated areas. Additional recommendations – revegetation and redesign drain to restore natural meanders. Dolva 140722**

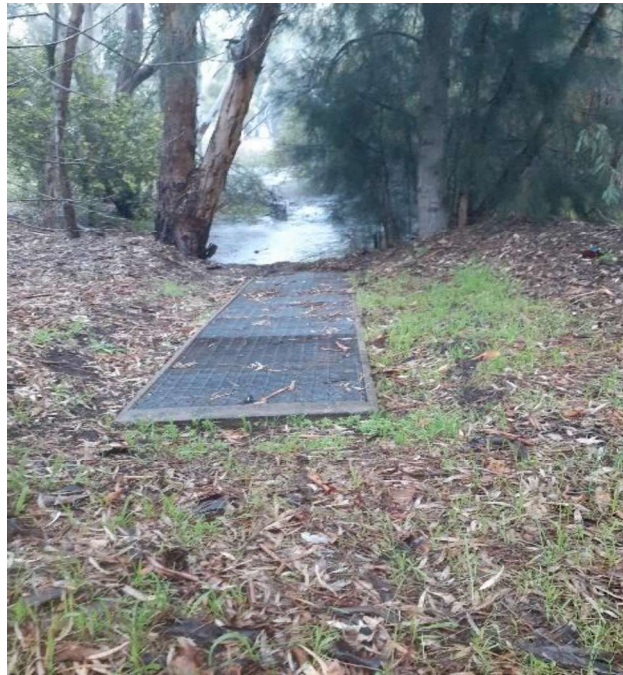
**Figure 220. John Creaney Park Inlet (MELDR-15). The inlet is surrounded by native vegetation and deep litter layers. These features assist maintaining ecosystem integrity but contributes to organic litter entering the lake.**

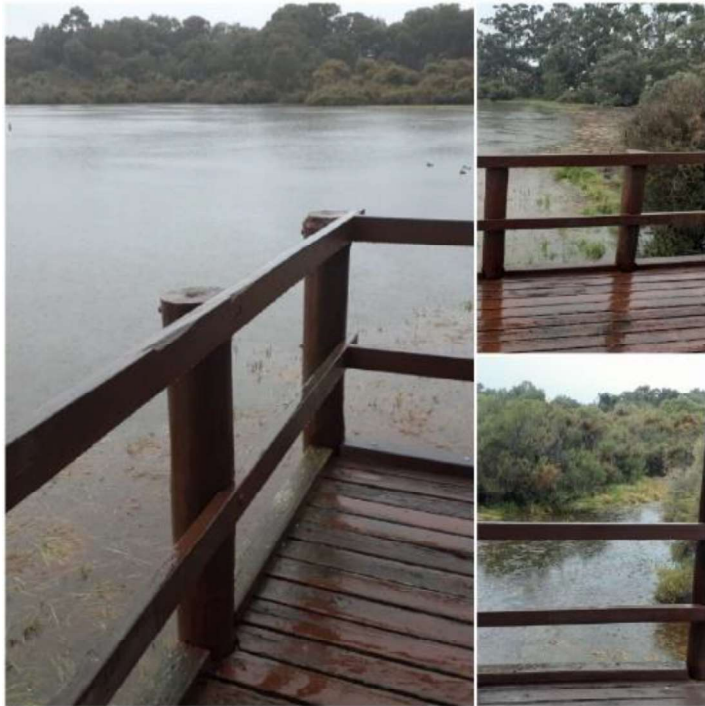
**Figure 226. Collage showing the view across Booragoon Lake at the end of the walkway. Views of the edge towards the NE (top) and SW (bottom) are included to the right. 14/07/22 Dolva**

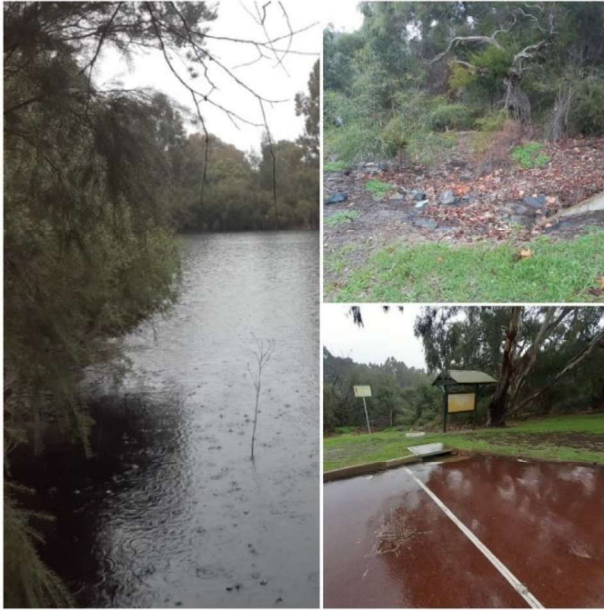
**Figure 227. Collage showing images of Blue Gum Lake. The main image shows a view to the North. The top right image shows the outlet closer to the lake and the bottom right the street drain that flows directly into the lake near the outlet.**

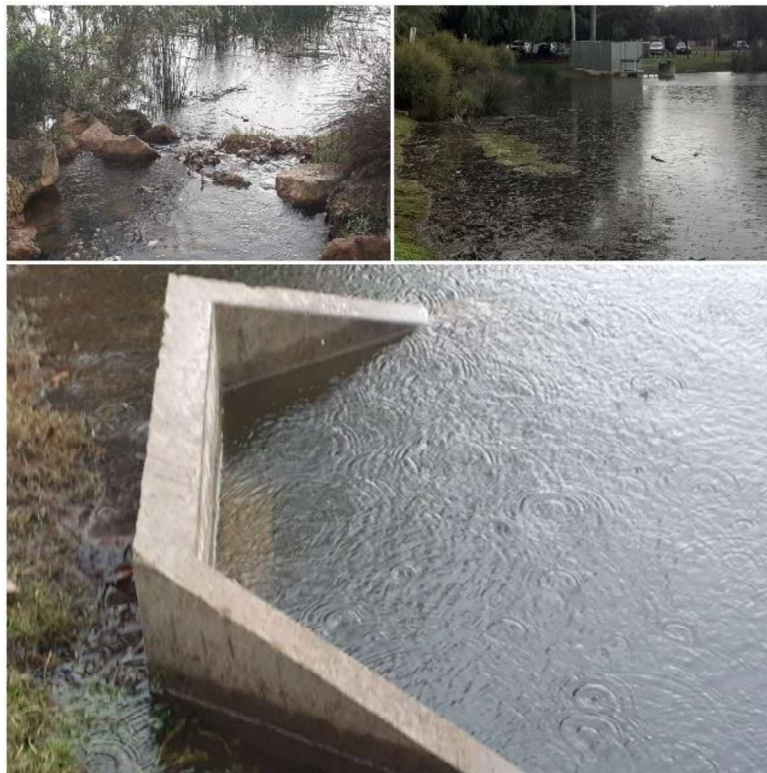
**Figure 229. Collage of images of Marmion Reserve. Top left – riffle inflow from a drain. Top right – view towards outlet. Bottom – submersed inflow pipe. 14/07/22 Dolva**
