**14 BEACH STREET, BICTON  
BUILDING CODE COMPLIANCE REPORT**

A site inspection of the retaining wall at 14 Beach Street, Bicton, was carried out at 3pm on the 9 December 2022. The inspection was carried out from 12 Beach Street.

Project details	
Our ref:	2022-4510
Document:	BCA Compliance Report
Project:	14 Beach Street, Bicton
Client:	City of Melville
Designer:	N/A
Builder:	N/A

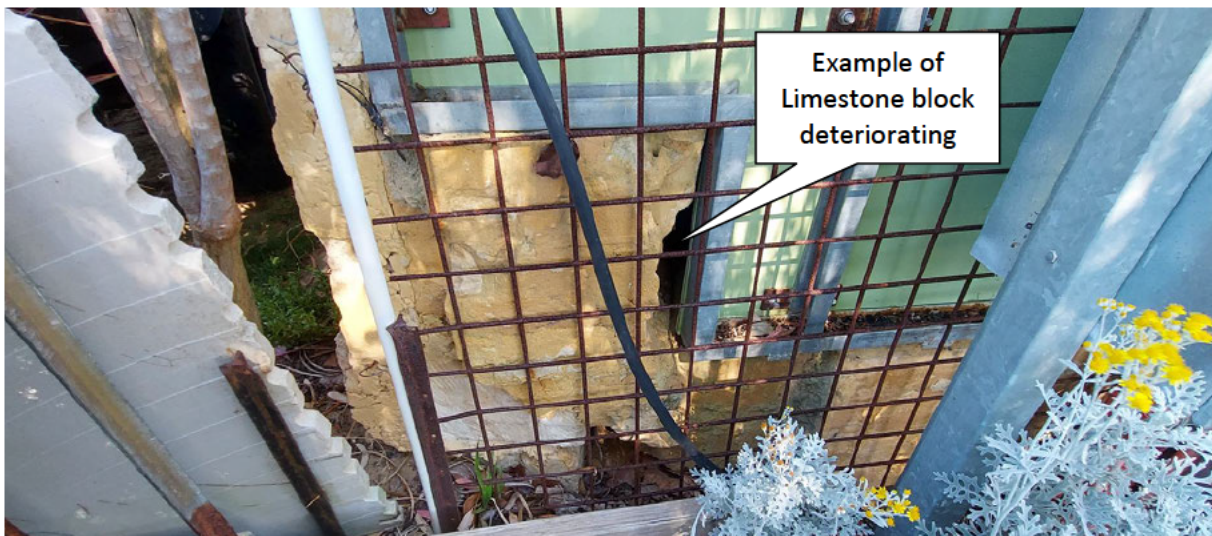
The following photos show the existing limestone block retaining wall located adjacent to the side allotment boundary with 12 Beach Street. Photo 1 shows the retaining wall at the front boundary, with subsequent photos showing the retaining wall as you move along the side allotment boundary towards the rear, with Photo 37 showing the retaining wall at the rear allotment boundary of 14 Beach Street.

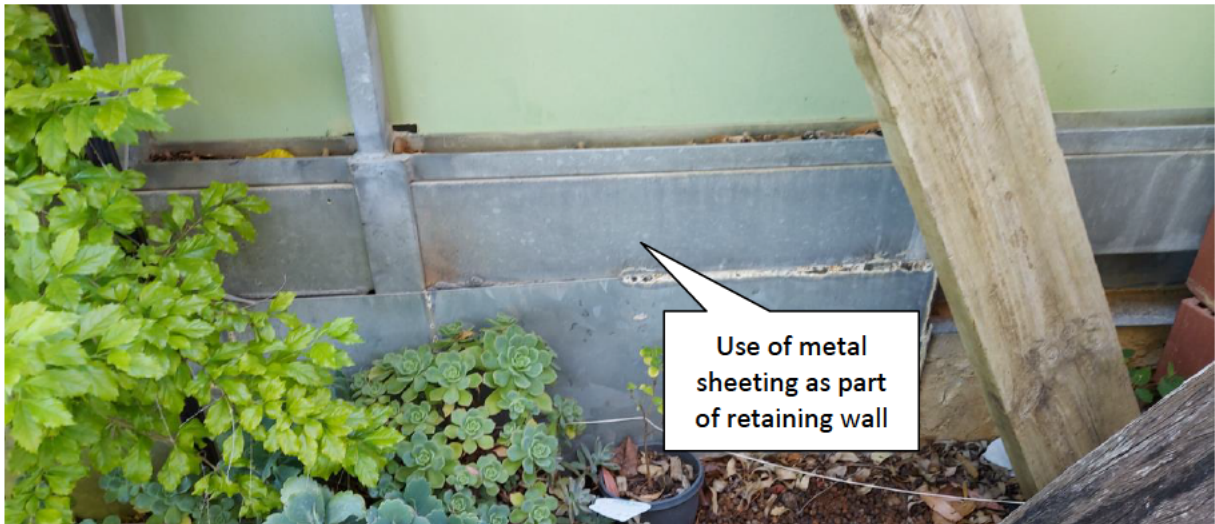
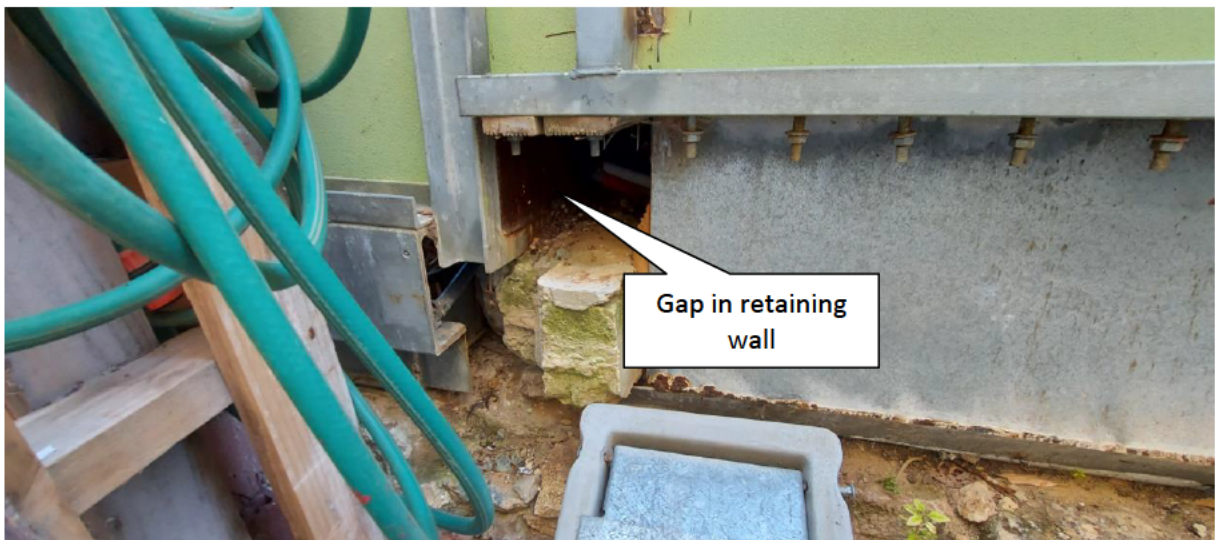
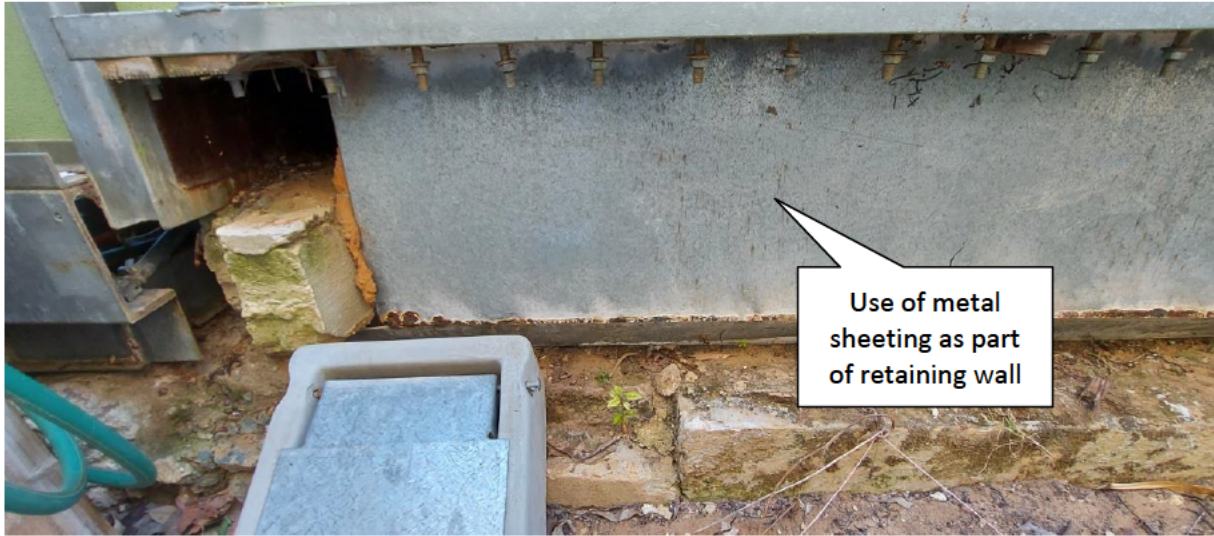
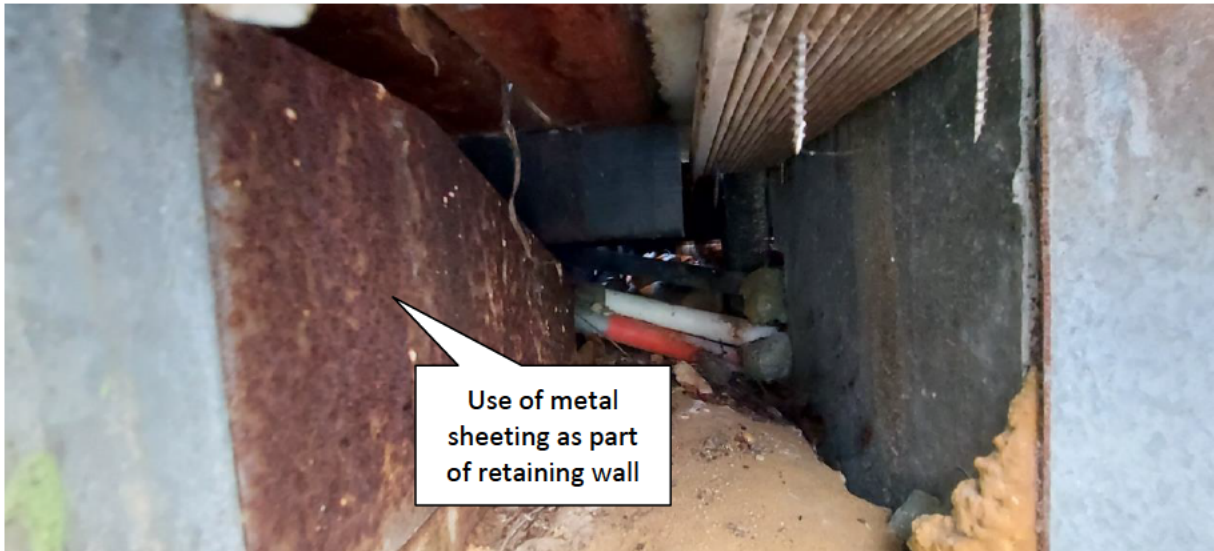
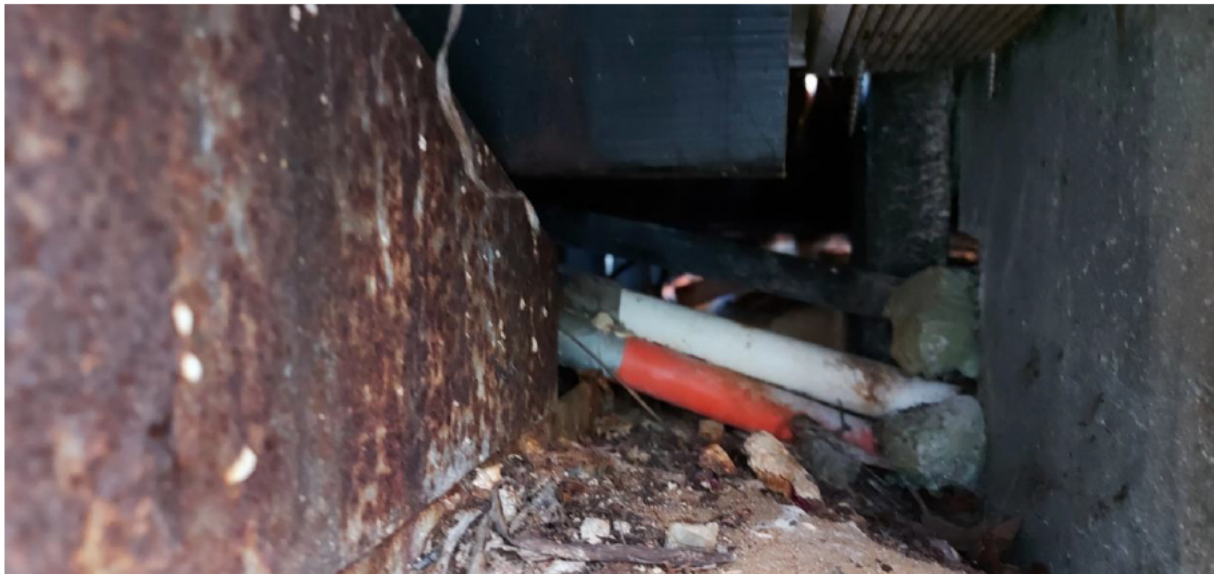
Photos 6 to 10, 13, and 17 to 33 show the use of what appears to be a metal sheet or board to act as part of the retaining wall. This is contrary to Note 1 which only permits the use of sawn good grade building stone.

1. The limestone retaining wall located adjacent to the side allotment boundary with 12 Beach Street should be inspected by a structural engineer to determine the structural adequacy of the retaining wall to determine:
  - a. compliance with the approved structural drawings, in particular compliance with Notes 5, 7 and 10; and
  - b. whether the limestone retaining wall and screen wall can reasonably be believed to be dangerous.
2. Subject to the outcome under (1)(b) above, consider issuing a building order under Section 112(2)(g) of the Building Act 2011 if the structural engineer considers the limestone retaining wall or screen wall to be dangerous.

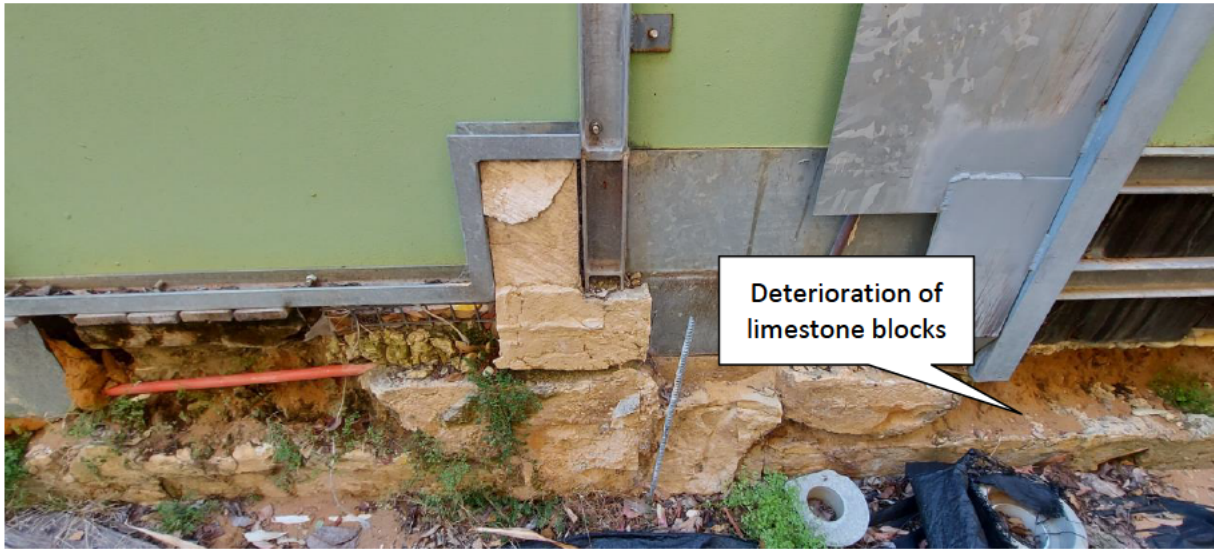
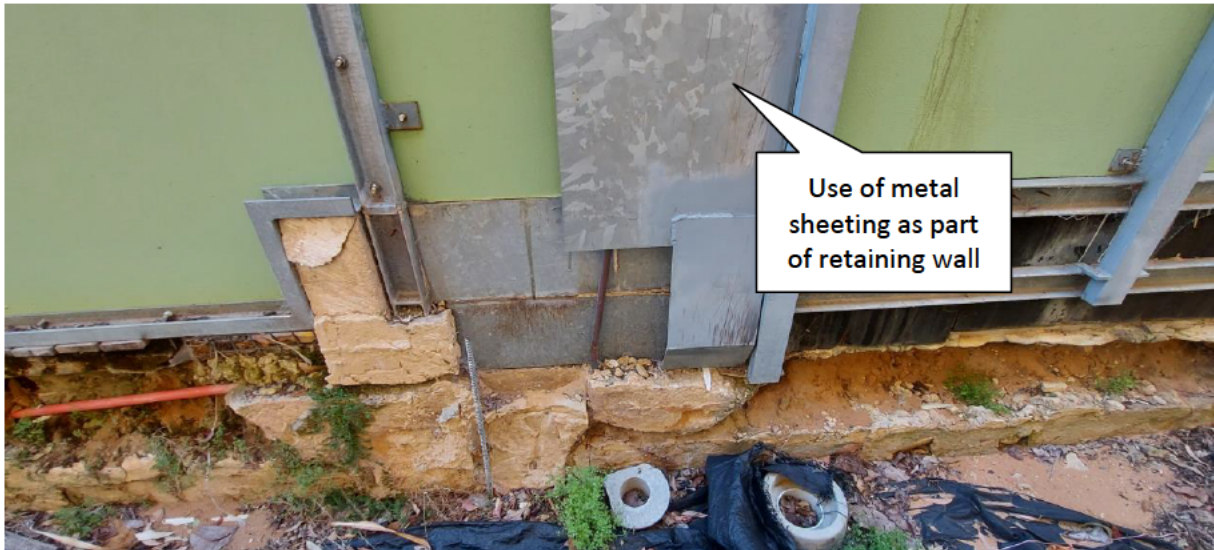
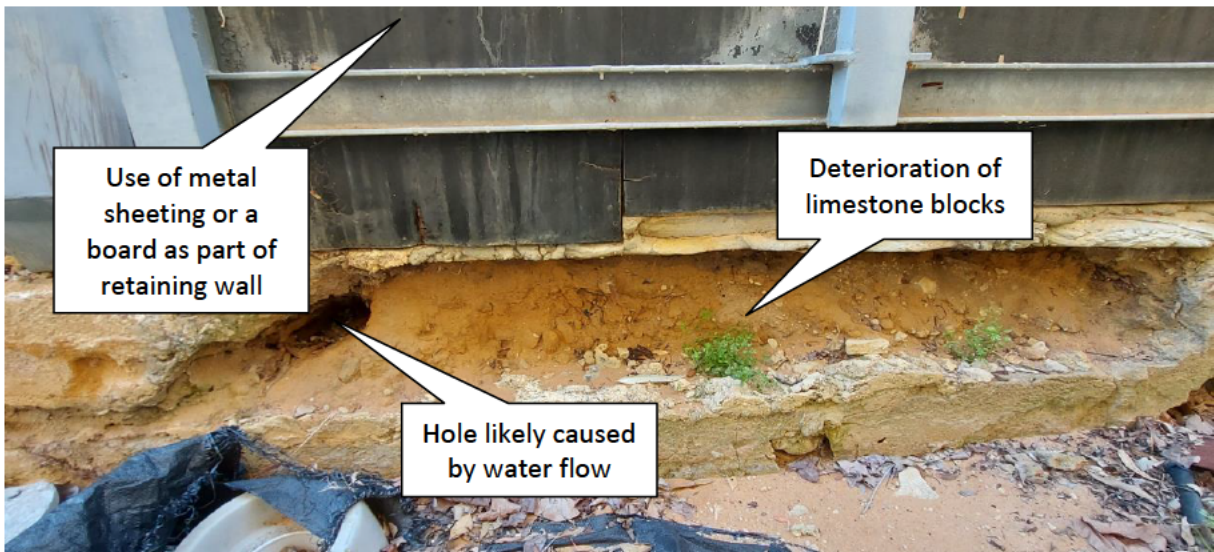
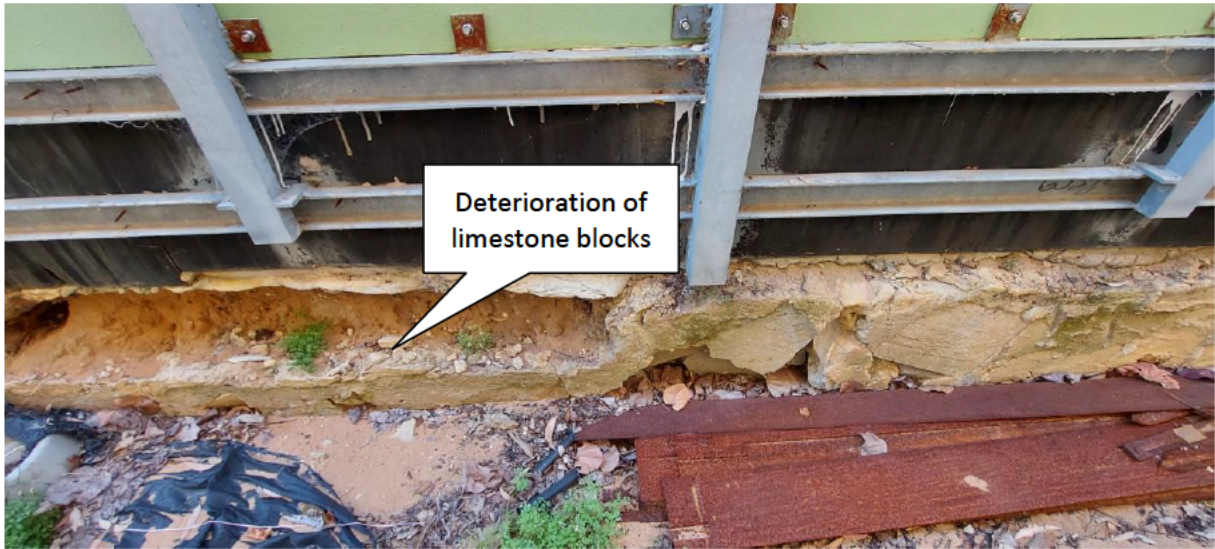
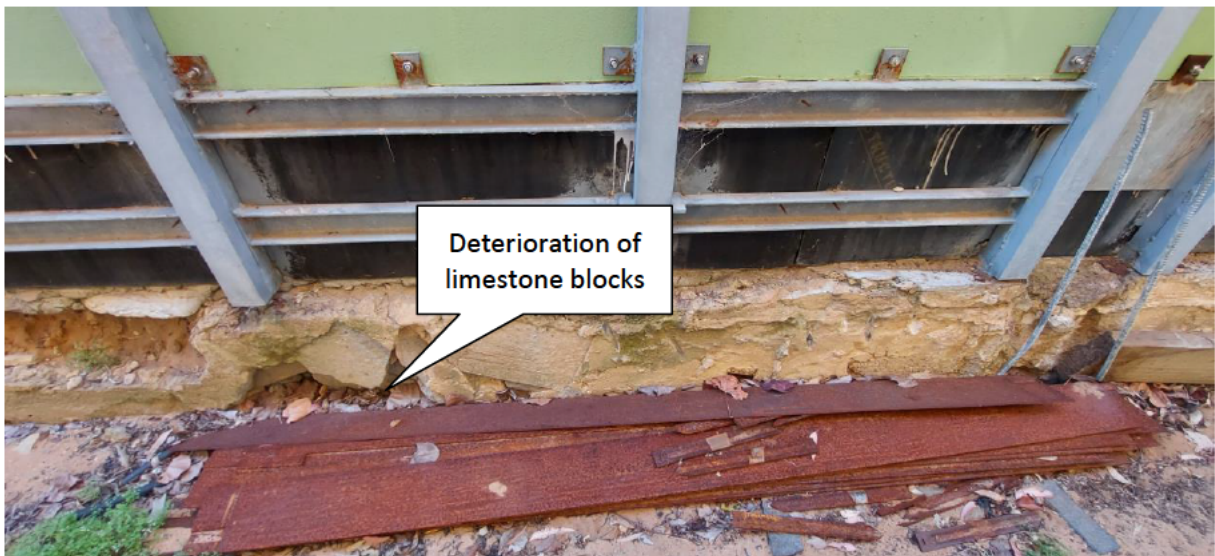
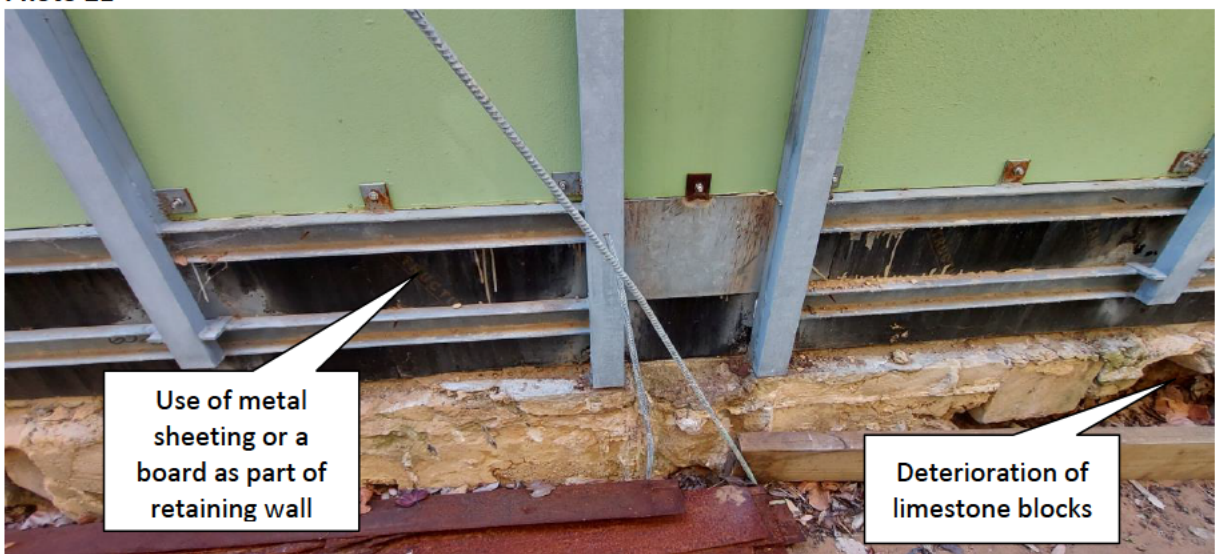
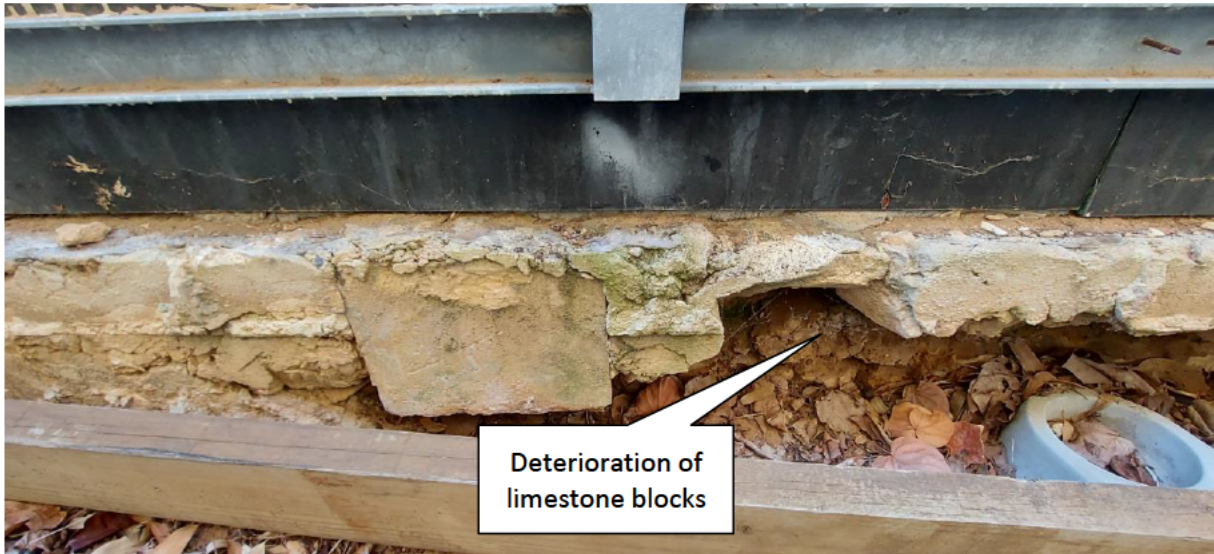
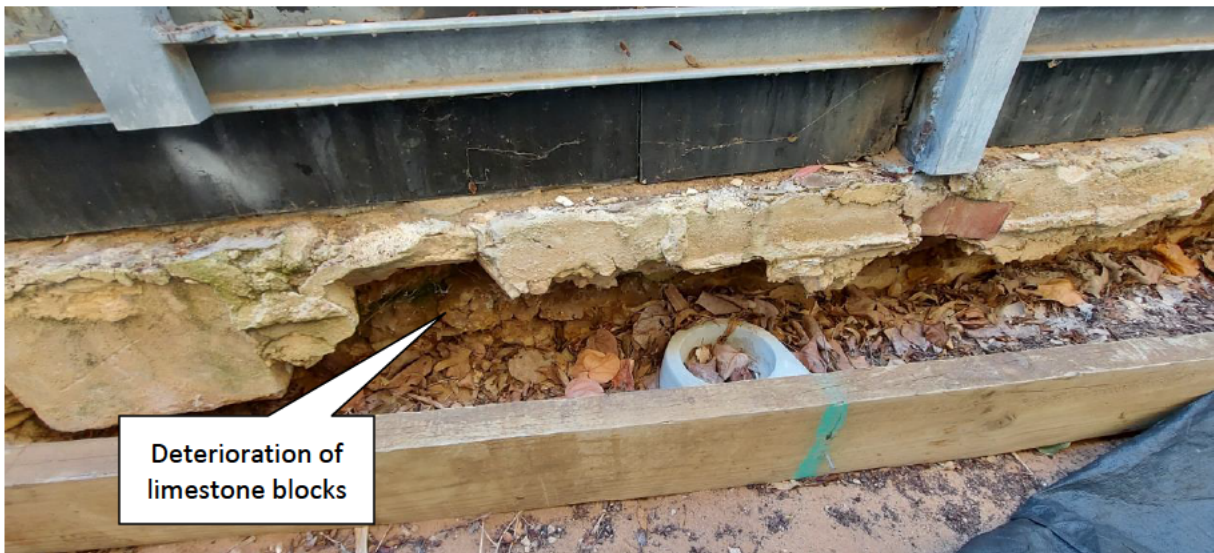
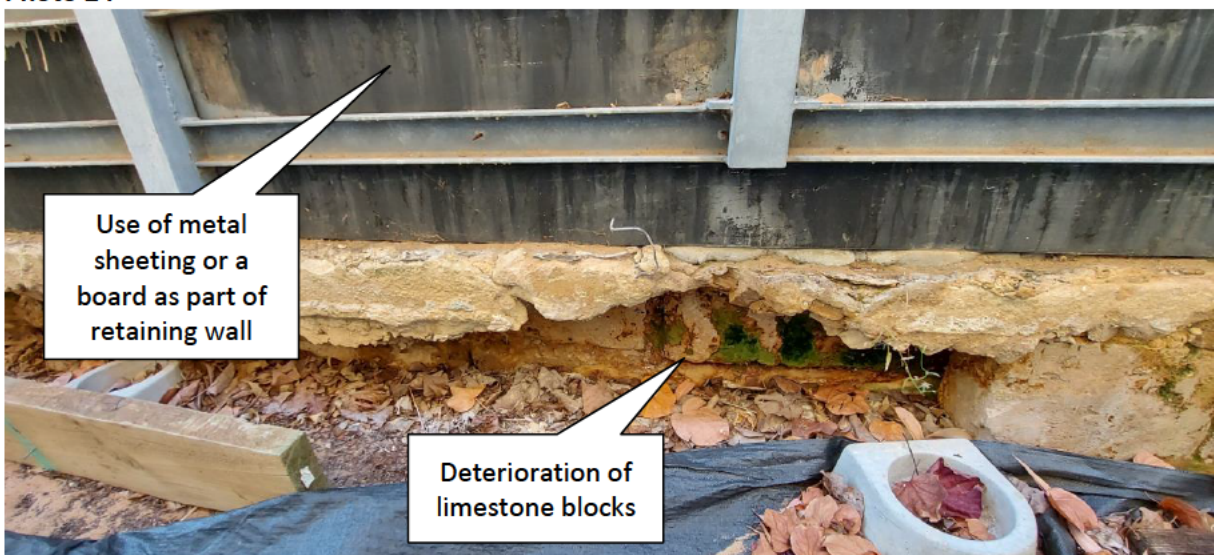
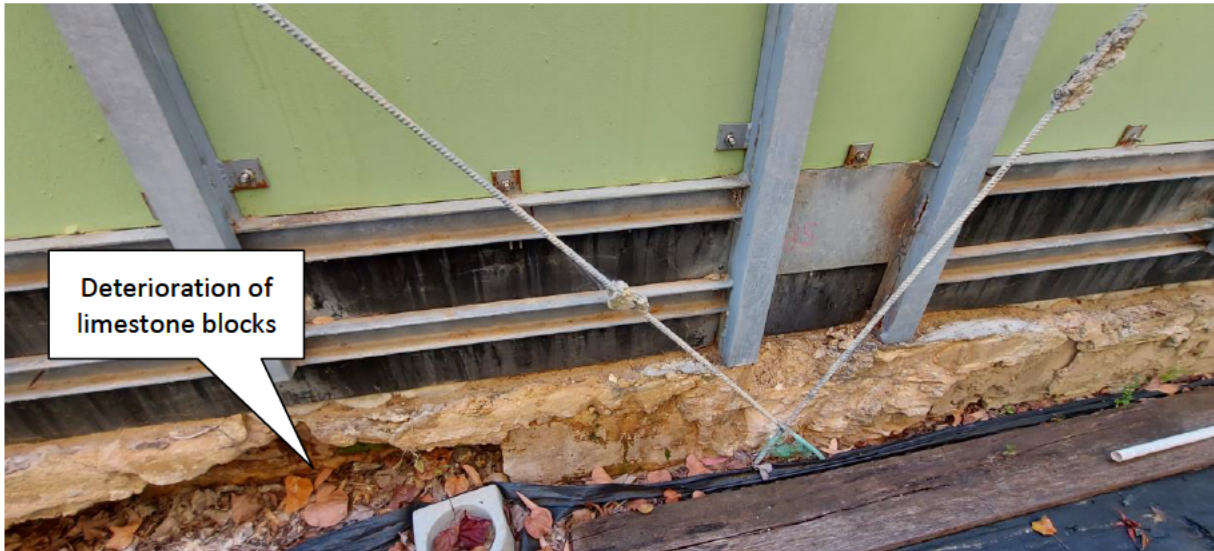
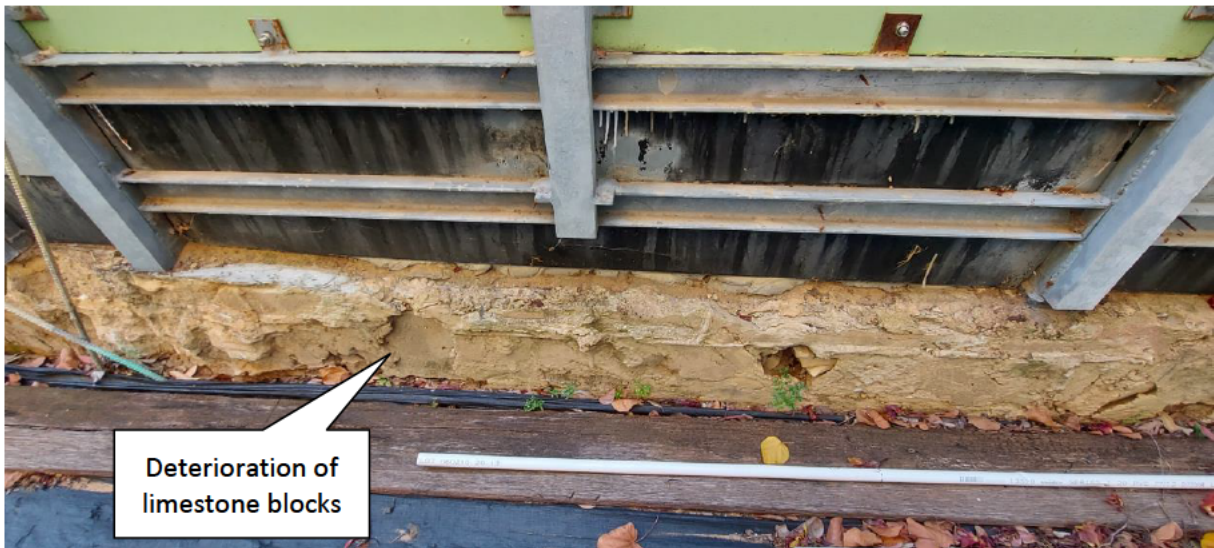
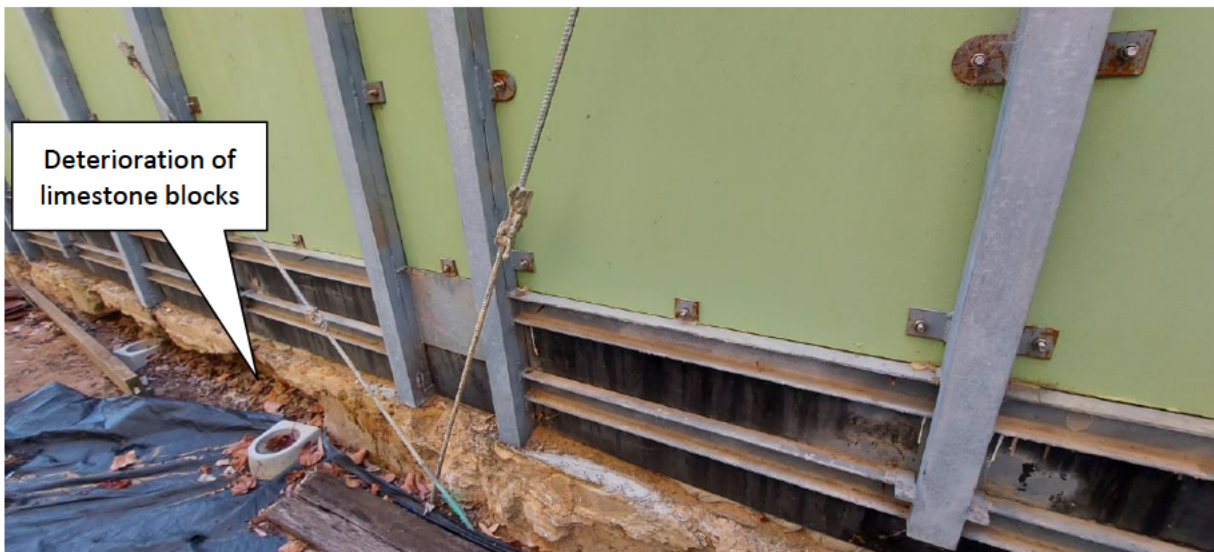
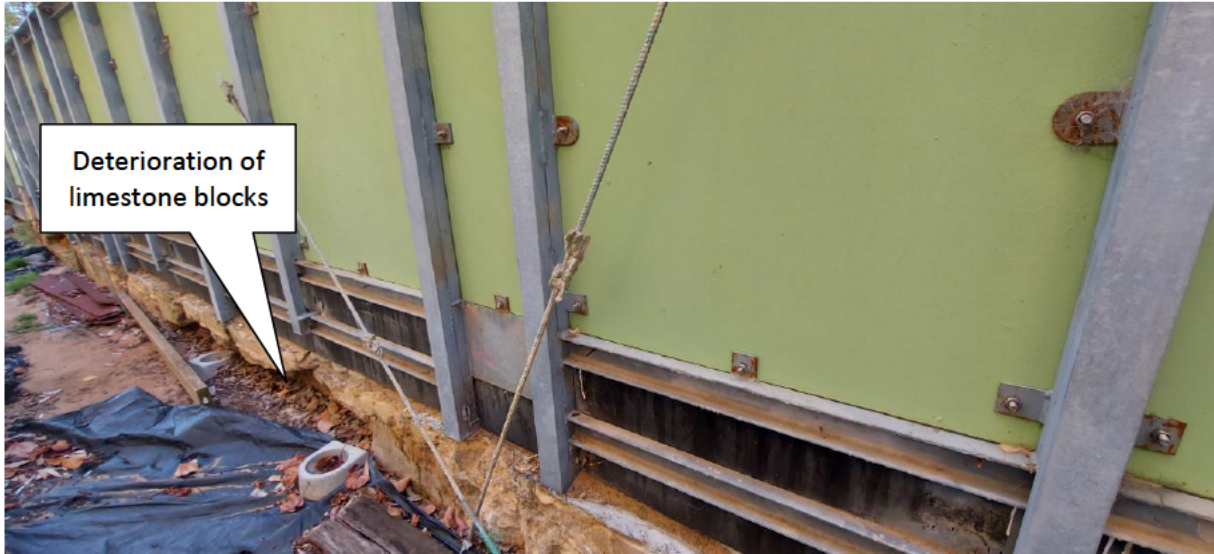
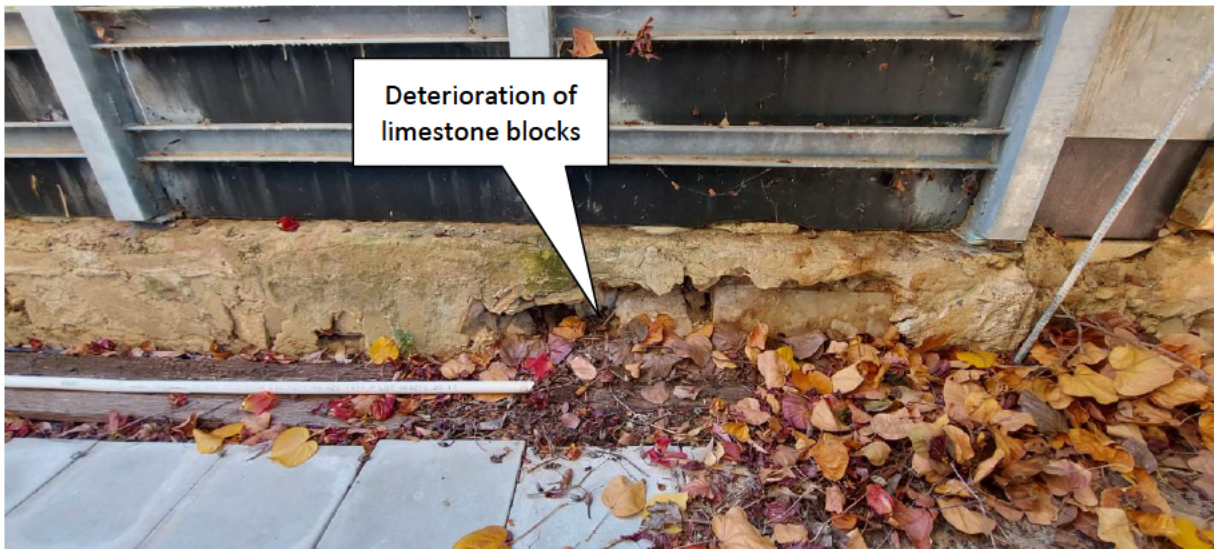
3. The limestone retaining wall appears to be exposed to moisture, resulting in the fretting of the mortar and the disintegration of the limestone blocks. Note 10 on the structural drawings states builder to provide drainage and waterproofing as required to rear. Either the drainage or waterproofing provided is not working adequately, or no drainage or waterproofing has been provided.

The photos show that parts of the limestone retaining wall has badly deteriorated (Photos 17 to 30), with either the limestone blocks or the mortar joints fretted away. This has resulted in Note 5 no longer being complied with. There are signs that moisture may be the cause of the mortar fretting away or the limestone blocks breaking apart (Photo 4, 19 and 20 appear to show holes created by a water flow). I was not able to determine whether Note 10 has been addressed.

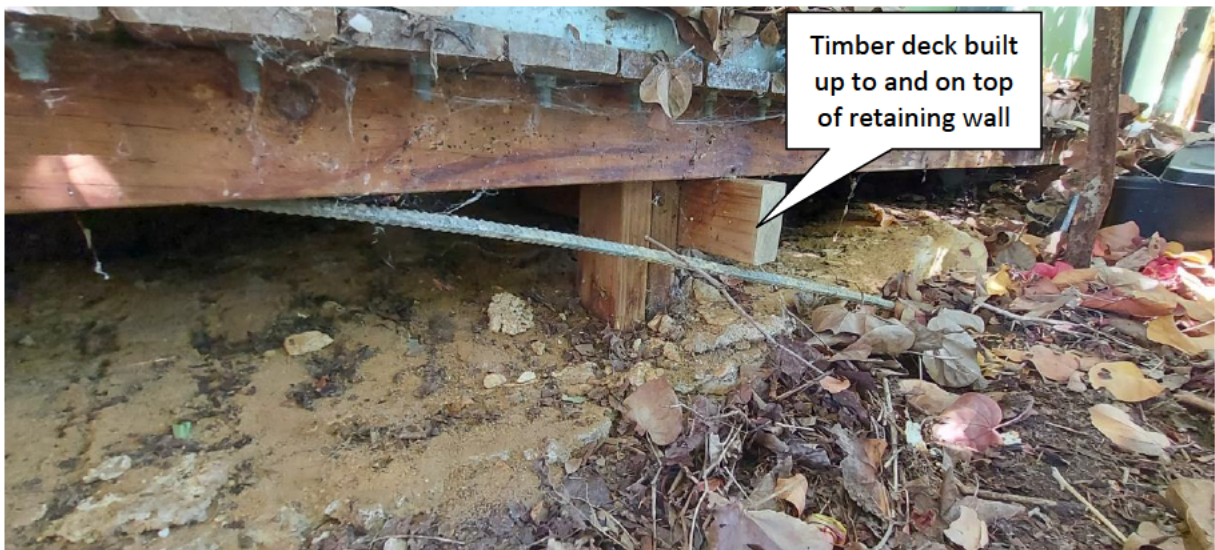
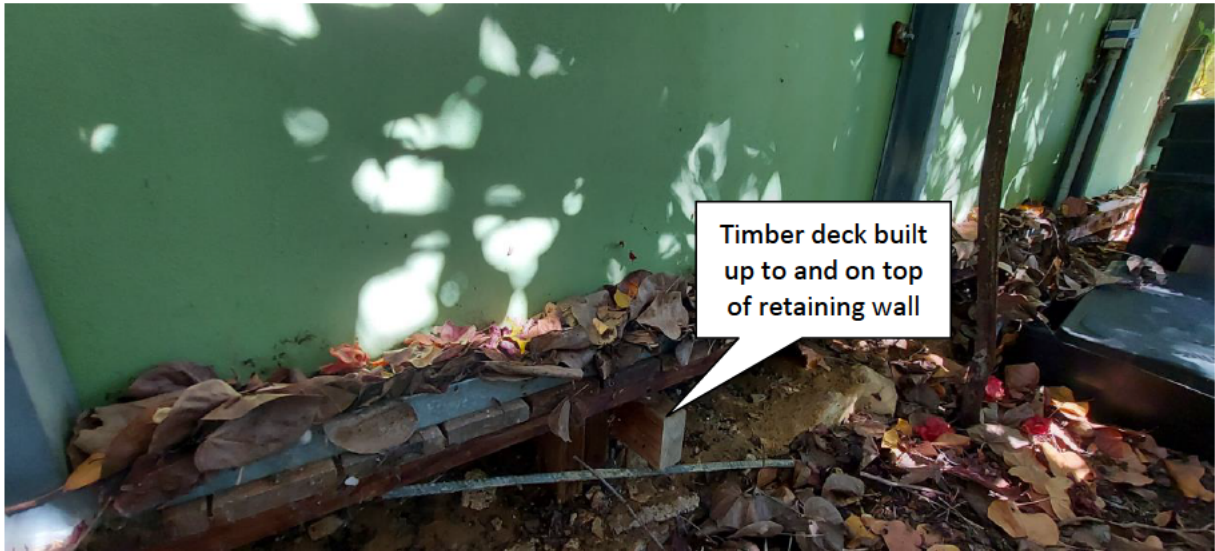
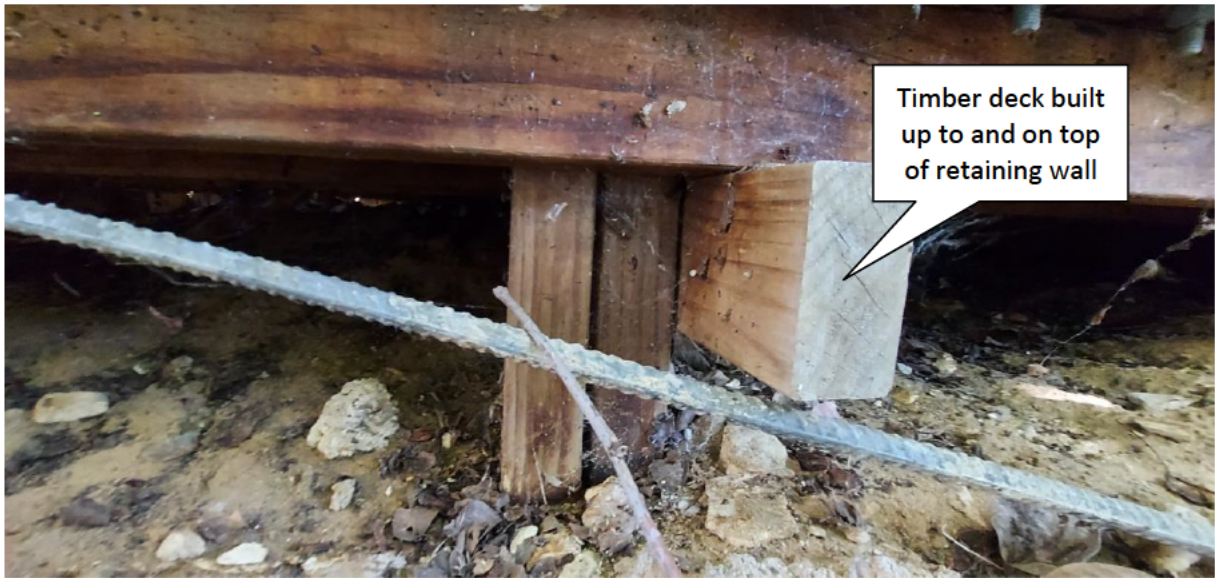
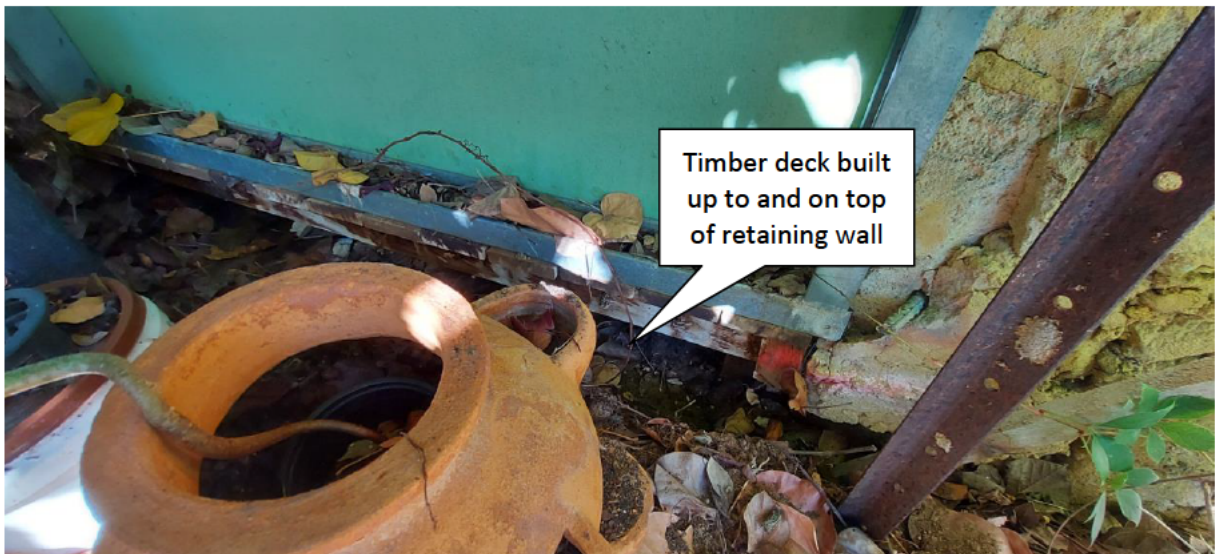
Note 7 states no structure is to be built closer than the height of the wall + base, away from the face of the wall. Photos 34 to 37 show a timber deck constructed up to and placed on top of the limestone wall. This is technically in contravention of Note 7.

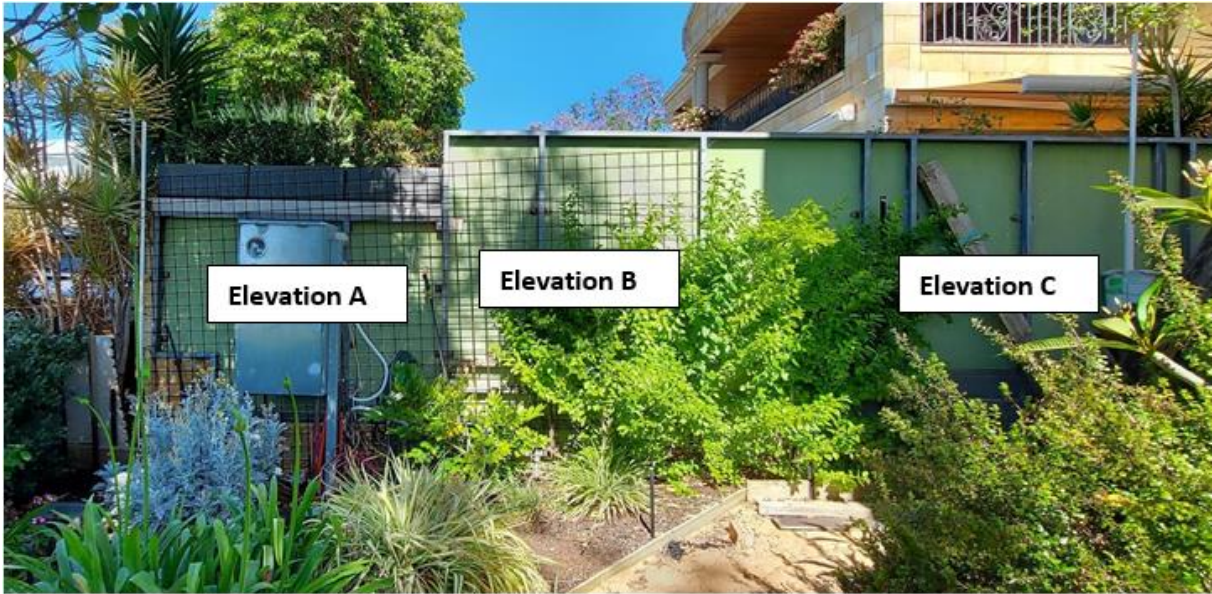
Photo 1 shows Elevation A, B & C

Based on my visual inspection, the construction appears to comply with the approved plans referenced in the Certificate of Building Compliance issued by the City of Melville. This is confirmed by the structural engineer in the Terpkos letter dated 21 March 2017. The letter confirms the screen fence, the base connection and lateral support from other structures is satisfactory for the typical screen fence loadings.

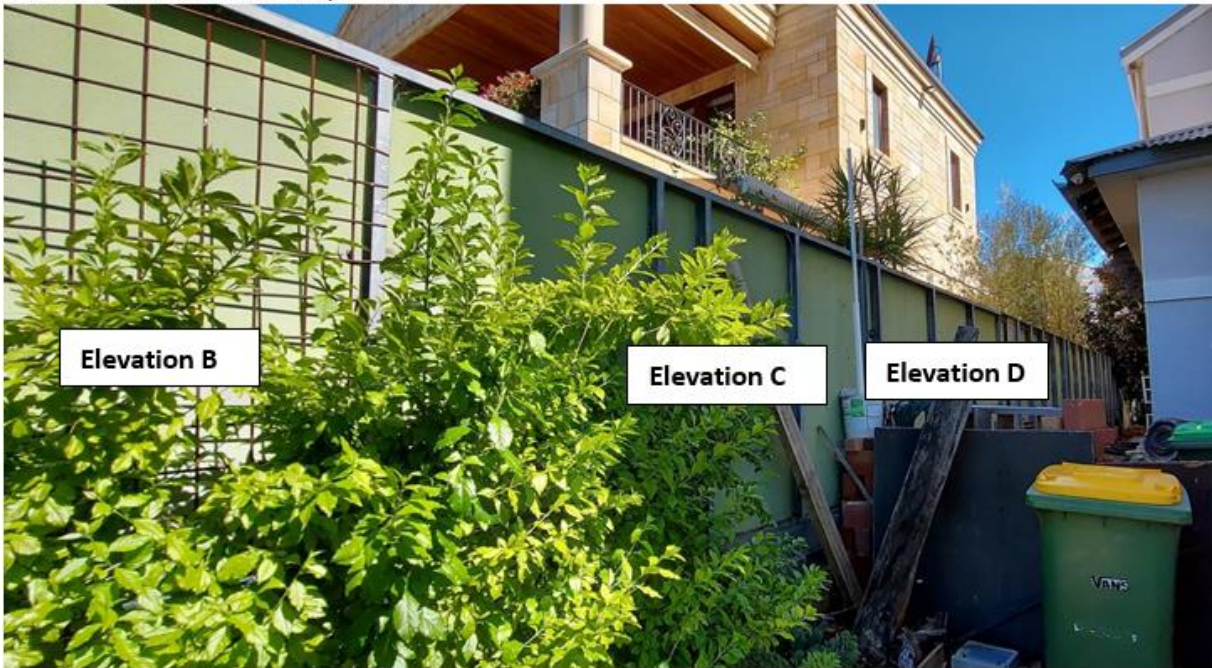
Photo 2 shows Elevation B, C & D

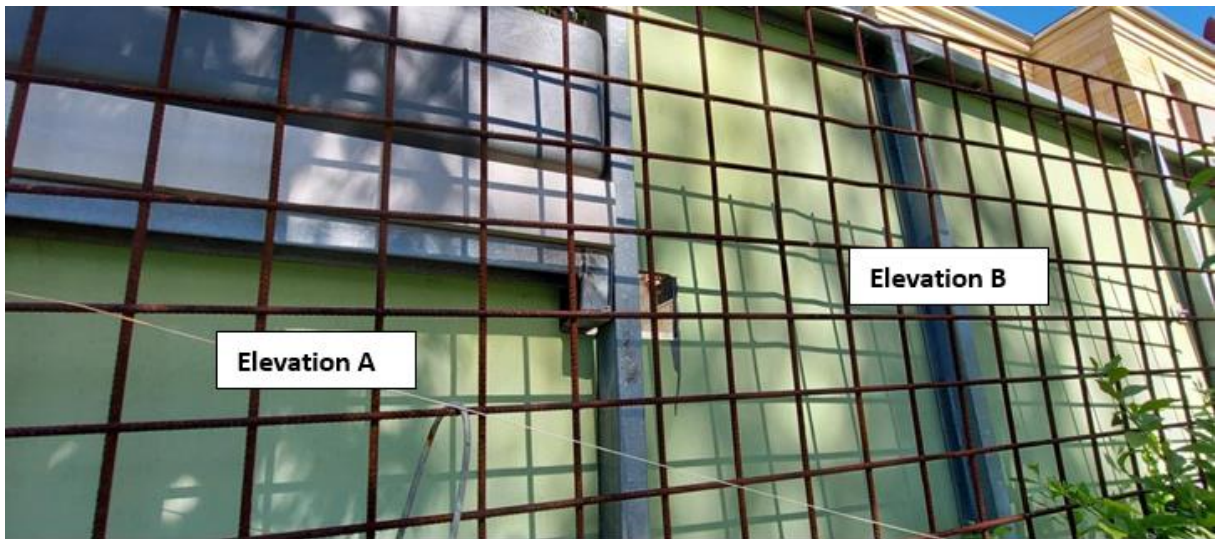
Photo 3 shows closeup of Elevation A & B

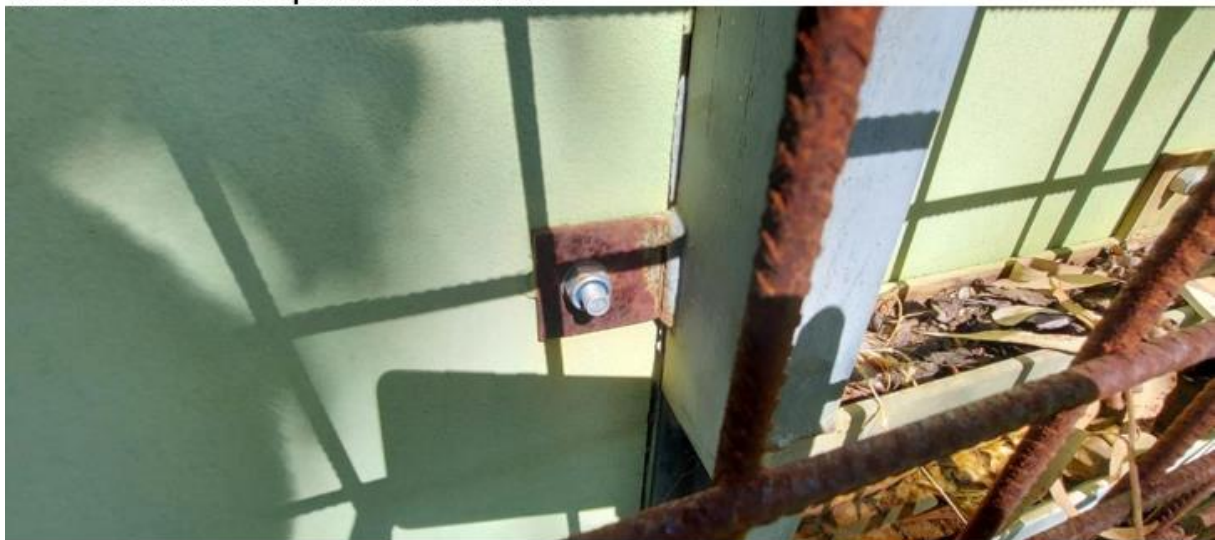
Photo 4 shows sheet connection

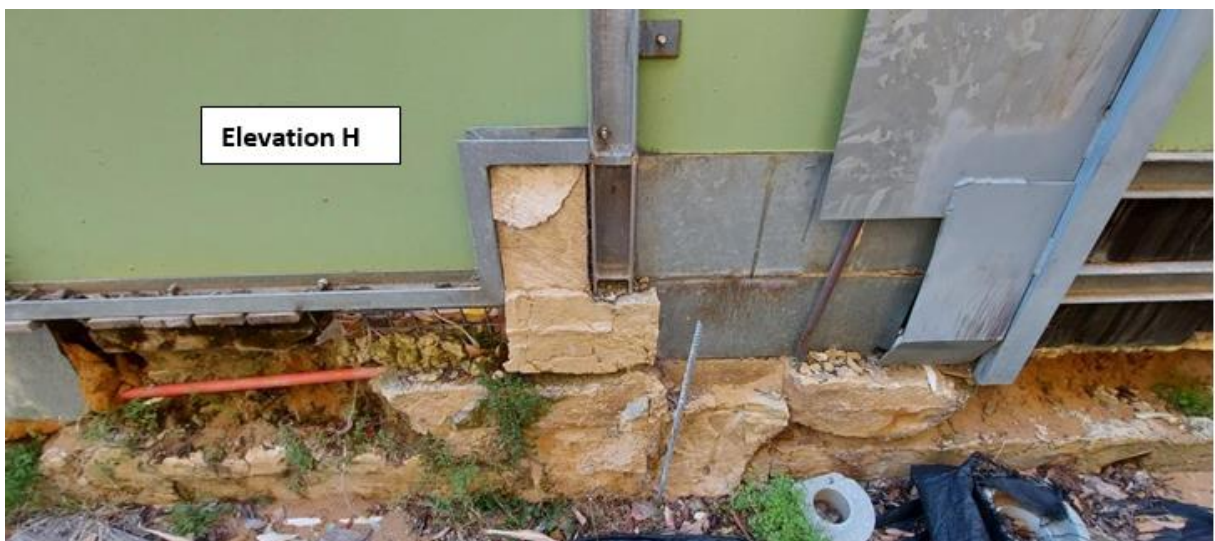
Photo 5 shows Elevation H

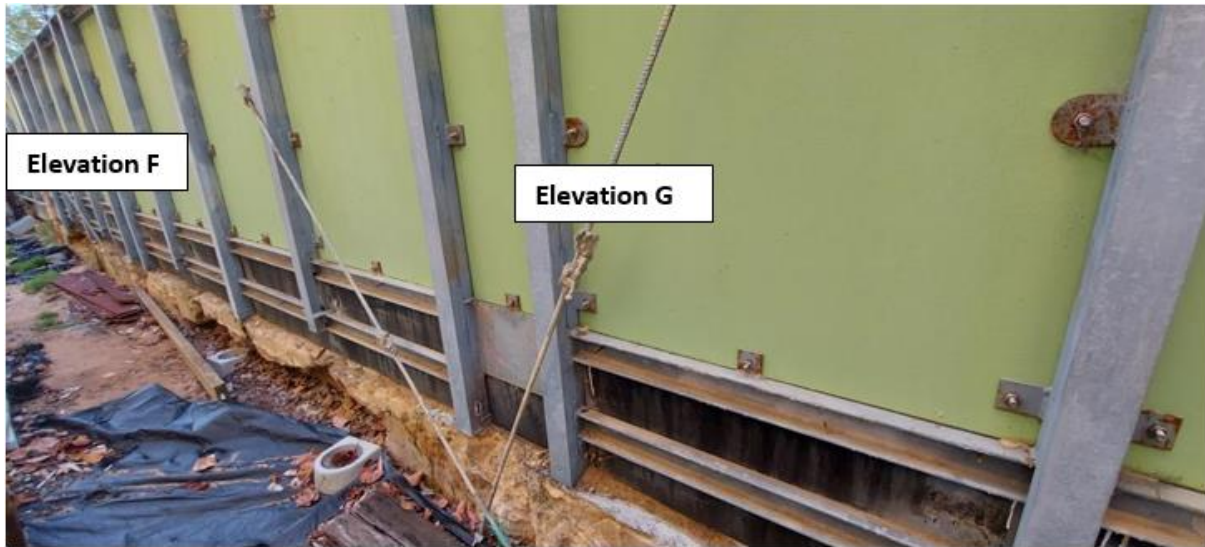
Photo 6 shows Elevation F & G
