Presented to	19 April 2022 Ordinary Meeting of Council
Related to Item	16.2 Removal of Trees 23a St Michael Terrace, Mount Pleasant
Submitted by	Director Urban Planning, Steve Cope
Attachments	Nil

This Advice Note is in response to a Motion to Meeting of Council from Cr Ross regarding the removal of verge trees to address pool safety concerns below.

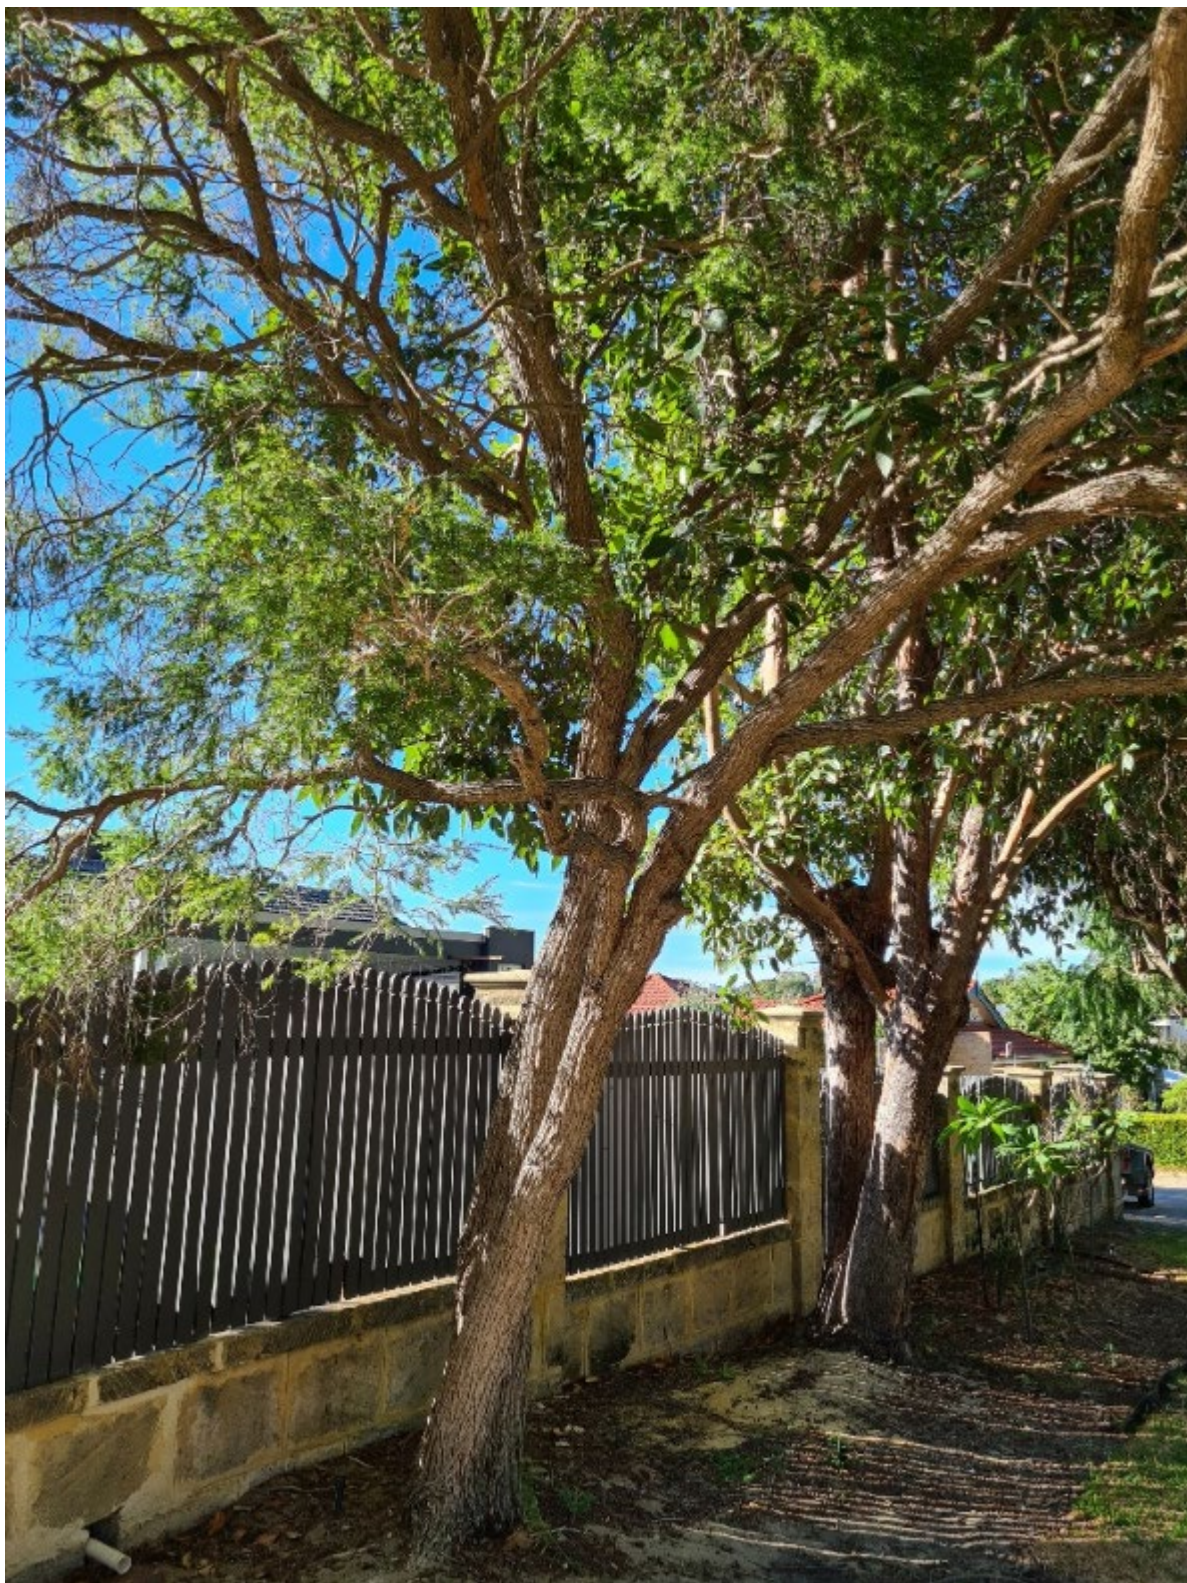
Photo above, taken by a City Officer at 23A St Michael Tce.

City Officers have conducted swimming pool compliance inspections of the front boundary barrier and have found it to be compliant with AS1926.1-1993. The two verge trees adjacent to the boundary pool barrier were found to be non-climbable and do not provide a foothold for a young child.

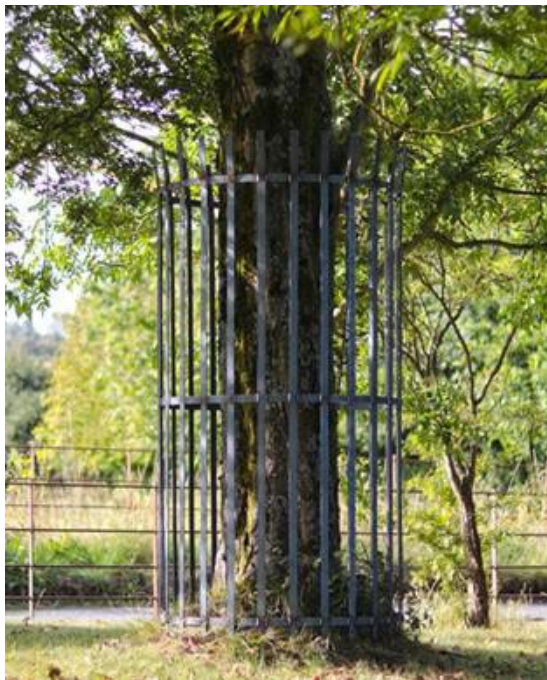
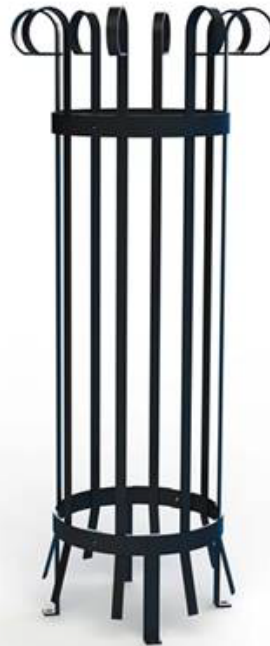
To minimise the risk of the trees being climbable by *anyone*, tree guards or similar structures could be installed, or the like (depicted below). Or, a permanent fence is installed in the verge area measuring 1800mm in height. It is acknowledged that either of these options will set a precedent in terms of ongoing asset management costs and create a public expectation in the future.

If any of the above actions are pursued, it should be noted that it is not in response to non-compliance of the pool barrier regulations and Australian Standards. Such a treatment to the verge trees would be going beyond the applicable legislation and Australian Standards and would not be recommended by officers.
