City Of Melville

Foreshore Restoration Strategy 2019

March 2020

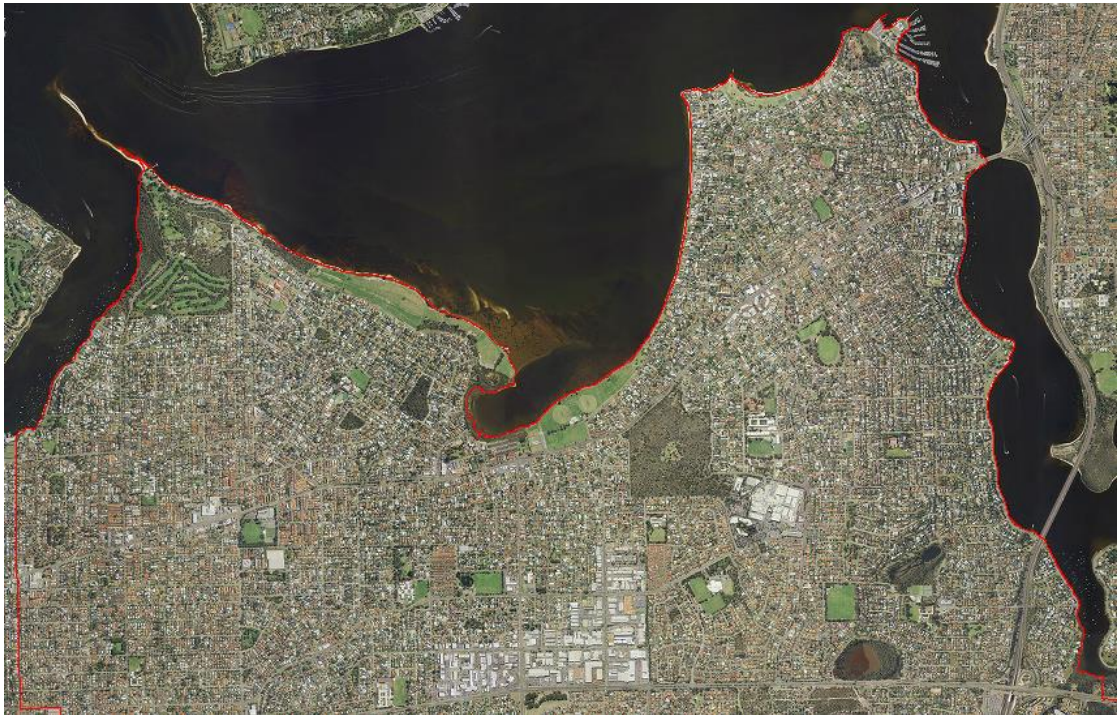
Figure 1-1 City of Melville Foreshore Area

The City of Melville (the City) covers 18 km in length of foreshore along the Swan and Canning Rivers which requires management by the City as shown in Figure 1-1). Management strategies for foreshore areas require review as conditions and use of certain areas change over time. Currently, foreshore areas of the Swan River Estuary are under stress from both recreation and environmental pressures. The combined impacts of increasing boating numbers on the river and the natural effects (from sea level rise, salinity stress on flora and storm events) all contribute to negative impacts on the river's riparian strips and bank stability.

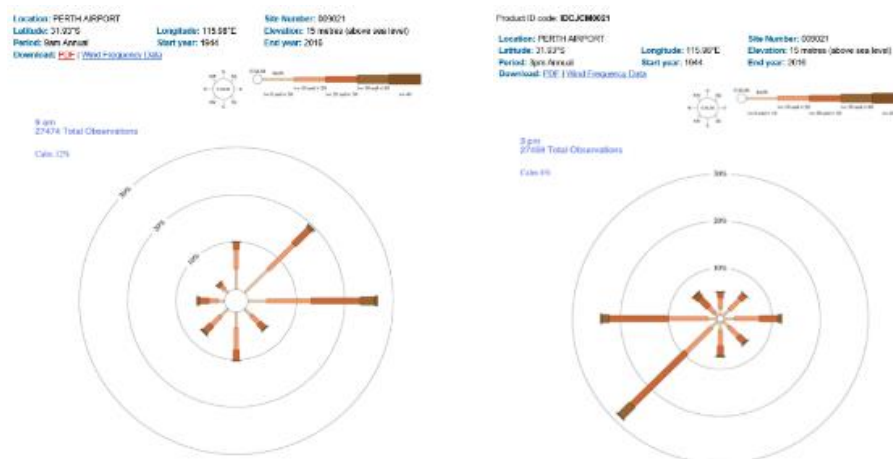
Figure 3-2 BOM Perth wind roses (BOM 2019)

The Perth annual wind profiles for the morning and afternoon are presented in Figure 3-2. The prevailing annual wind directions in Perth at 9am are easterly as a result of moderate summer morning easterlies and the prevailing annual 3pm wind direction is from the south west as a result of strong summer sea breezes. The data shown was recorded from 1944 – 2016.

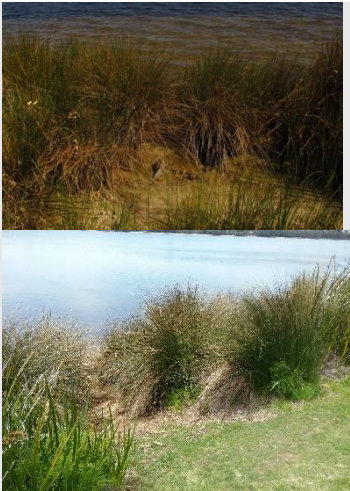
Type	Sub-type	Example Photograph	Location
Vegetated	Sedge-shore with riparian vegetation dominated by sedges. This classification also covers wetland environments

Occurrences along the whole foreshore, particularly along Canning River and Bull Creek (2014 & 2019)
	Tree-lined – shore maintained by riparian trees

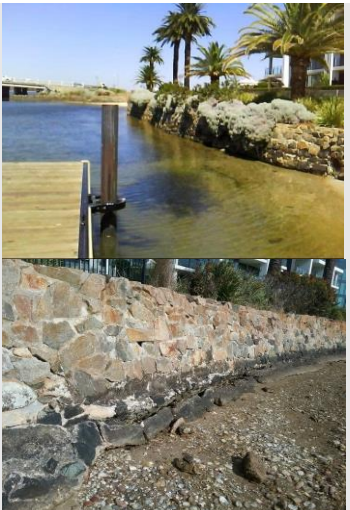
Raffles Hotel (2014 & 2019))

Isolated occurrences along the foreshore. (2014 & 2019)
Built Structure			
Wall	Steep foreshore structure (>60°). Usually constructed from concrete, rock or timber.

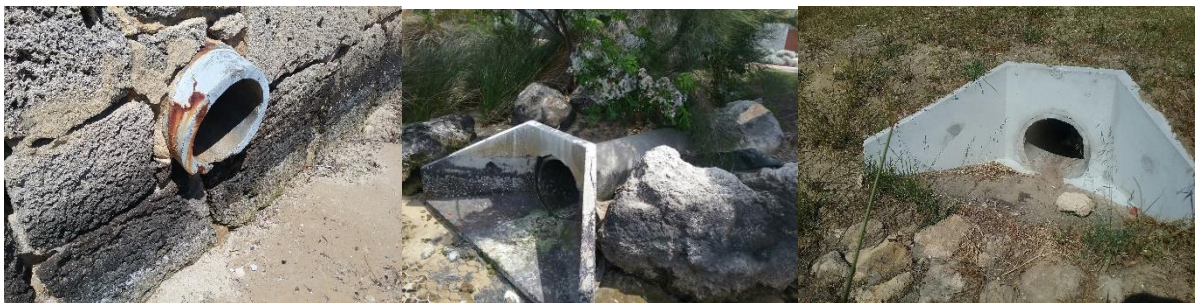
Figure 3-3 Drainage Outlets (2019)

The City foreshore consists of numerous storm water outlets to manage the outflows from the local road catchments. These outlets range in design and condition as shown in Figure 3-3. Potential water quality issues could result from poor condition of outlets and storm water treatment devices. An assessment of these issues was beyond the scope of this report.

8. Undertake an assessment of the inundated/damaged drainage outlets along the foreshore to ensure flow rates are acceptable and implement remedial action where applicable.

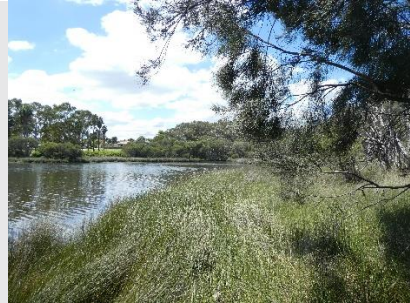
Vegetation type	Description	Location	Example photo
VT1: <i>Juncus</i> dominated Sedgeland	<i>Juncus kraussii</i> , <i>J. pallidus</i> , <i>Ficinia nodosa</i> and <i>Bolboschoenus caldwellii</i> closed sedgeland over <i>*Cynodon dactylon</i> , <i>*Stenotaphrum secundatum</i> and <i>Sporobolus virginicus</i> grassland with <i>*Cakile maritima</i> , <i>*Atriplex prostrata</i> and <i>Suaeda australis</i> isolated herbs along the edges of beaches.	Occurs throughout the foreshore areas, often occurs as small fringing patches of vegetation

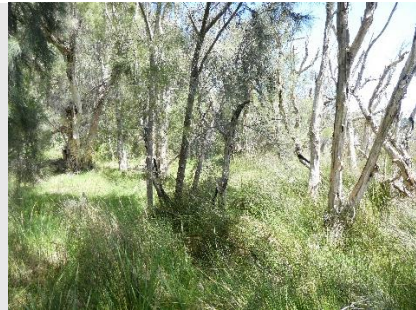
VT2: <i>Melaleuca</i> and Flooded Gum woodlands	<i>Casuarina obesa</i> isolated trees with <i>Melaleuca raphiophylla</i> and <i>Eucalyptus rudis</i> woodland over of <i>Juncus kraussii</i> , <i>Hardenbergia comptoniana</i> and <i>Pteridium esculentum</i> sedgeland/ herbland.	Mainly occurs in the Bull Creek and Canning River area, on banks above the inundation area

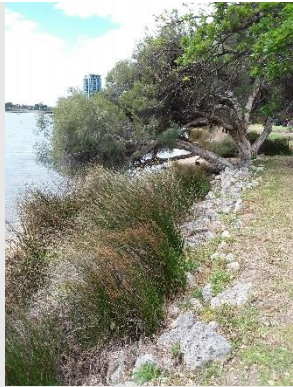
VT3: <i>Melaleuca</i> over sedgeland	<i>Melaleuca cuticularis</i> and <i>Casuarina obesa</i> isolated trees with <i>Melaleuca raphiophylla</i> woodland over <i>Juncus kraussii</i> and/ or <i>Typha orientalis</i> sedgeland with <i>Suaeda australis</i> open herbland.	Occurs as a line of fringing vegetation along the Canning River

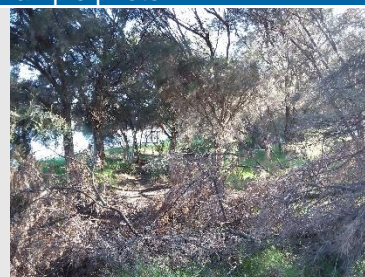
Vegetation type	Description	Location	Example photo
VT4: <i>Casuarina</i> stand	<i>Casuarina obesa</i> and <i>Melaleuca cuticularis</i> isolated clumps of trees over <i>Juncus kraussii</i> open sedgeland over * <i>Cynodon dactylon</i> and * <i>Stenotaphrum secundatum</i> open grassland	Small, isolated occurrences south of Canning Bridge and south of the South of Perth Yacht Club

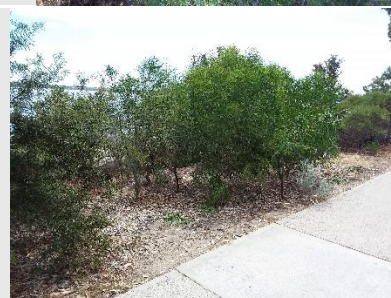
V5: Mixed <i>Acacia</i> shrublands (rehabilitation species)	<i>Acacia rostellifera</i> , <i>A. cyclops</i> , <i>A. saligna</i> and <i>Jacksonia furcellata</i> tall shrubland over * <i>Pelargonium capitatum</i> . <i>Scaevola canescens</i> and <i>Conostylis candicans</i> low shrubland over * <i>Cynodon dactylon</i> and * <i>Bromus diandrus</i> grassland	Isolated occurrences east of Point Walter, at Jeff Joseph Reserve and along Blackwall Reach Parade

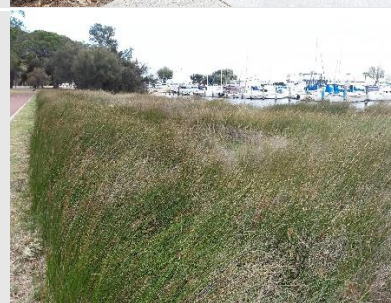
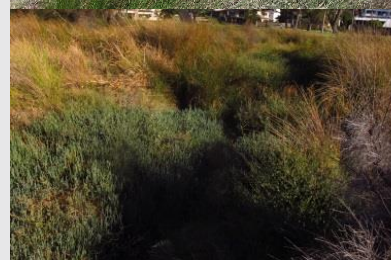
VT6: Samphire shrubland and <i>Juncus</i> sedgeland	<i>Melaleuca cuticularis</i> and <i>Casuarina obesa cuticularis</i> isolated trees over <i>Juncus kraussii</i> closed sedgeland with <i>Sarcocornia blackii</i> , <i>S. quinqueflora</i> and <i>Suaeda australis</i> open shrubland over * <i>Cynodon dactylon</i> open grassland	South of the South of Perth Yacht Club Plus very small isolated patches along the foreshore that are too small to map individually

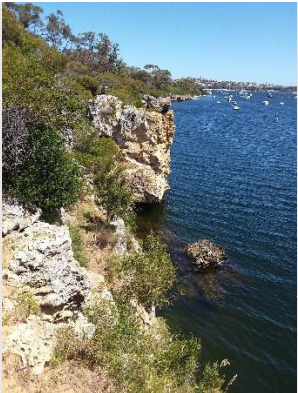
Vegetation type	Description	Location	Example photo
VT7: Cliffs with scattered salt-tolerant natives	Includes species adapted to living on limestone with salt spray including <i>Olearia axillaris</i> , <i>Rhagodia baccata</i> , <i>Acanthocarpus preissii</i> , <i>*Tetragonia decumbens</i> and <i>Alyxia buxifolia</i>	At Point Heathcote and Point Walter

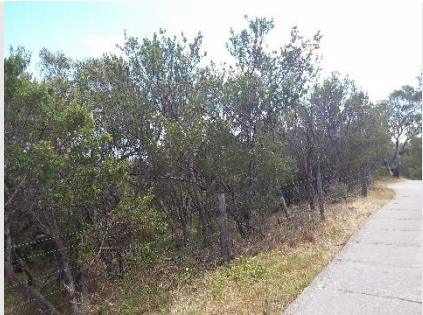
VT8: Mixed shrubland	<i>Banksia sessilis</i> , <i>Hakea prostrata</i> and <i>Acacia rostellifera</i> tall open shrubland over <i>Macrozamia riedlei</i> <i>Templetonia retusa</i> , <i>Melaleuca systema</i> and <i>Olearia axillaris</i> low open shrubland over <i>*Ehrharta calycina</i> <i>*Avena barbata</i> and <i>*Lagurus ovatus</i> grassland	At Point Heathcote and Point Walter

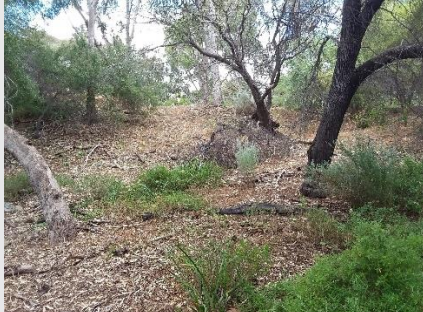
VT9: Tuart woodland	<i>Eucalyptus gomphocephala</i> and <i>Agonis flexuosa</i> woodland over <i>Spyridium globulosum</i> , <i>Acacia rostellifera</i> and <i>Olearia axillaris</i> tall open shrubland over <i>Rhagodia baccata</i> , <i>Acanthocarpus preissii</i> and <i>Lepidosperma gladiatum</i> low open shrubland/ sedgeland over <i>*Oxalis pes-caprae</i> , <i>*Euphorbia terracina</i> and <i>*Ehrharta</i> spp. herbland/grassland	Occurs in the area directly to the west of the Point Walter sandbar, and in the higher areas of the Point Heathcote area

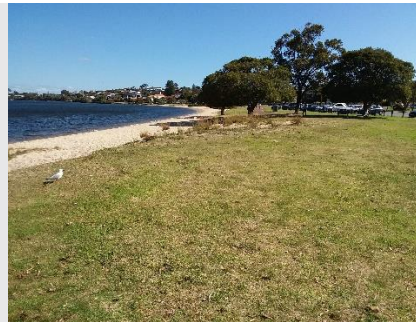
Vegetation type	Description	Location	Example photo
VT10: Parkland cleared	<i>Eucalyptus gomphocephala</i> <i>Eucalyptus rudis</i> * <i>Eucalyptus</i> sp., <i>Agonis flexuosa</i> , * <i>Araucaria heterophylla</i> , * <i>Quercus suber</i> , * <i>Erythrina x sykesii</i>), isolated trees over * <i>Cynodon dactylon</i> , * <i>Stenotaphrum secundatum</i> and * <i>Cenchrus clandestinus</i>	Occurs along much of the foreshore. Often occurs in thin a strip between the footpath and fringing vegetation but also occurs all the way up to the foreshore. Larger areas occur within the park areas.

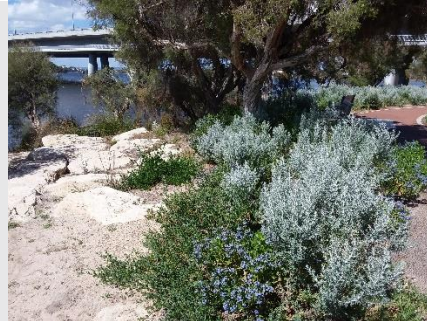
VT11: Landscaped / rehabilitated	Planted native species including <i>Scaevola crassifolia</i> , <i>Olearia axillaris</i> , <i>Myoporum insulare</i> , <i>Leucophyta brownii</i> , <i>Eremophila glabra</i> and <i>Xanthorrhoea preissii</i>	Isolated occurrences along the foreshore, particularly at Point Walter, at the Raffles and along the Esplanade south of Canning Bridge

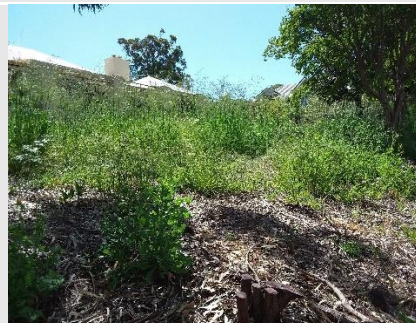
VT12: Weedy shrubland	* <i>Schinus terebinthifolius</i> , * <i>Ficus carica</i> , * <i>Arundo donax</i> over weedy grassland/ herbland	Adjacent to Spinaway Crescent

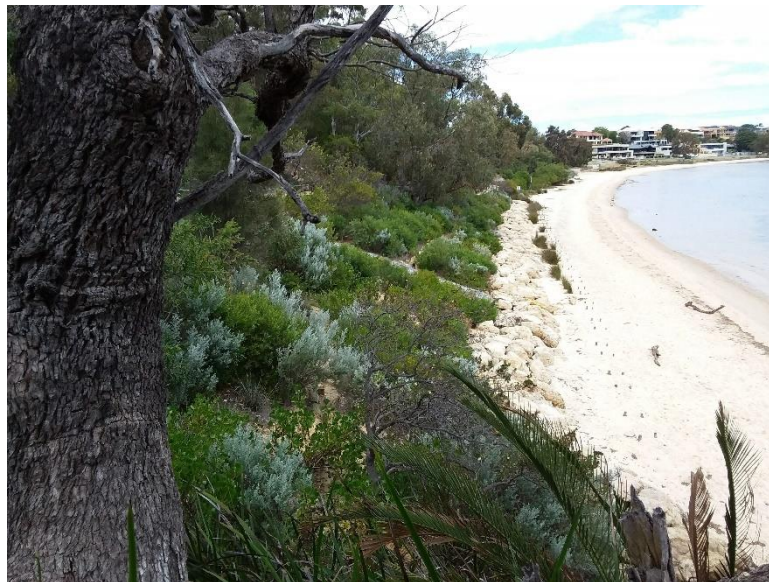
Figure 3-4 Point Heathcote revegetation

The western extent of Point Heathcote has been revegetated with endemic Tuart woodland species. This area has been rated as Very Good as, even though the area has obviously been altered, the disturbance has come from attempts to rehabilitate the area back to its natural state, refer Figure 3-4.

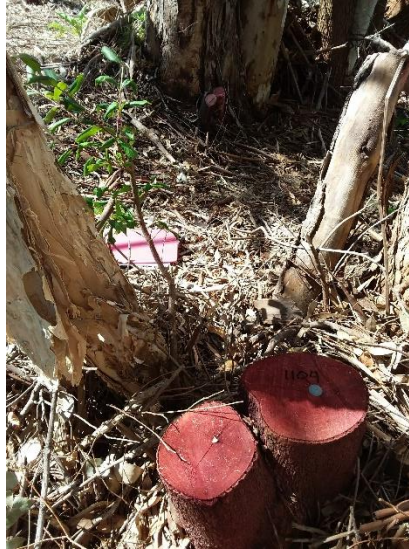
Figure 4-1 Japanese pepper re-sprouting after an attempt to eradicate

During the 2019 survey it was noted that weed eradication and or management was attempted adjacent to Spinaway Crescent, Brentwood. Unfortunately the attempt to kill the Japanese peppers (**Schinus terebinthifolius*) through herbicide and lodging nails into the stumps were unsuccessful; in many instances the tree has re-sprouted from the stump or roots (Figure 4-1). Also in the same area were numerous of Arum Lily (**Zantedeschia aethiopica*) saplings.

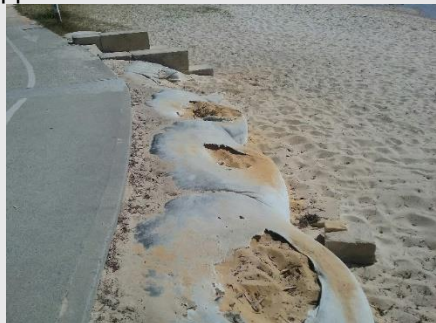
9	Manage foreshore access to ensure traffic is directed away from sensitive areas and diverted to designated public access points. *	Fences, stairs and paths are installed throughout the Melville foreshore to manage traffic but trampling in areas of unrestricted access is still a problem.
10	Remove failed foreshore treatments along the foreshore that have become potential safety hazards.	Observation recorded as part of the 2019 survey. Some areas noted have not been removed, such as failed sandbags located -The Strand opposite #54A .

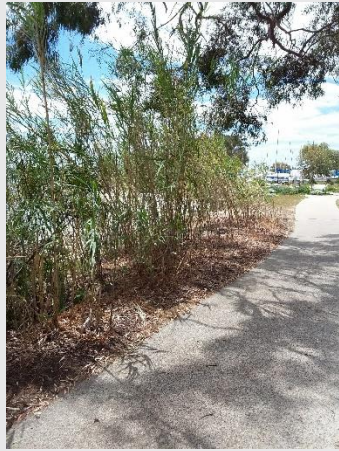
Item Number	Site Recommendations (2014)	Comments (2019)
PHWB2	Weed control of Giant Reed infestations east of Point Heathcote	<p>Weed control has not been undertaken. *<i>Arundo donax</i> (Giant Reed) still dominates the area</p>

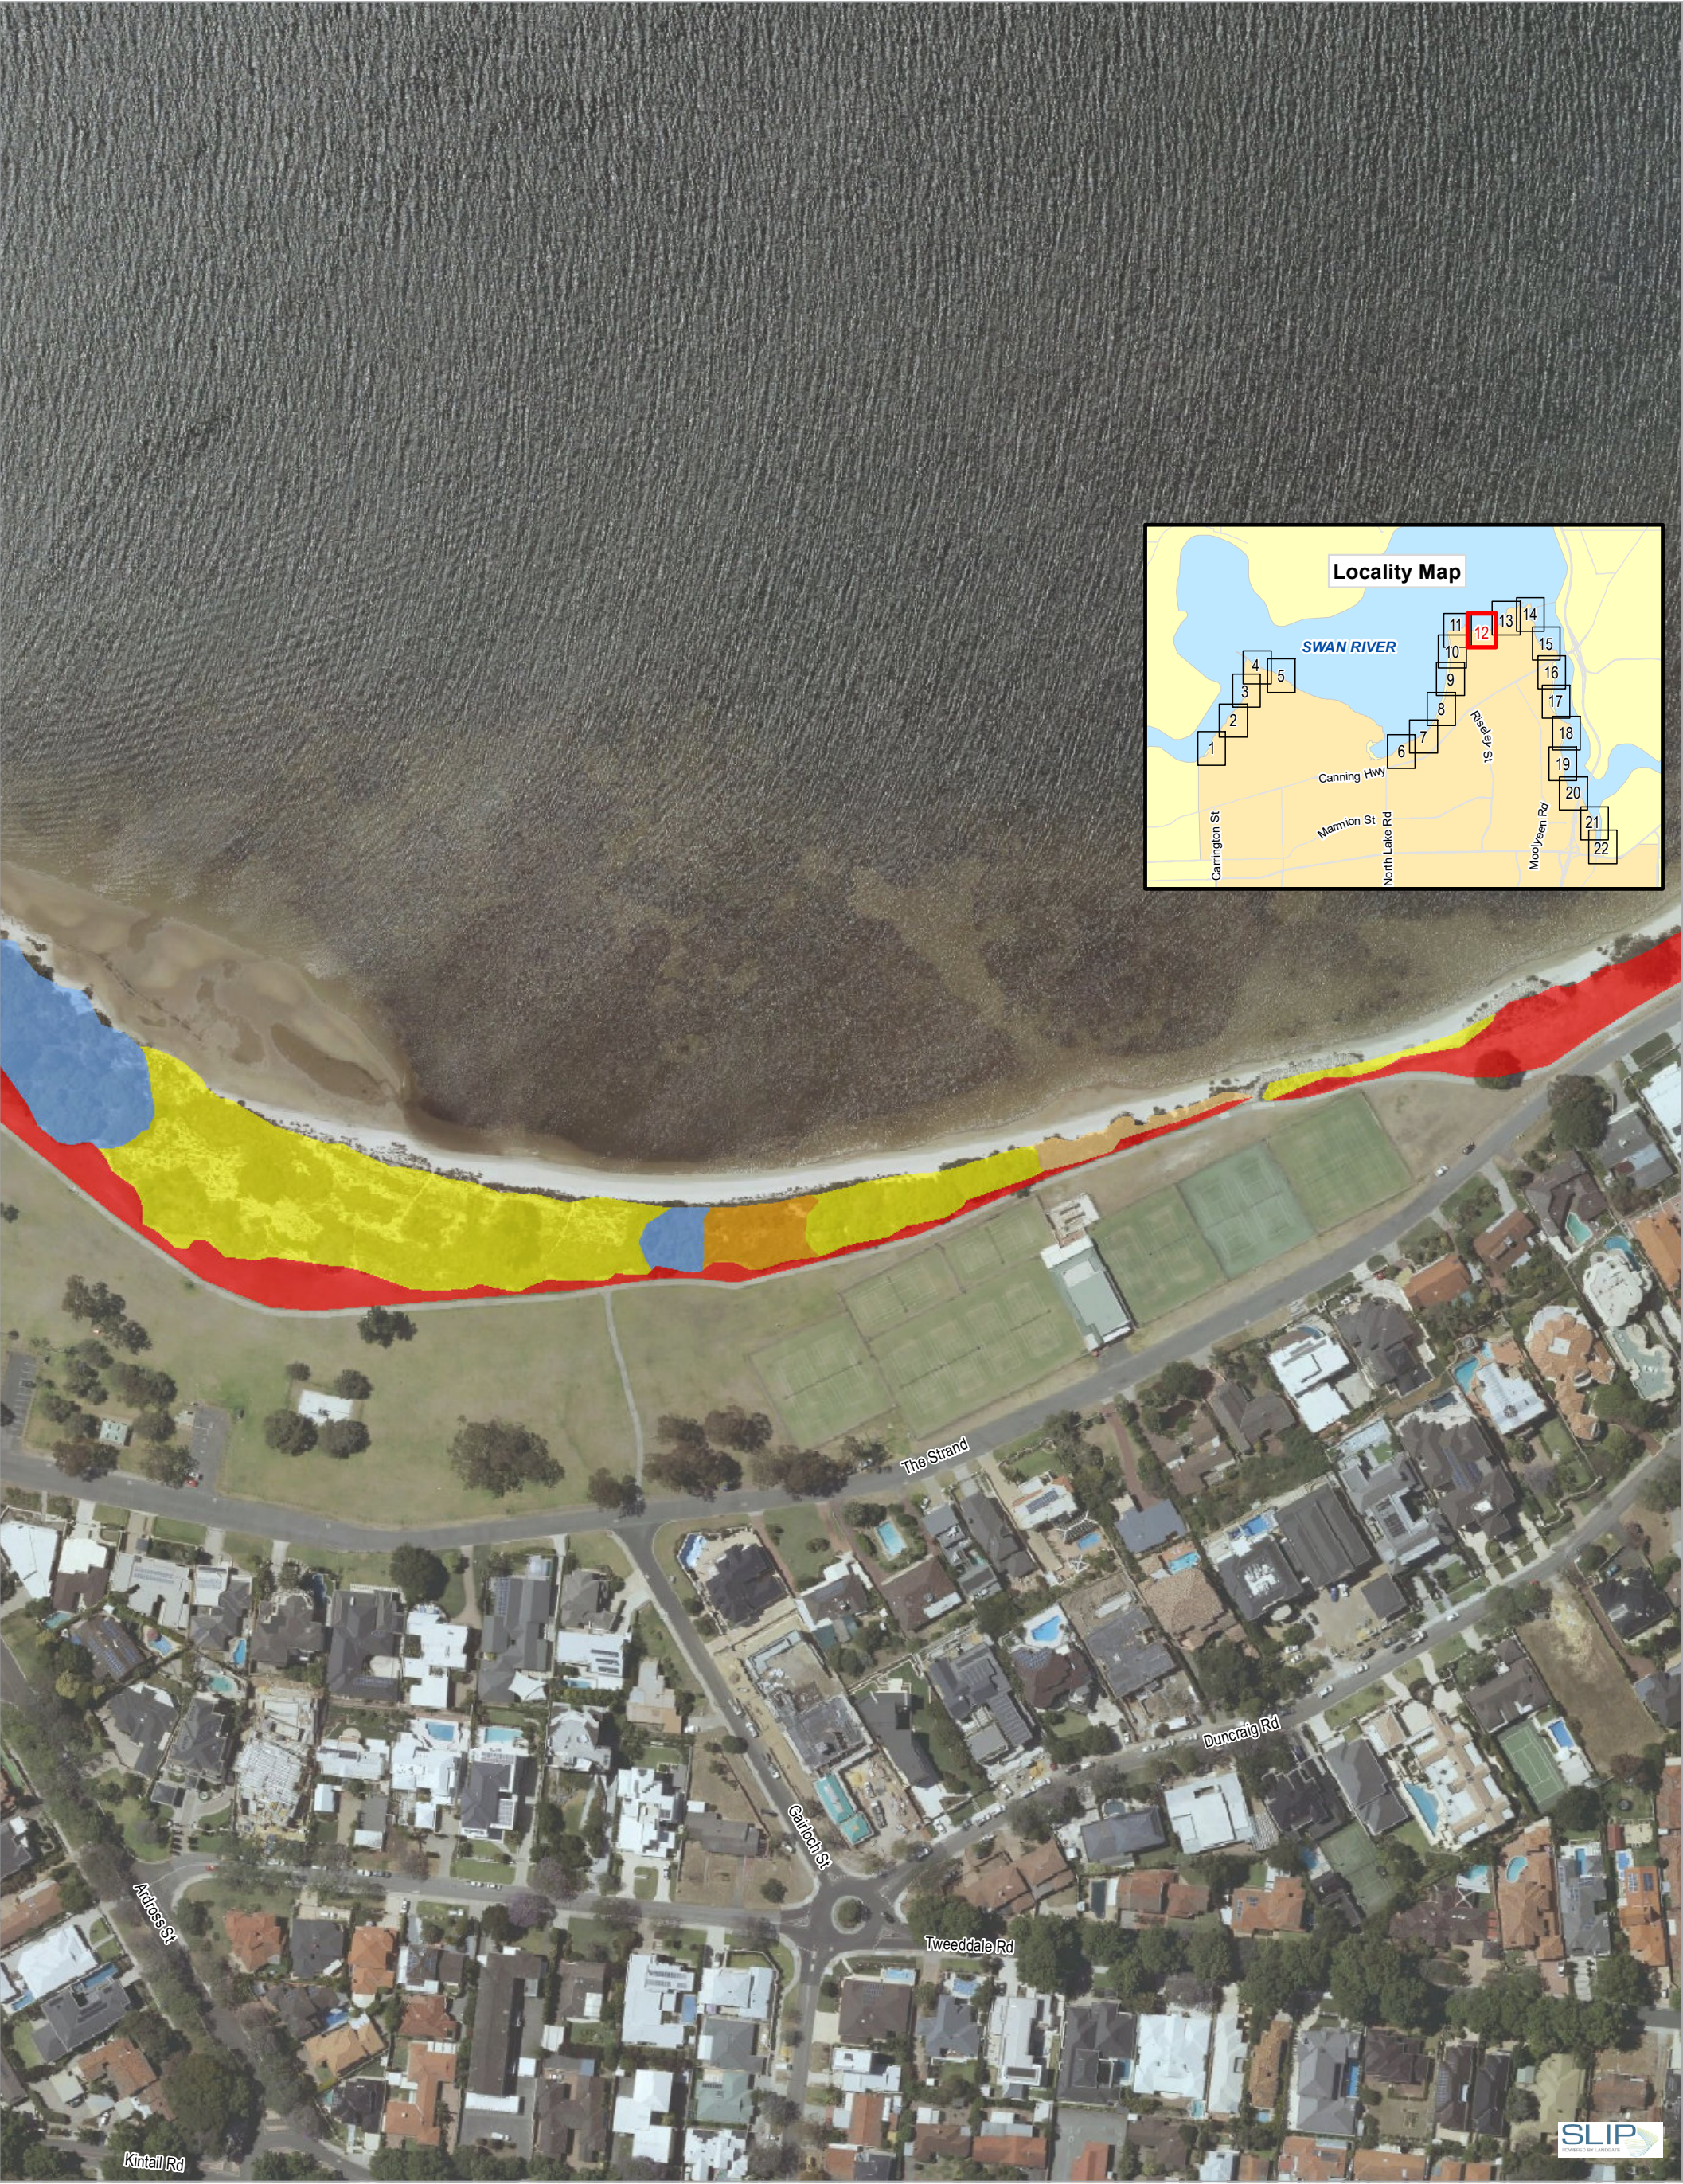
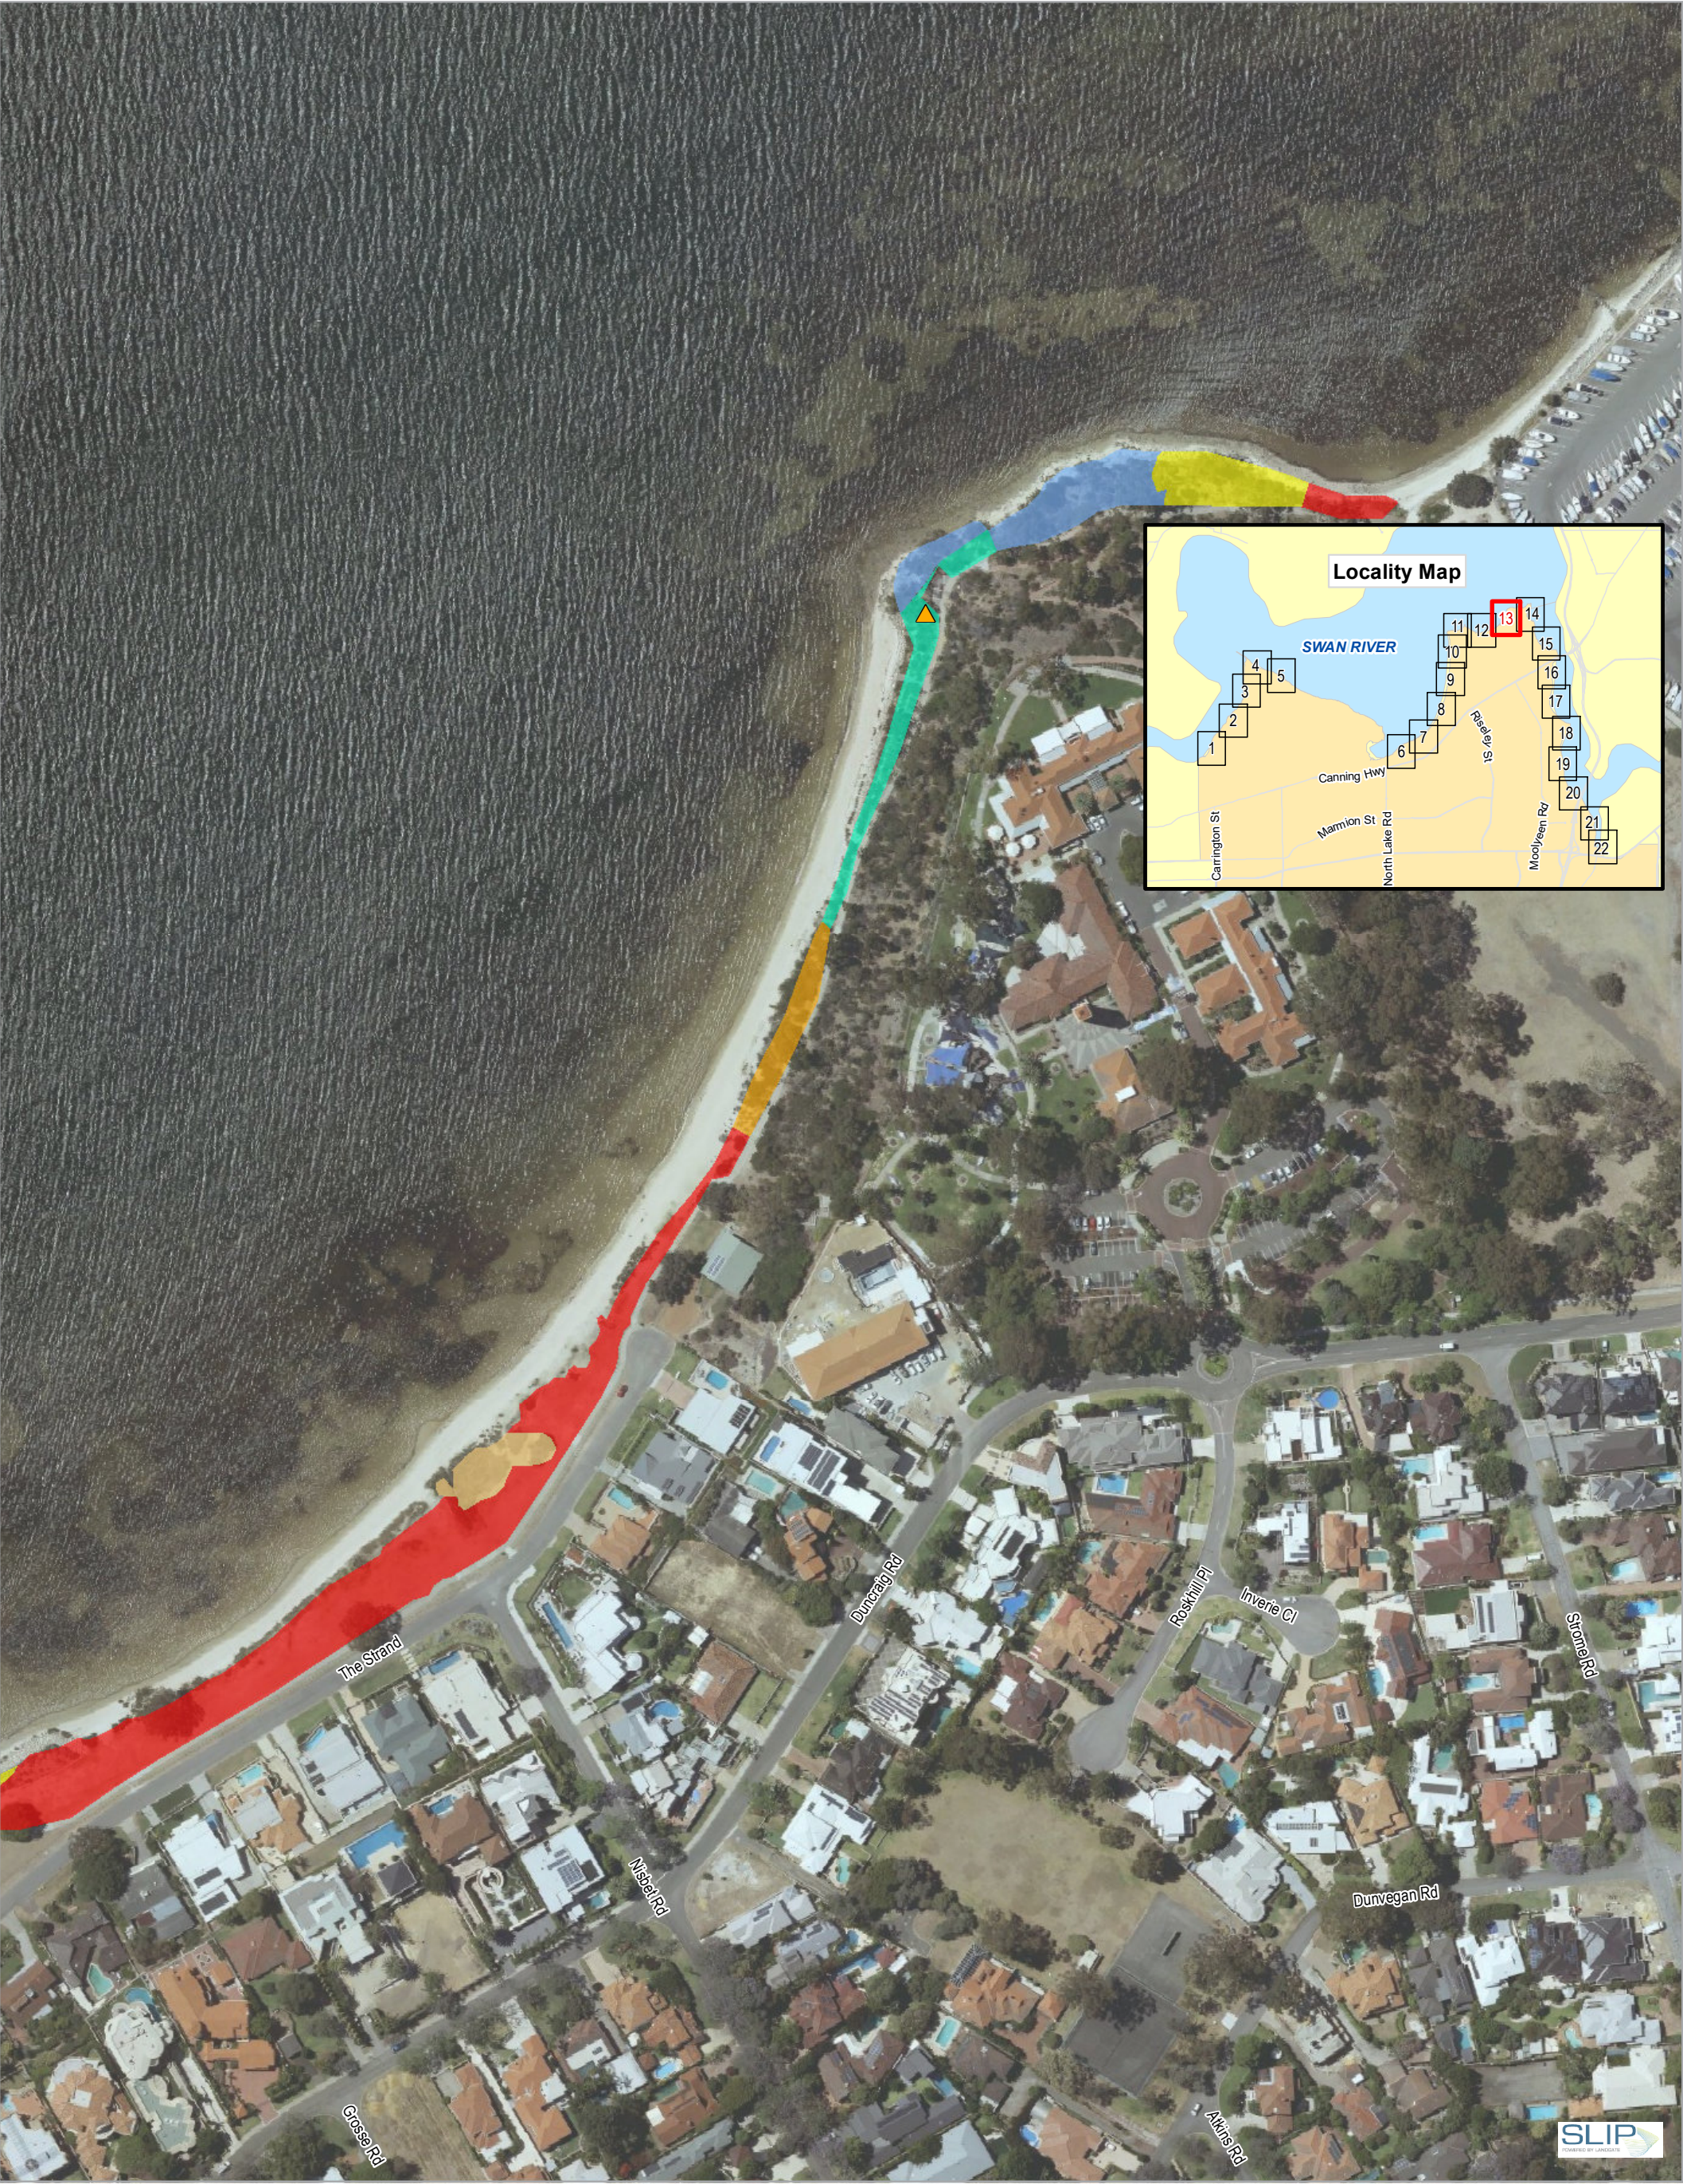
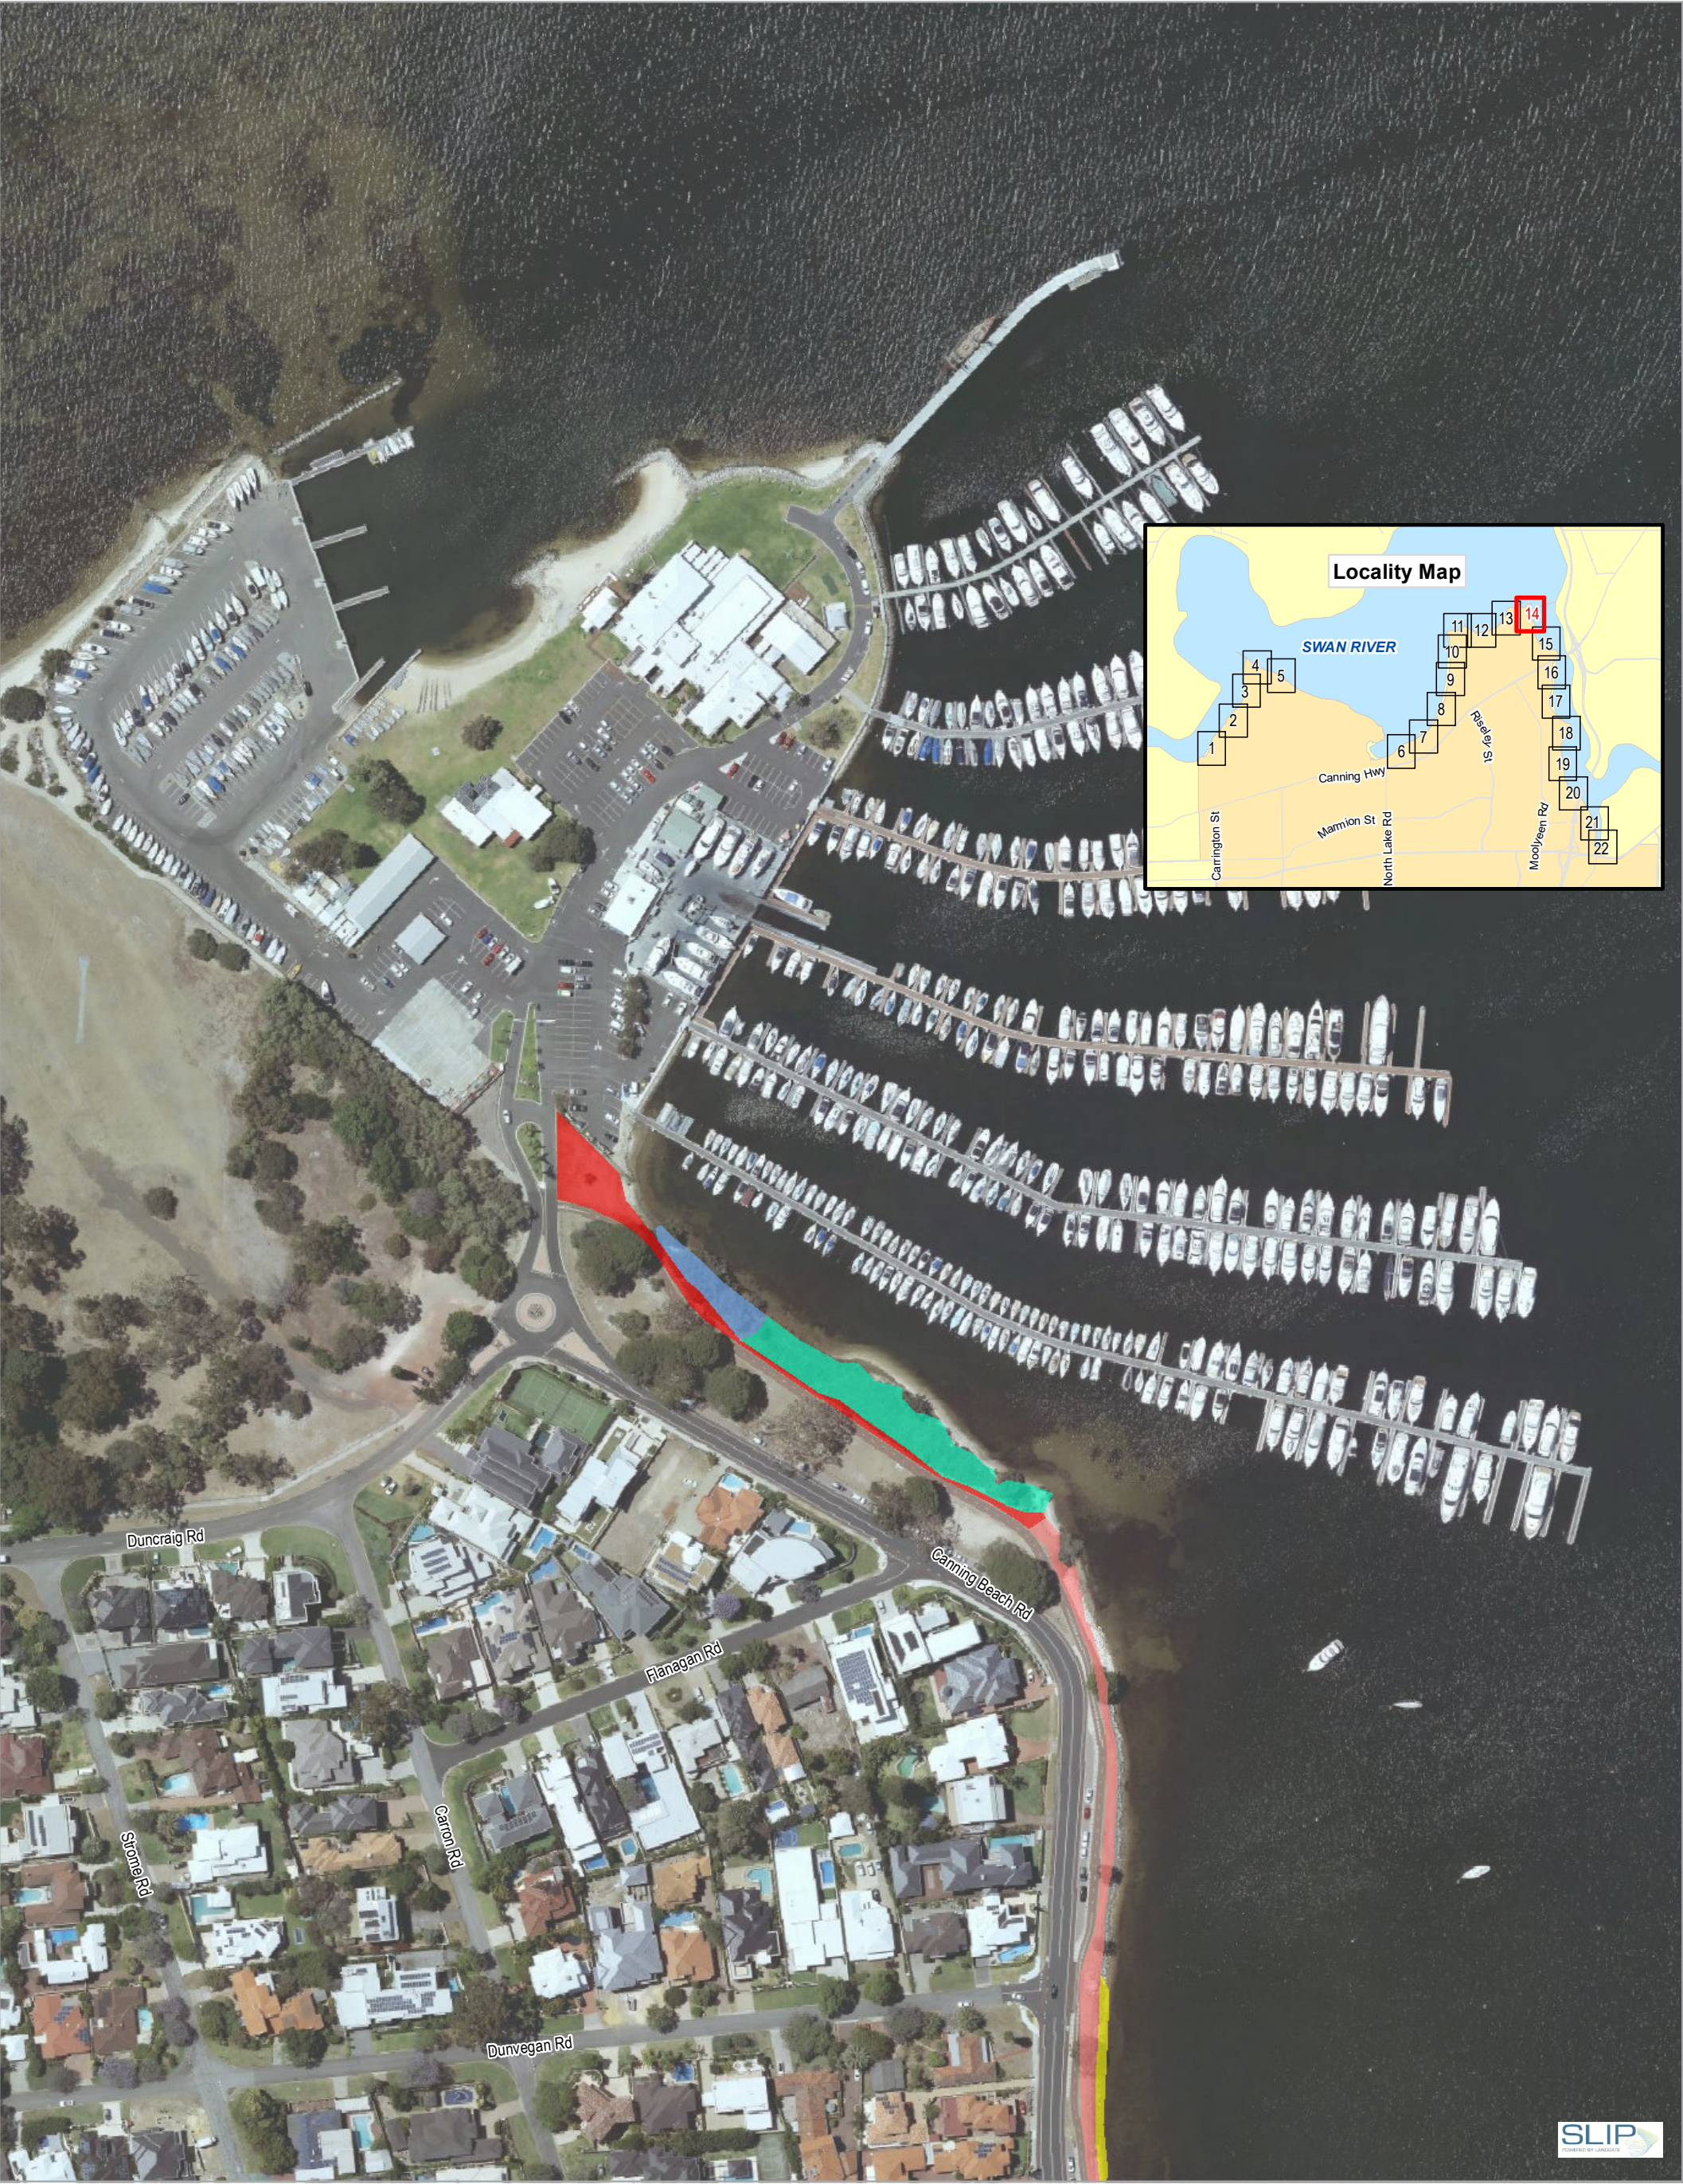
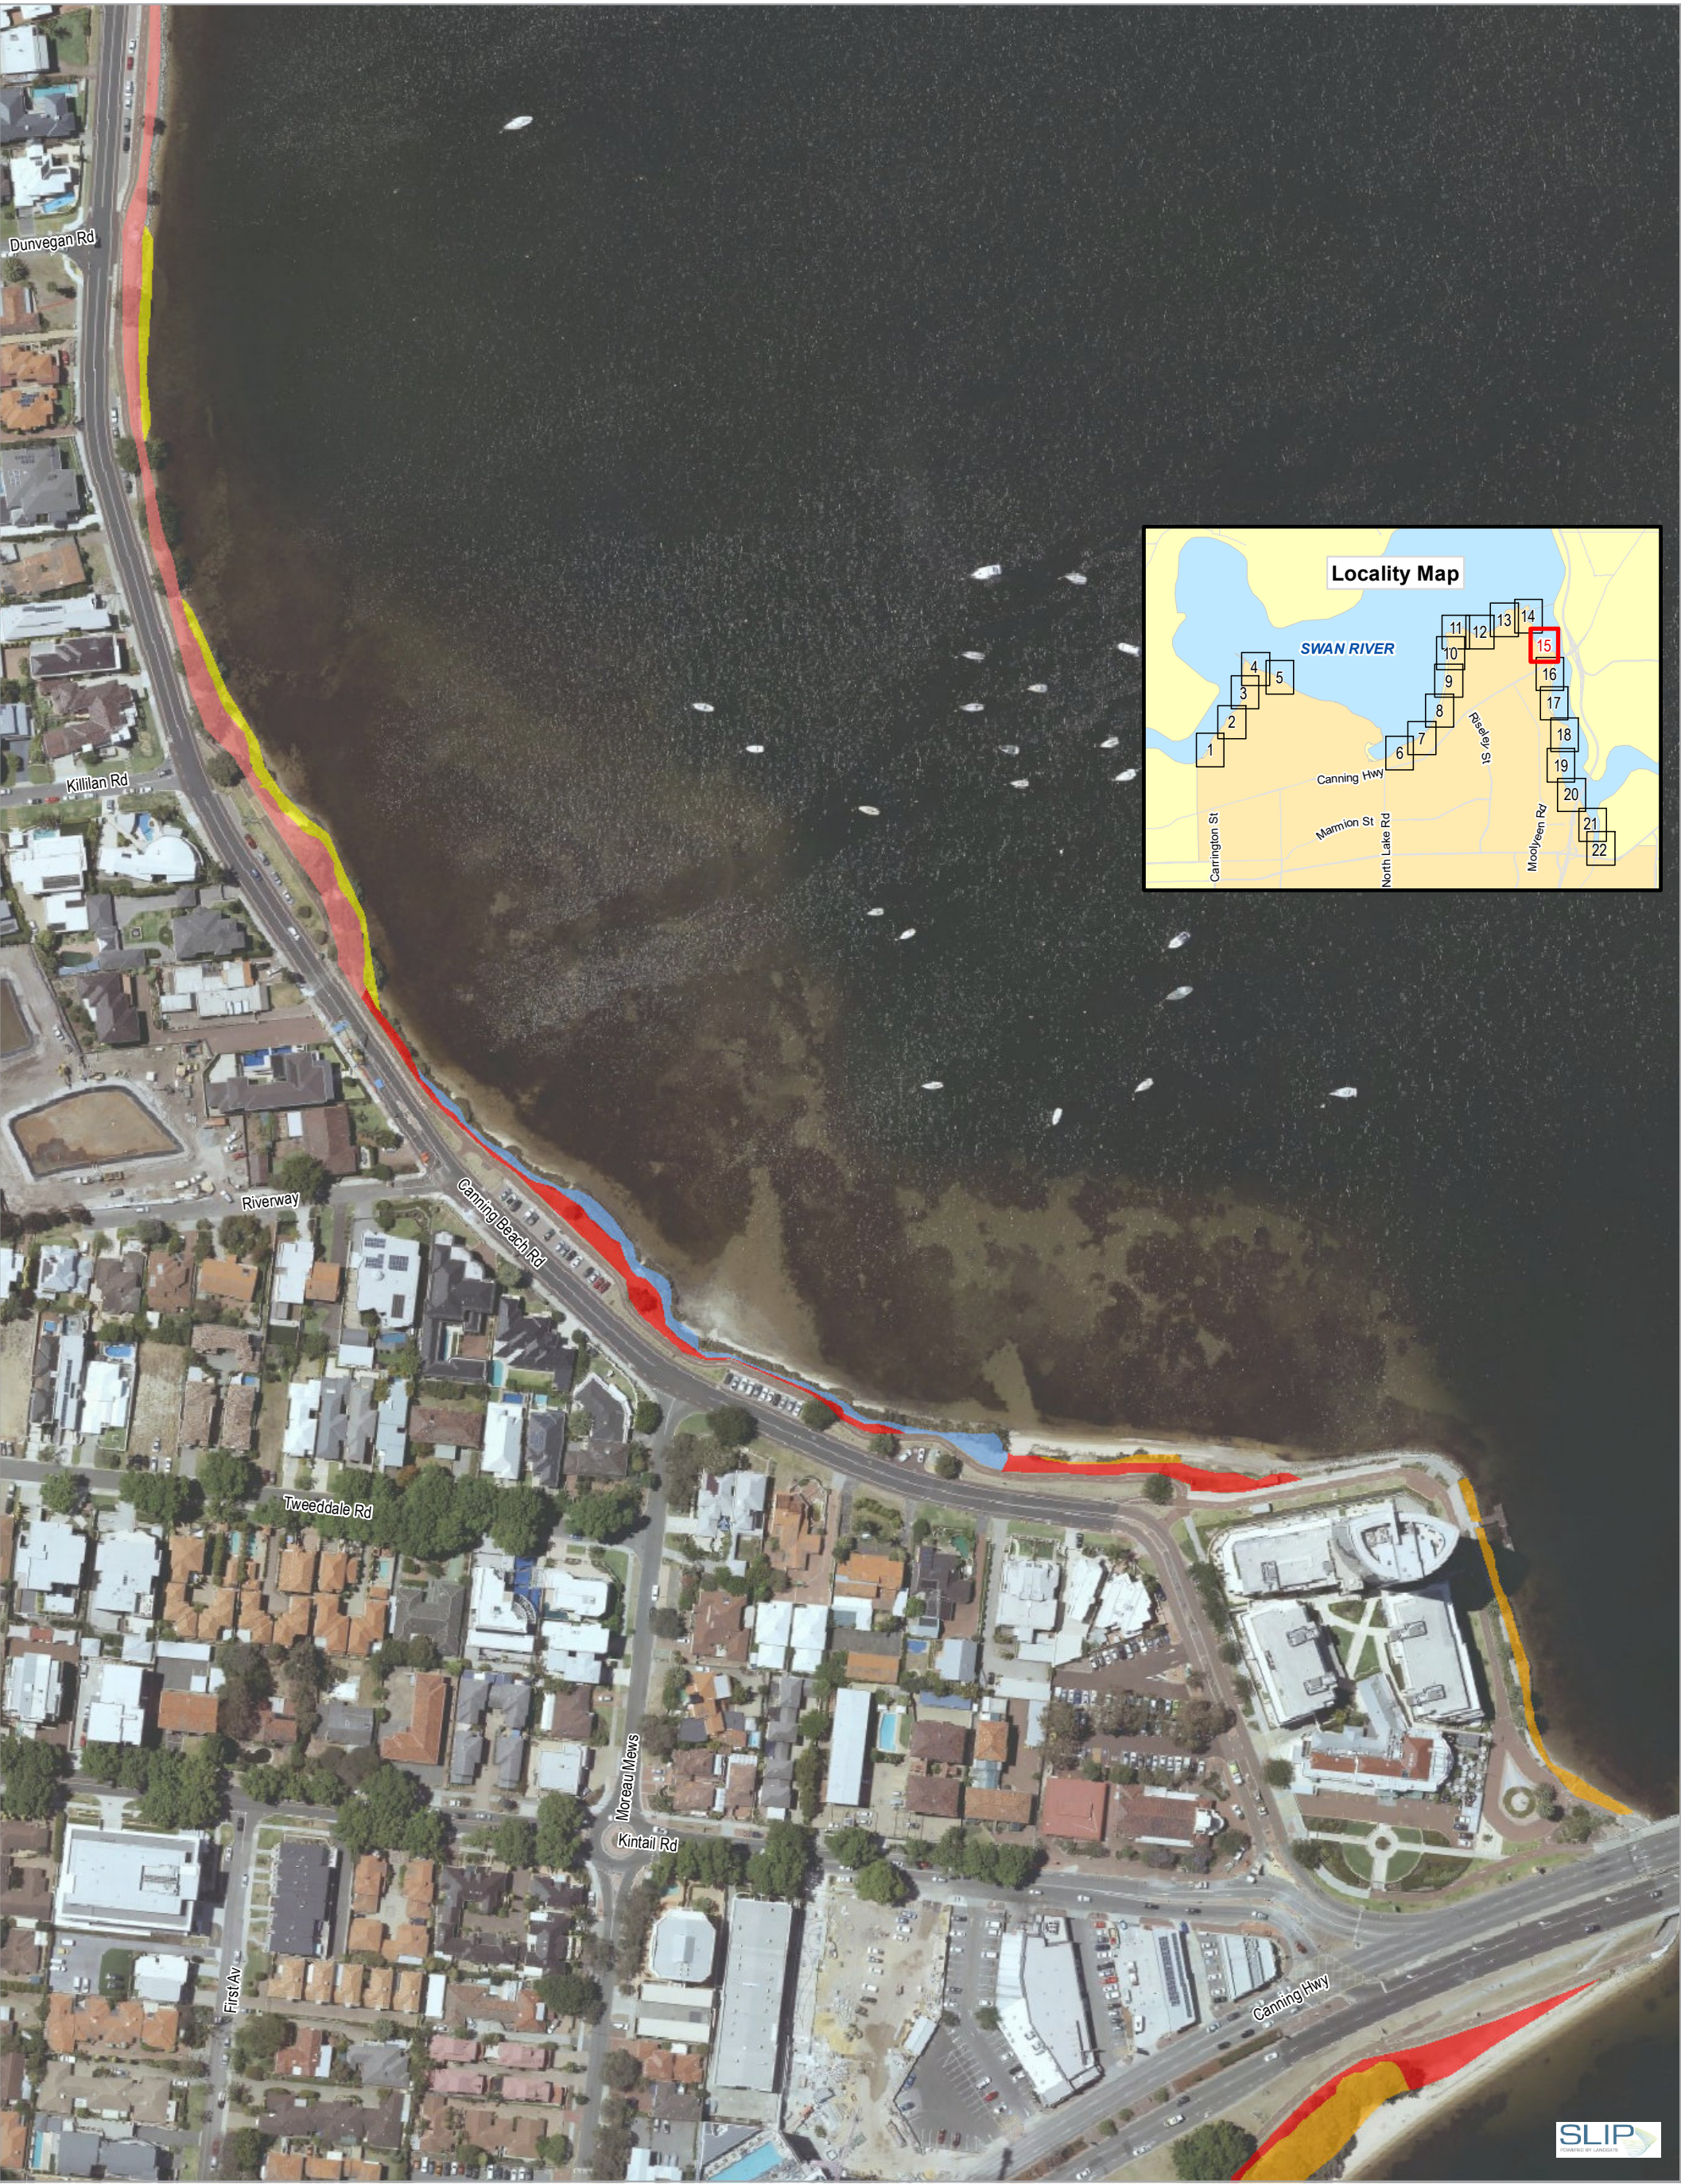
FIGURE 7

Vegetation condition and significant weeds
