City Of Melville

Foreshore Restoration Strategy 2019

March 2020

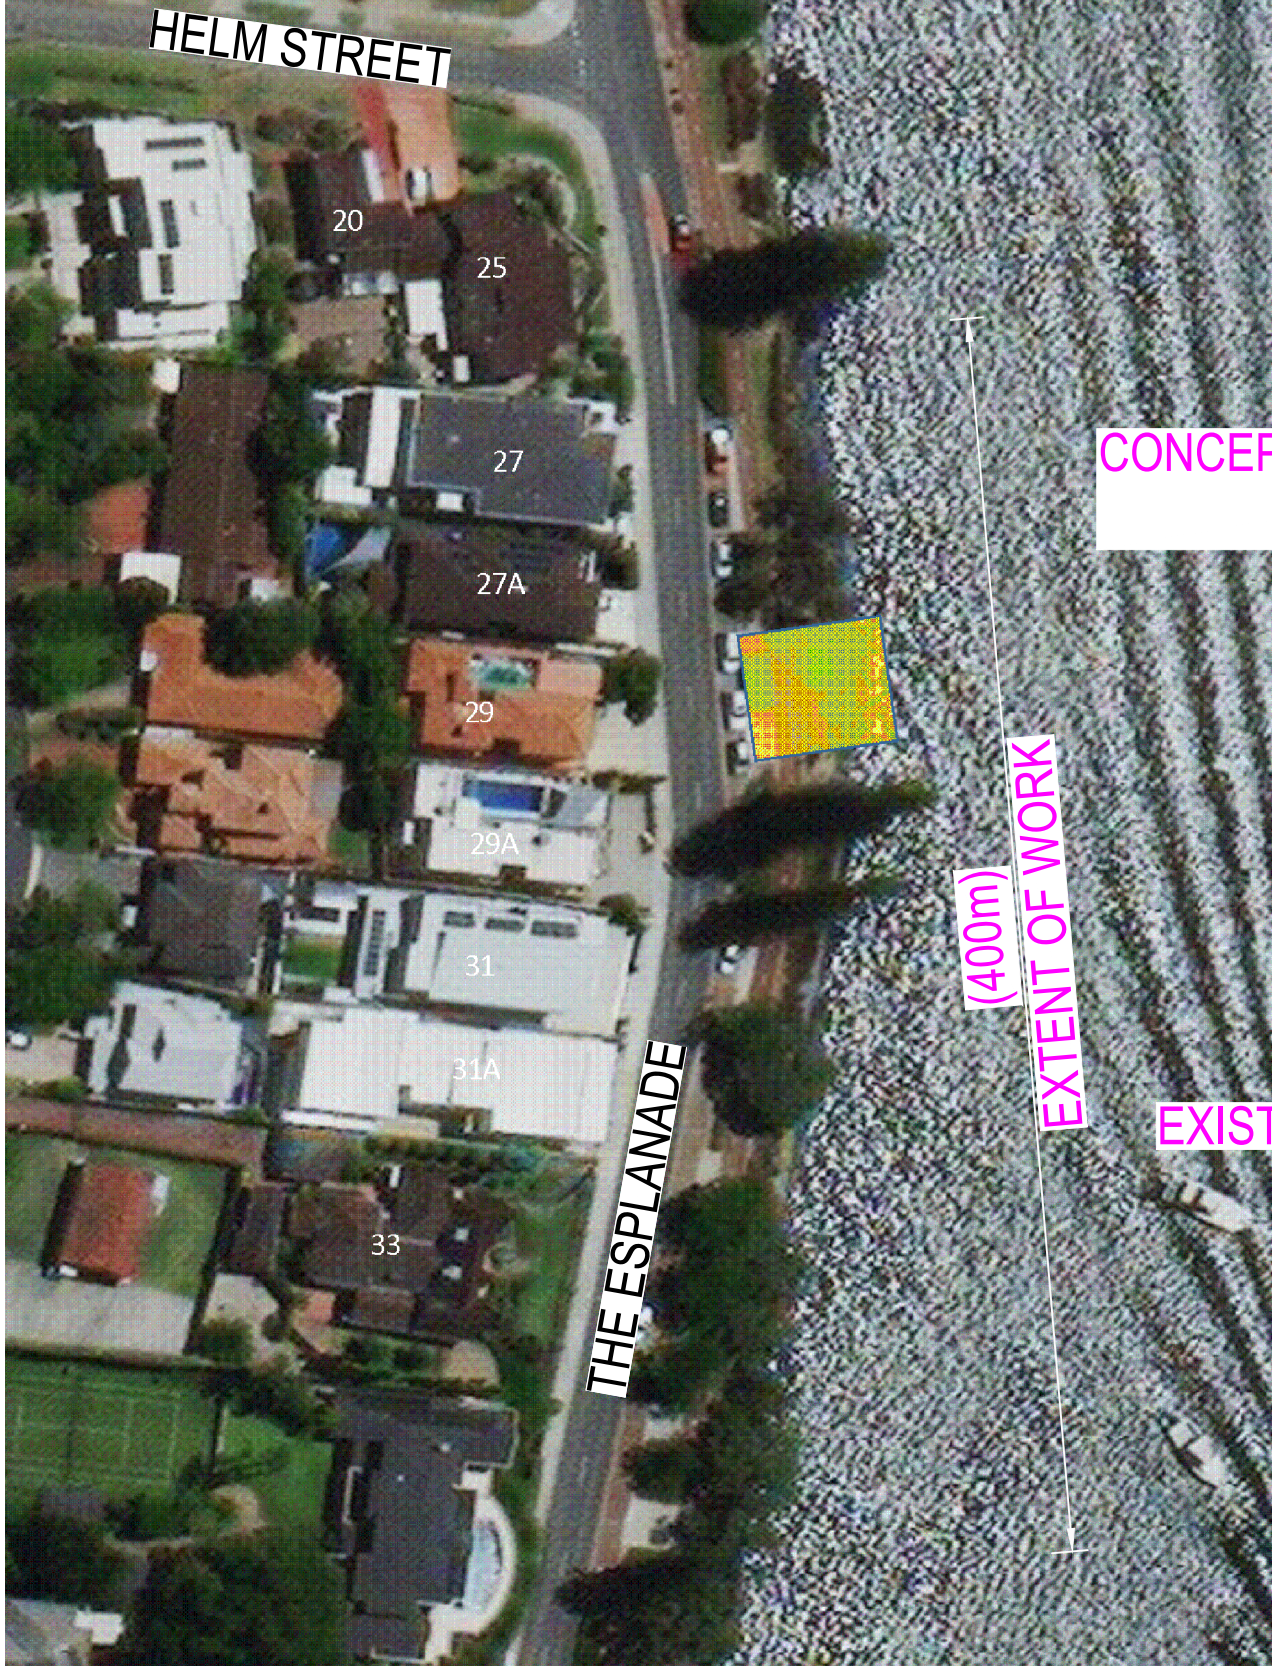
CONCEPT 1 - MAP PLAN

CONCEPT 1 - BEACH ACCESS AND SLOPE PROTECTION
