**City of Melville**

**FORESHORE MANAGEMENT PLAN**

**October 2025**  
**For City of Melville**

<b>Report</b>	<b>25001.RPT001</b>			
<b>Version</b>	<b>Date</b>	<b>Prepared by</b>	<b>Review/Approval</b>	<b>Issue Details</b>
1	16.10.25	RT, ME, KT	JS, DW	Draft 1 for comment
2	15.07.2025	RT, ME	JS, DW	Draft 2 for review
3	16.10.2025	RT	JS	Final Document Issue

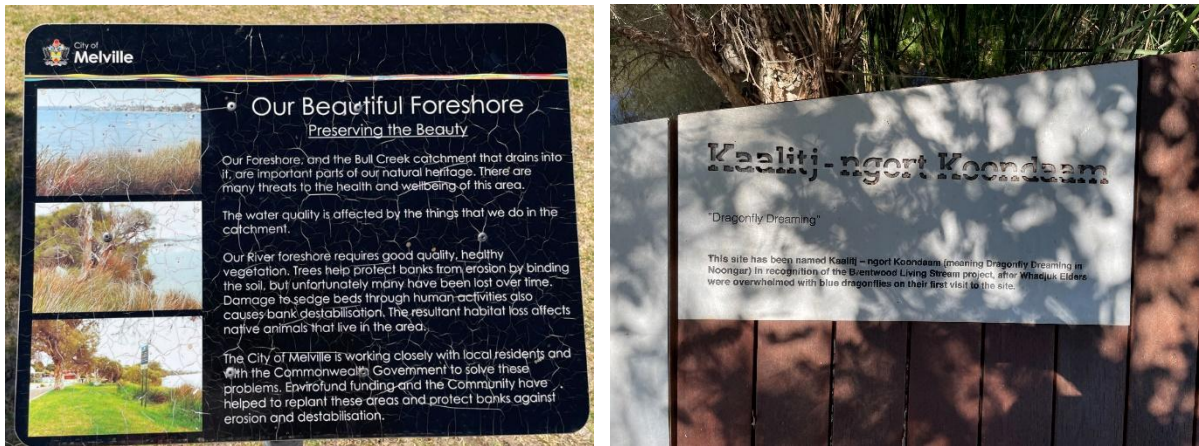
**Figure 22. Examples of signage and interpretive nodes along foreshore.**

Interpretive signage featuring text regarding natural values of the river shoreline is present throughout, but they are aging, and the placement is not always conducive to being easily observed due to the growth of vegetation. There are also several signs representing settler / European history (e.g., German Jetty), and these are generally presented as brass plaques.

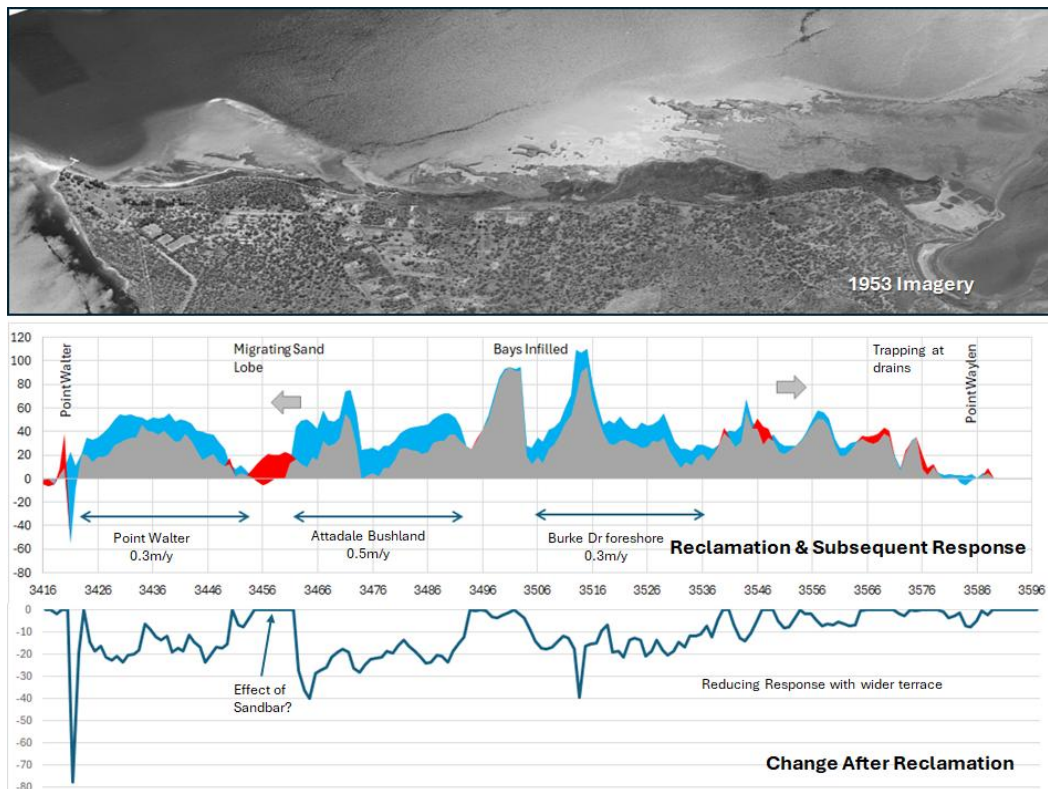
**Figure 29. Attadale foreshore response after reclamation**

Sediment transport along Attadale foreshore following reclamation has developed as three focal areas of erosion pressure (Figure 29). Immediately following placement, mobility was high, with a reducing rate of change following establishment of foreshore vegetation, including riparian sedges and nearshore Sheoak (Figure 29).

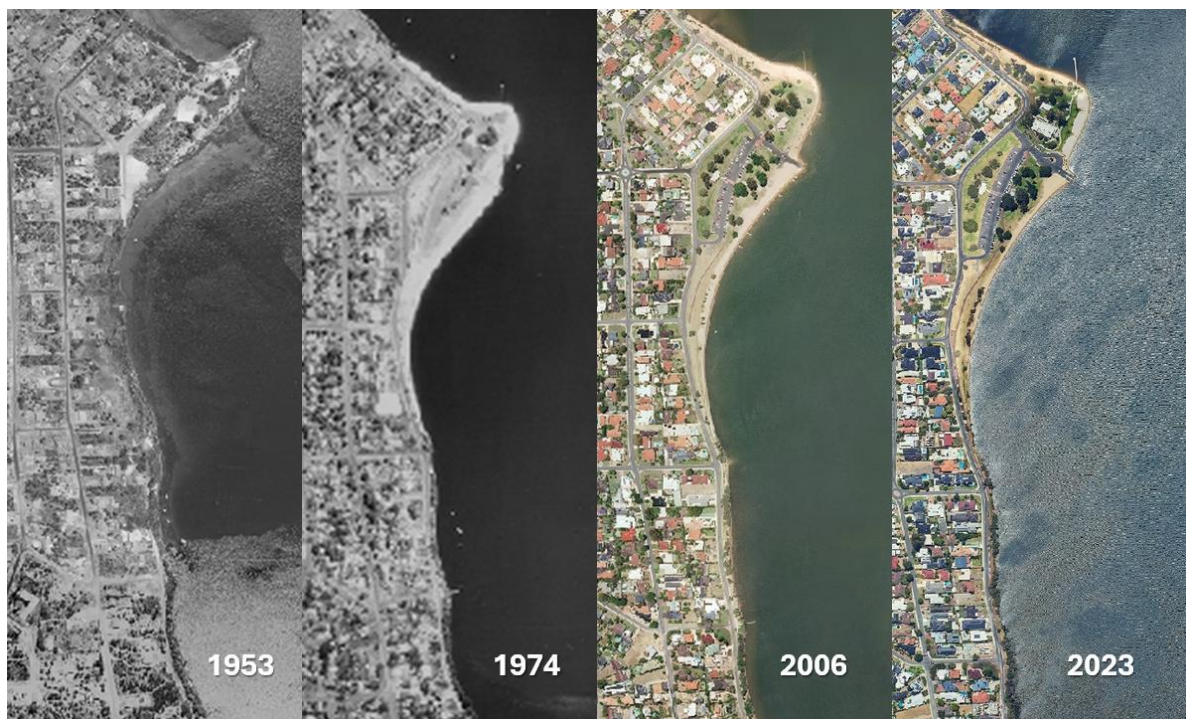
Figure 30. Deepwater Point Attadale foreshore response after reclamation.

- Behaviour near **Deepwater Point** has seen erosion pressure on the originally reclaimed foreshore extend to the foreshore ~500 m to the south. The arcuate beach, which formed following reclamation, has progressively rotated, with additional net loss from the southern end of the beach, near Queens Road (Figure 30). Trapping by the ramp has had a local effect only, with renourishment and headlands constructed in 2018 partly offsetting the erosion previously experienced north of the ramp.

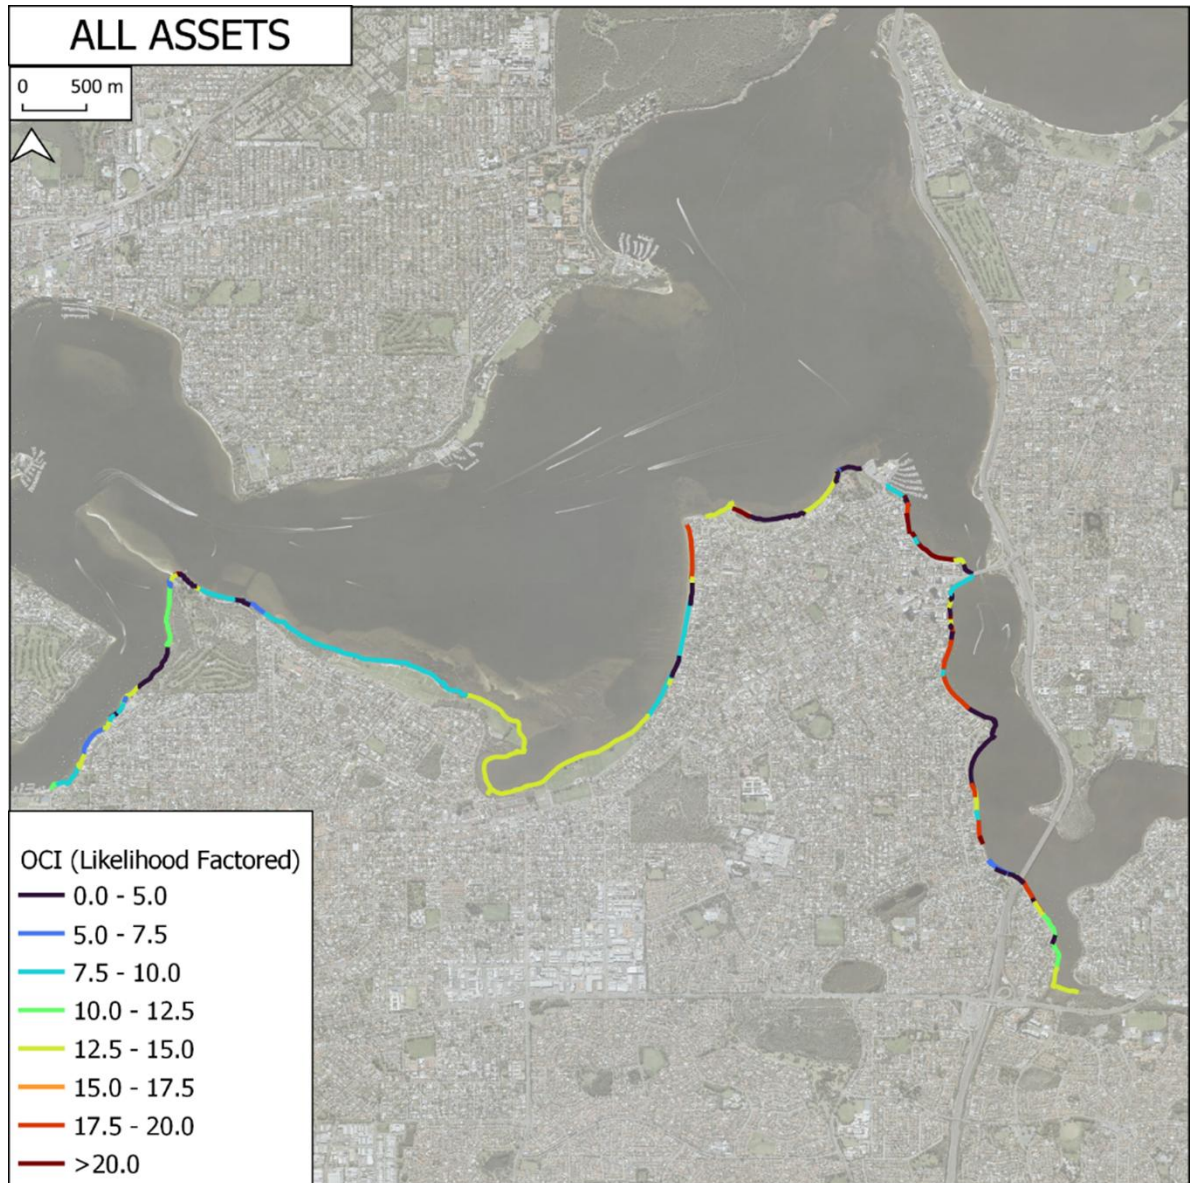
Figure 32. Asset overall condition index, including likelihood.

Approximately 75% of the foreshore length was classified as natural, with 25% built, noting the original classification requires updating. Most built assets have been assessed as Condition  $\geq 3$ , indicating a need for maintenance or upgrades. Similarly, many natural assets are Condition  $\geq 3$ , including:

- Narrow riparian zones along the Canning River foreshore, which typically give higher ratings.
- Erosion in beach areas, with net loss and small scarps.

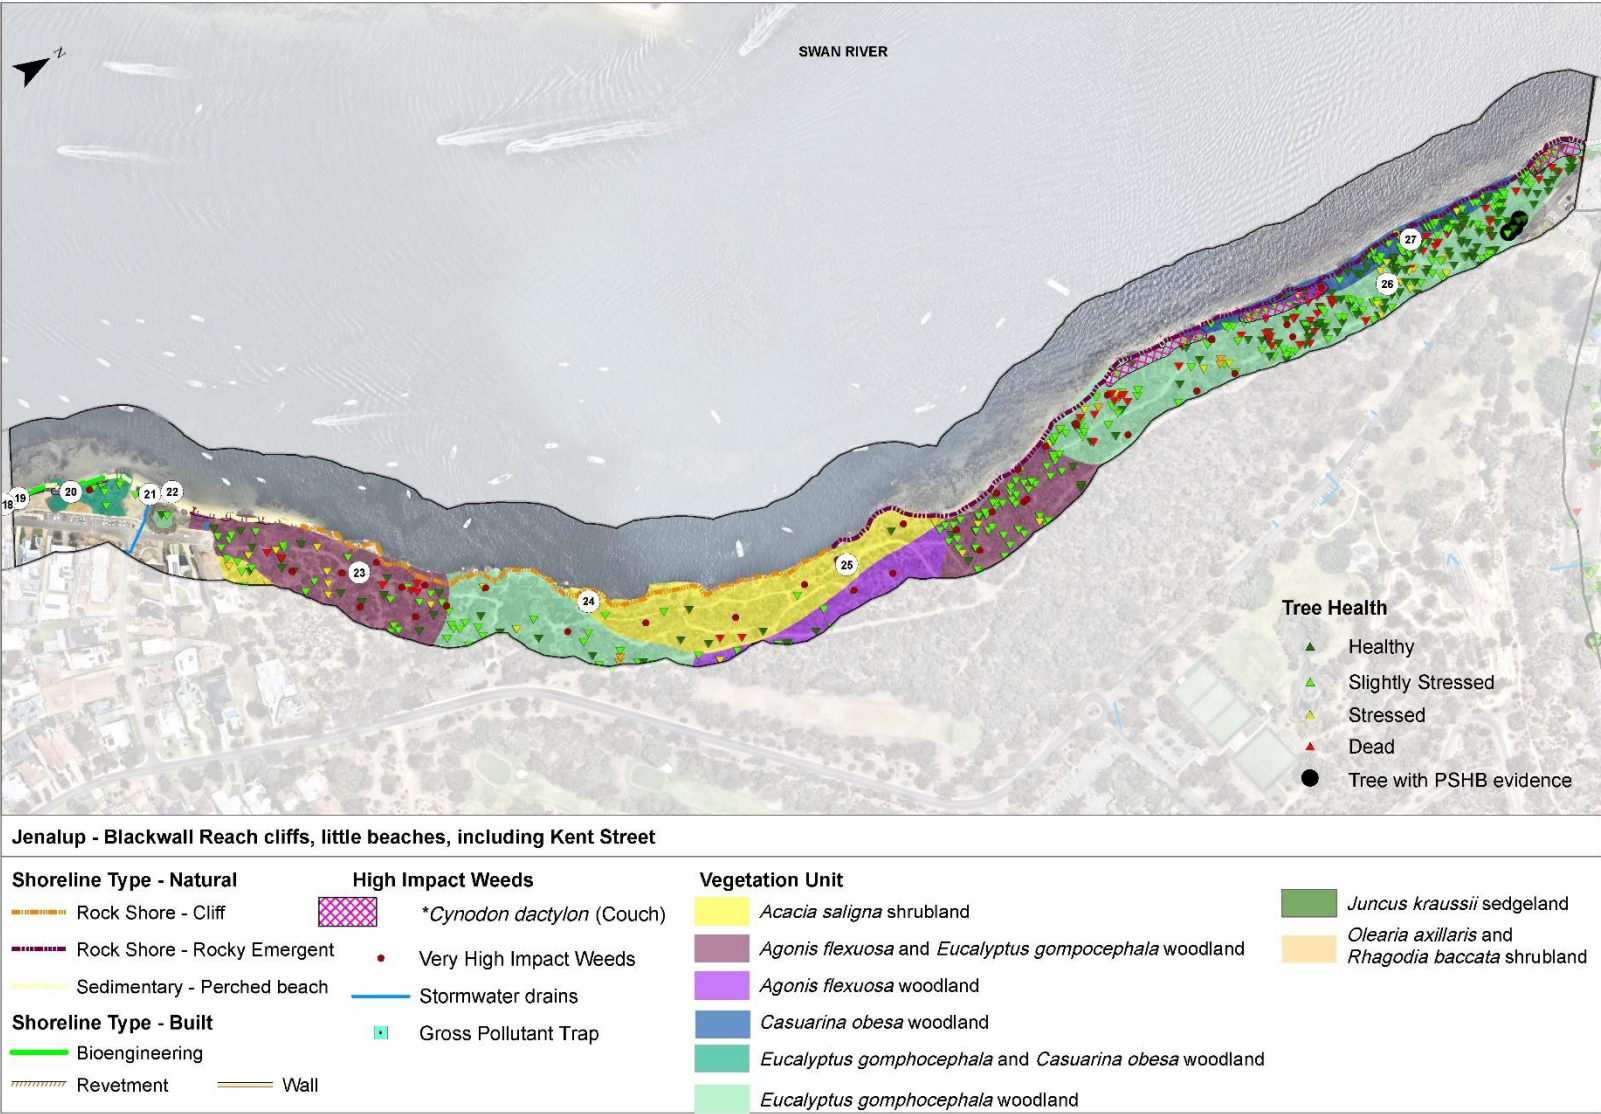
Figure 40. Jenalup - Blackwall Reach cliffs, little beaches, including Kent Street key management action sites

**Note:** Condition of viewing platforms on the cliffs was not examined beyond visual appearance. The composite decking is in serviceable condition; however, many boards are warping. The inspection and servicing of these platforms is scheduled on a regular basis via the City's asset management system outside of aquatic assets like jetties or boardwalks over water, and hence not elaborated on in the FMP.

26	Repair fence (bent over as a result of unauthorised access).	High	Maintenance
27	Revegetate the upper foreshore. Consult with the Coastal engineer regarding the placement of any trees lost to erosion to facilitate sand capture.	High	Maintenance

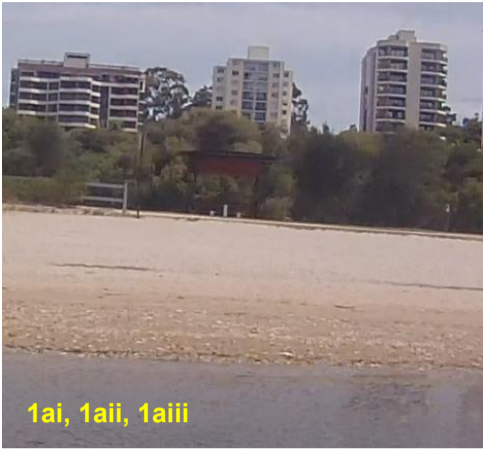
<p>1ai, 1aii, 1aiii</p>	(i) wide beach (>10m), gentle grade (<1V:6H) and <10% alongshore erosion to landward

Sedimentary 1 of 2 (a–beach/perched, b–exposed bank)				
Rating	Condition descriptor	Performance	Photo (with associated code)	
1	(a) Relatively stable	Good Condition

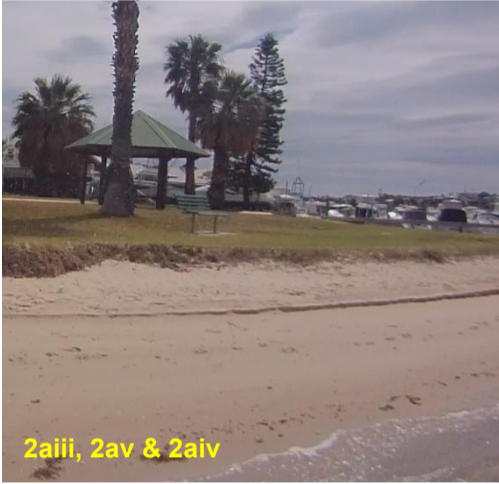
<p>2aiii, 2av &amp; 2aiv</p>	(iii) low damage factors to landward with minimal scarping, undercutting and retreat

(b) Relatively stable			(ii) beach width >4m and accreted >1m from 2008-2015
2	(a) Limited areas of erosion of the beach or of the bank behind the beach	Minor Defects

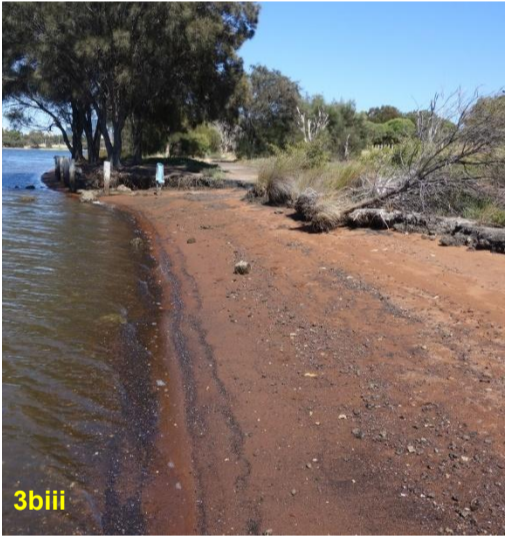
<p>3biii</p>	(ii) low damage factors (<10% alongshore extent of undercutting/incising/slumping)

(b) Limited areas of, or low elevation, erosion indicators			(i) Vertical scarps/exposed face of <0.3m for <50% of the alongshore length (trees/sedge may cover 50% of the shoreline)
3	(a) Some erosion of the beach or of the bank behind the beach	Fair Condition

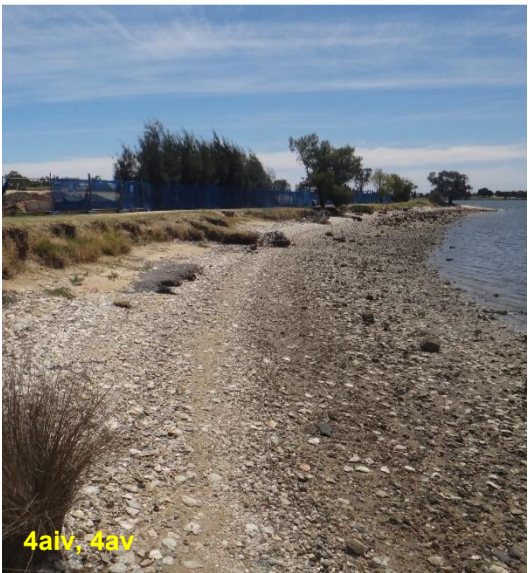
<p>4aiv, 4av</p>	(i) Beach width >4m and <10% erosion

(b) Some areas of, or low-to-moderate elevation, erosion indicators			(iii) Destabilising processes by human extra influence impacting <10% of the alongshore length
4	(a) Moderate erosion of the beach or of the bank behind the beach	Poor Condition

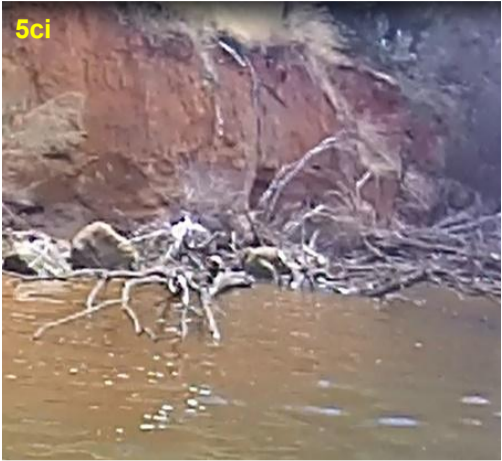
<p>5ci</p>	<ul style="list-style-type: none"> <li>(i) vertical scarps on banks of main river channel for &gt;70% of alongshore length</li> <li>(ii) extensive sedimentation, with anastomosing channel</li> <li>(iii) bare sediment for &gt;90% of alongshore length (&lt;10% vegetation)</li> </ul>

Sedimentary 2 of 2 (c – scarp, d – embankment)				
Rating	Condition descriptor	Performance	Photo (with associated code)	
	(d) Extensive sedimentation, extensive scarps or poor vegetation cover

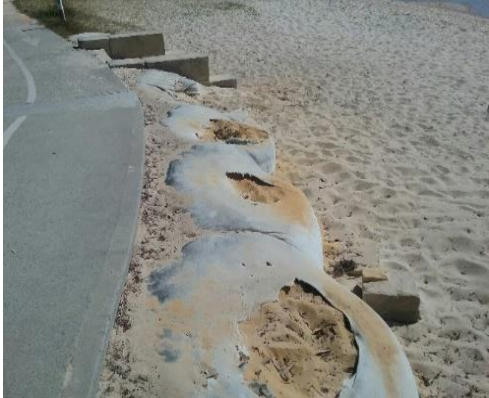
9	Manage foreshore access to ensure traffic is directed away from sensitive areas and diverted to designated public access points. *	Fences, stairs and paths are installed throughout the Melville foreshore to manage traffic but trampling in areas of unrestricted access is still a problem.	Trampling is still a problem, however a number of foreshore sites have been fenced off and provide good protection with minimum visual impact.
10	Remove failed foreshore treatments along the foreshore that have become potential safety hazards.	Observation recorded as part of the 2019 survey. Some areas noted have not been removed, such as failed sandbags located -The Strand opposite #54A

This area has been rehabilitated, however additional areas are showing degradation - Refer to site specific report cards.
