Mt Pleasant Bowling Club

Address: 40 Barrisdale Road Ardross

Audit Date: 27 March 2020

Prepared for City of Melville

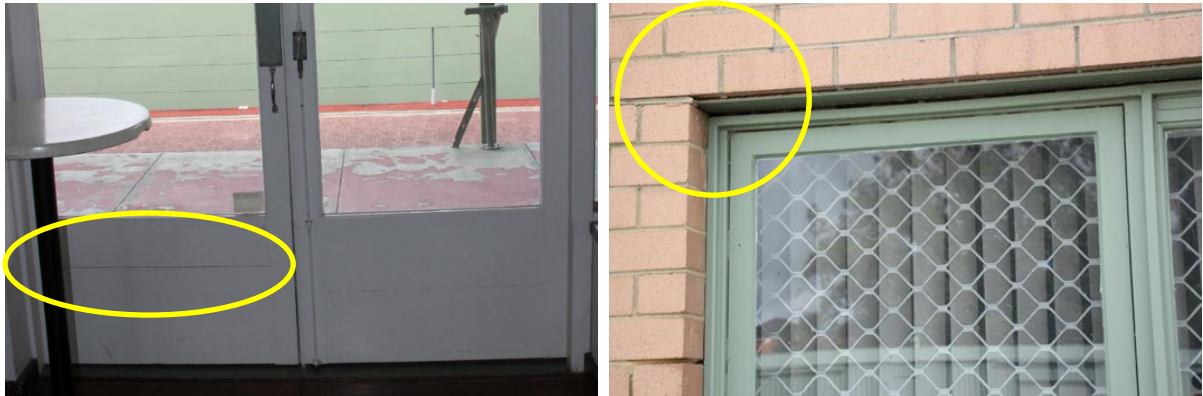
Figure 3: Photo 17, 18, 19, 20, 21, 22, 23 & 24 - Windows and doors

The doors and windows are in good condition for their age see Figure 3. However the paint is starting to flake off on some windows and the paint on the timber doors appears thin. It is recommended that the paint on the windows is removed and timber repainted. The south facing double doors are also in average condition. The bottom timber panel of the joinery has started to split. It is recommended that the doors are repaired and painted.

The steel lintels are in poor condition. The steel is rusting and in some cases causing corrosion jacking which has damaged the structural integrity of the brick walls. It is recommended that the lintels are replaced and brickwork is repaired.

The aluminium windows are in good condition. There are only a few windows with security screens fitted to the windows. There is also glass louver windows with broken glass. It is recommended that the glass is replaced. In general the windows and doors require a lot of maintenance and repairs. No further action is recommended.

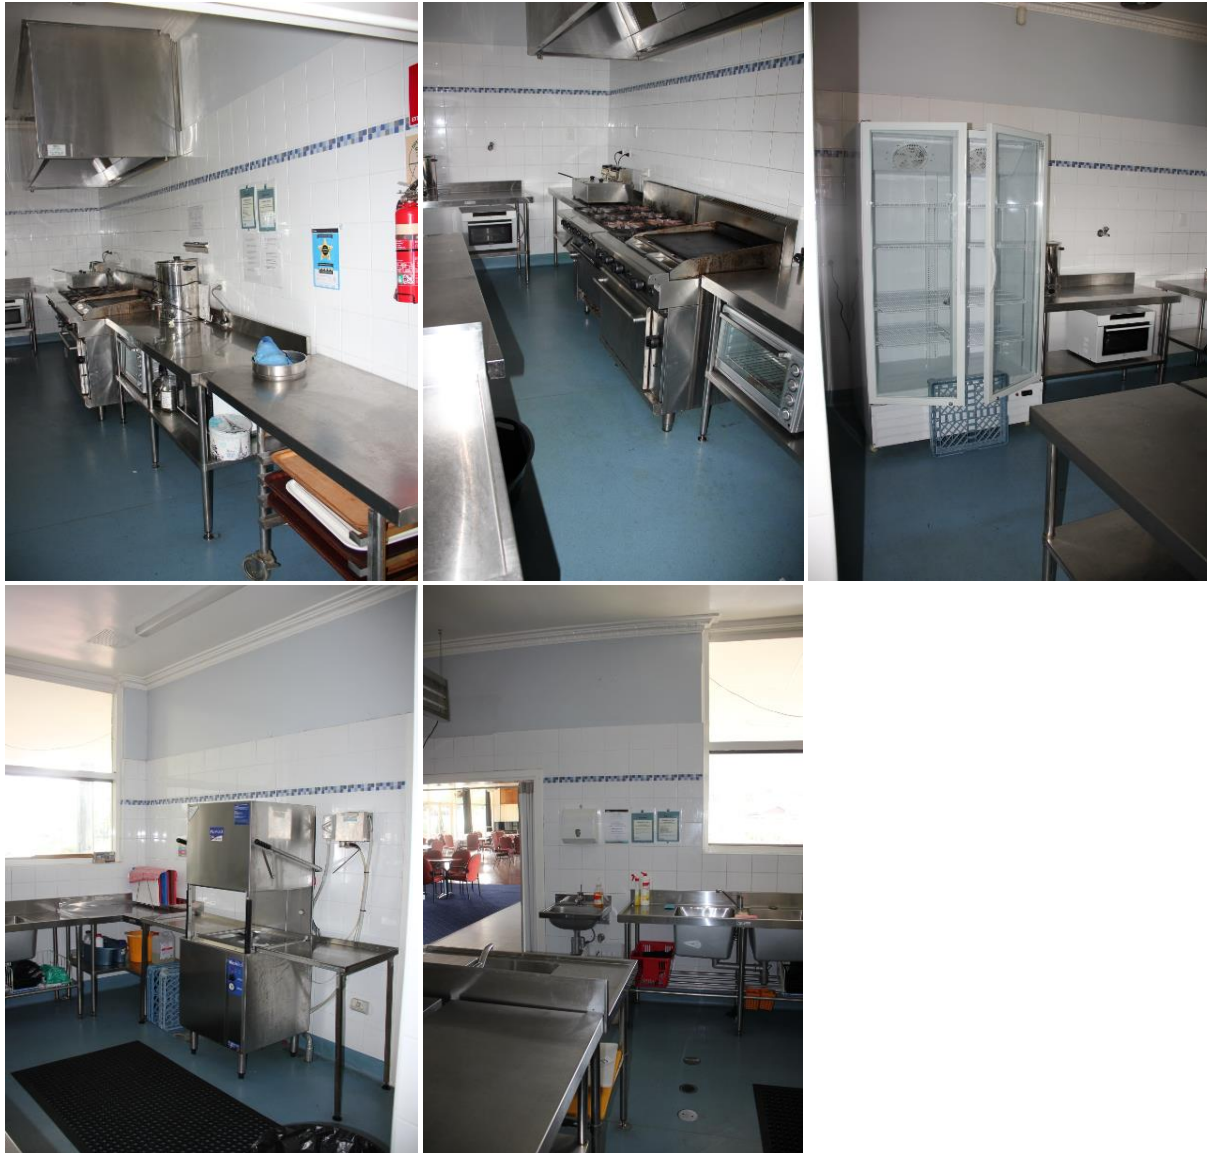
Figure 21: Photo 95, 96, 97, 98 & 99 – Kitchen

The kitchen appears to be newly renovated and is in very good condition see Figure 21. The walls and ceiling are in very good condition. The stainless steel benches are in very good condition. The commercial rangehood and cooking appliances are in very good condition. The commercial vinyl floor lining and wall tiles are new and in very good condition. The kitchen is functioning correctly. No action is recommended.

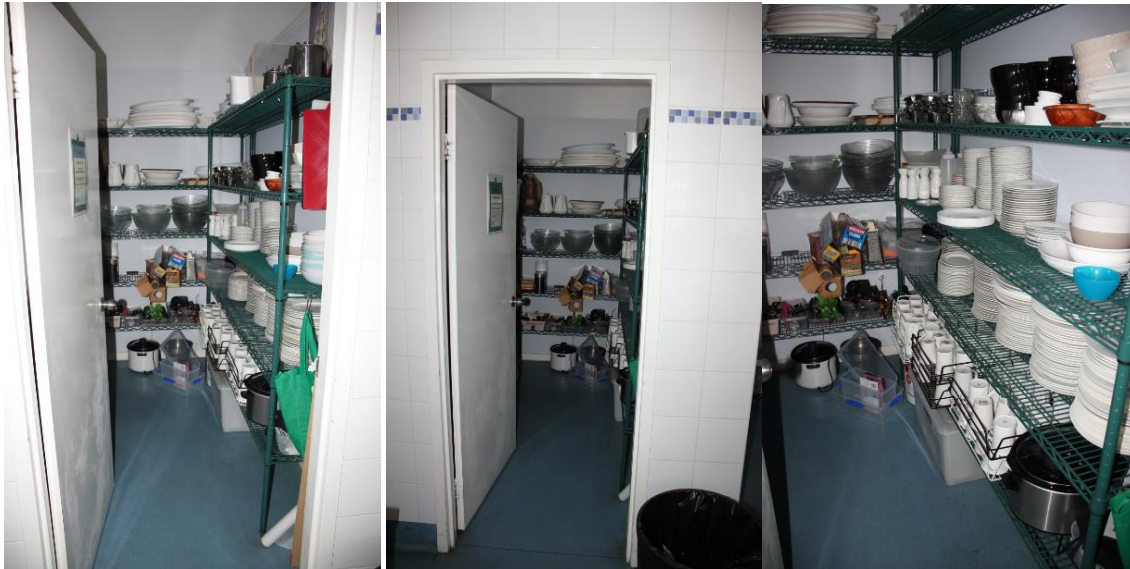
Figure 22: Photo 100, 101 & 102 - Pantry

The kitchen pantry appears to be newly renovated and is in very good condition see Figure 22. The walls and ceiling are in very good condition. The stainless steel benches are in very good condition. The commercial vinyl floor lining is new and in very good condition. The entry door is well painted and is in very good condition. The wire shelving is also in good condition. No action is recommended.

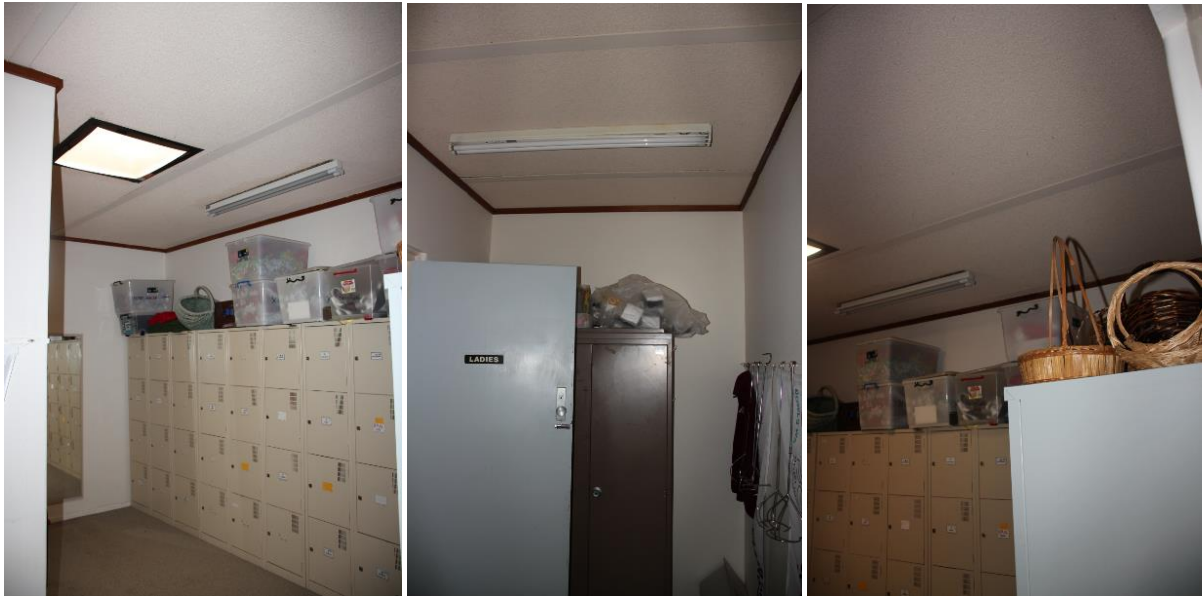
Figure 26: Photo 117, 118 & 119 – Ladies locker room

The storeroom is in good condition see Figure 26. The walls and ceiling are well painted and are in good condition for their age. The entry doors and door frames are well painted and are in good condition. The carpet floor cover appears to be in good condition and is fit for purpose. No action is recommended.

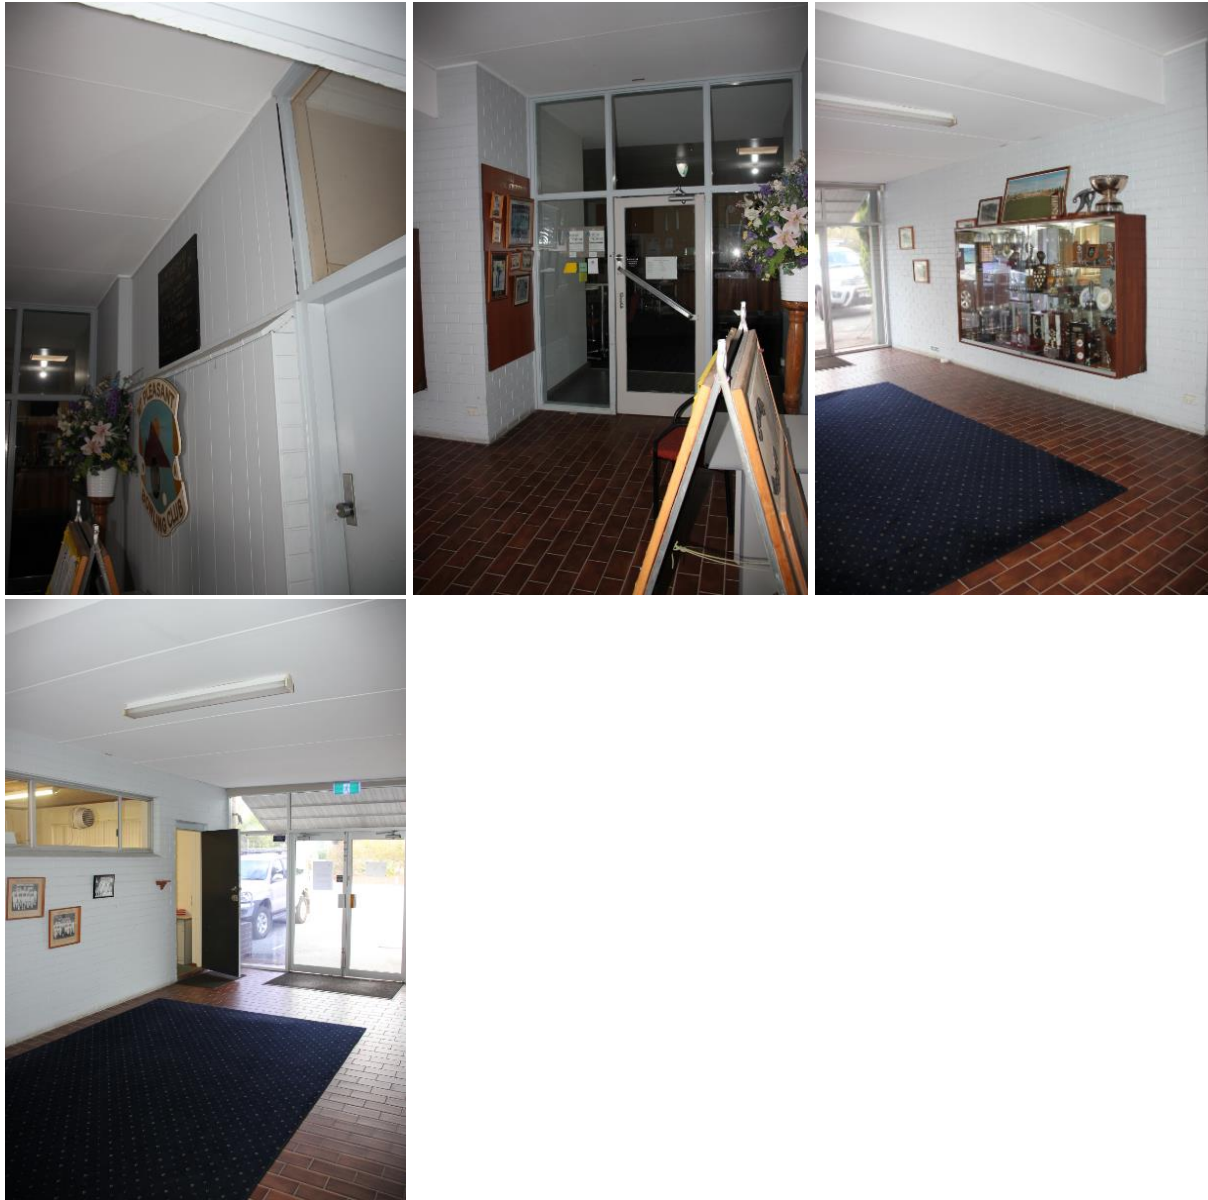
Figure 29: Photo 132, 133, 134, 135 & 136 – Entry

The entry is in very good condition see Figure 29. The brick walls and asbestos ceiling are well painted and are in good condition. The doors and door frames are well painted and are in good condition. The tiled and carpet floor cover is in very good condition. No action is recommended.

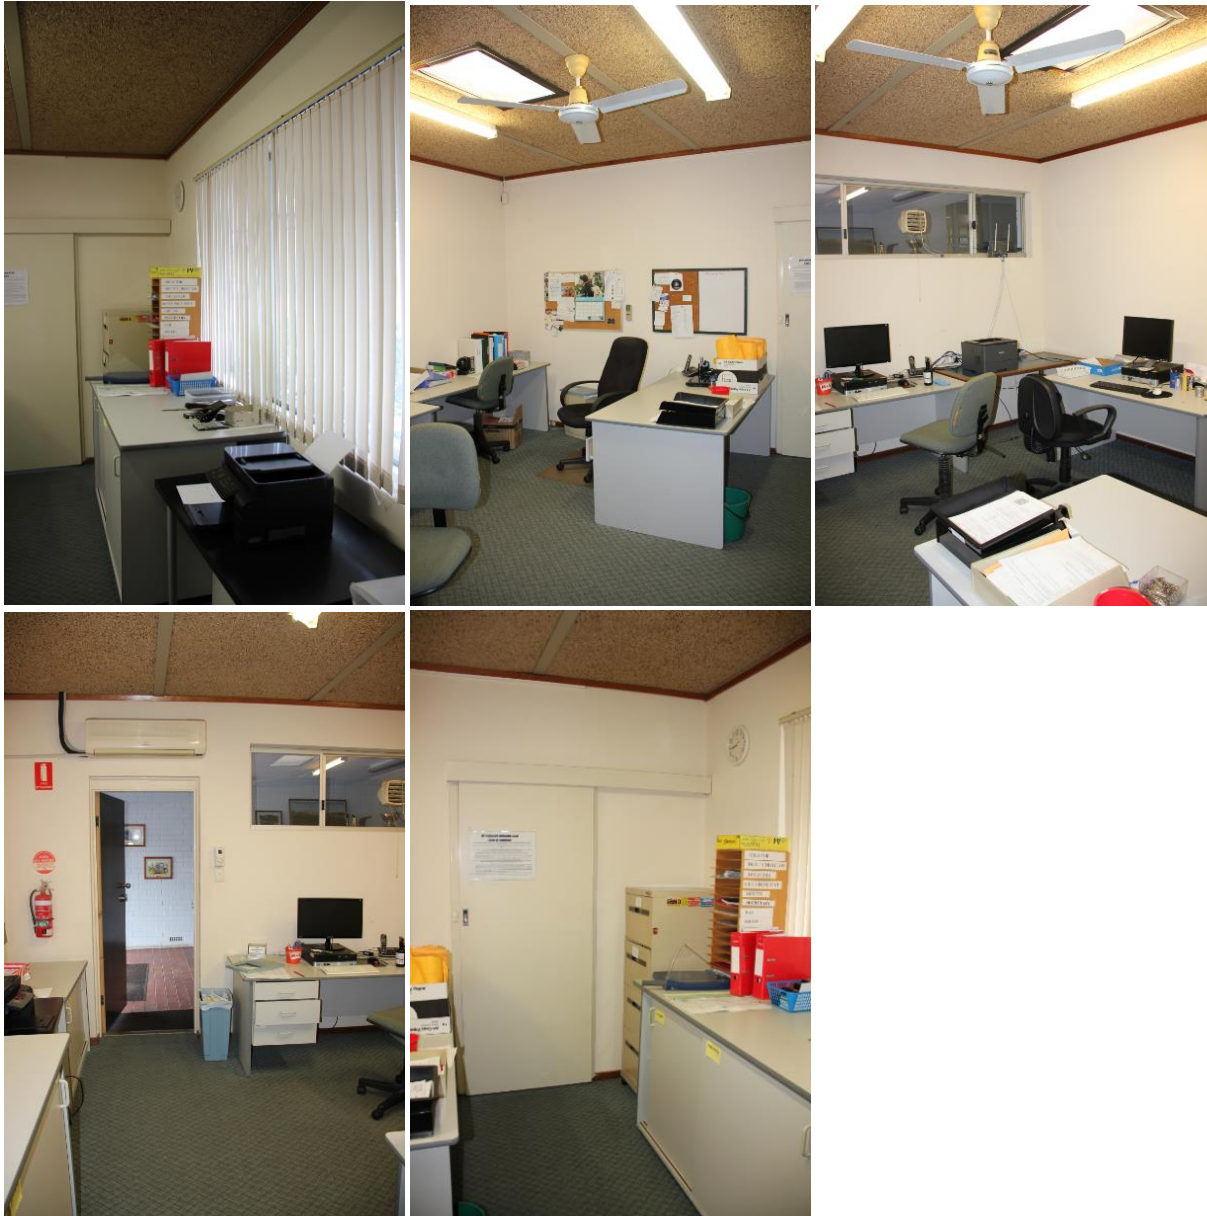
Figure 30: Photo 137, 138, 139, 140 & 141 – Front office

The office is in good condition for its age see Figure 30. The walls are well painted and are in good condition. The ceiling is very old but is in good condition for its age. The doors and door frames are well painted and are in good condition. The carpet floor cover is in good condition. The airconditioner is in good working condition. No action is recommended.
