City of Melville

FORESHORE MANAGEMENT PLAN

October 2025
For City of Melville

Report	25001.RPT001			
Version	Date	Prepared by	Review/Approval	Issue Details
1	16.10.25	RT, ME, KT	JS, DW	Draft 1 for comment
2	15.07.2025	RT, ME	JS, DW	Draft 2 for review
3	16.10.2025	RT	JS	Final Document Issue

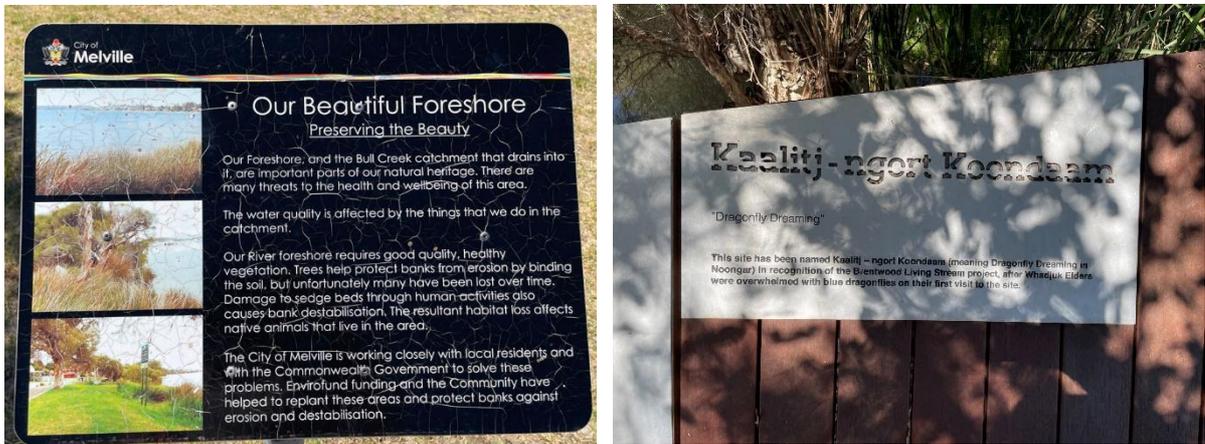
Figure 22. Examples of signage and interpretive nodes along foreshore.

Interpretive signage featuring text regarding natural values of the river shoreline is present throughout, but they are aging, and the placement is not always conducive to being easily observed due to the growth of vegetation. There are also several signs representing settler / European history (e.g., German Jetty), and these are generally presented as brass plaques.

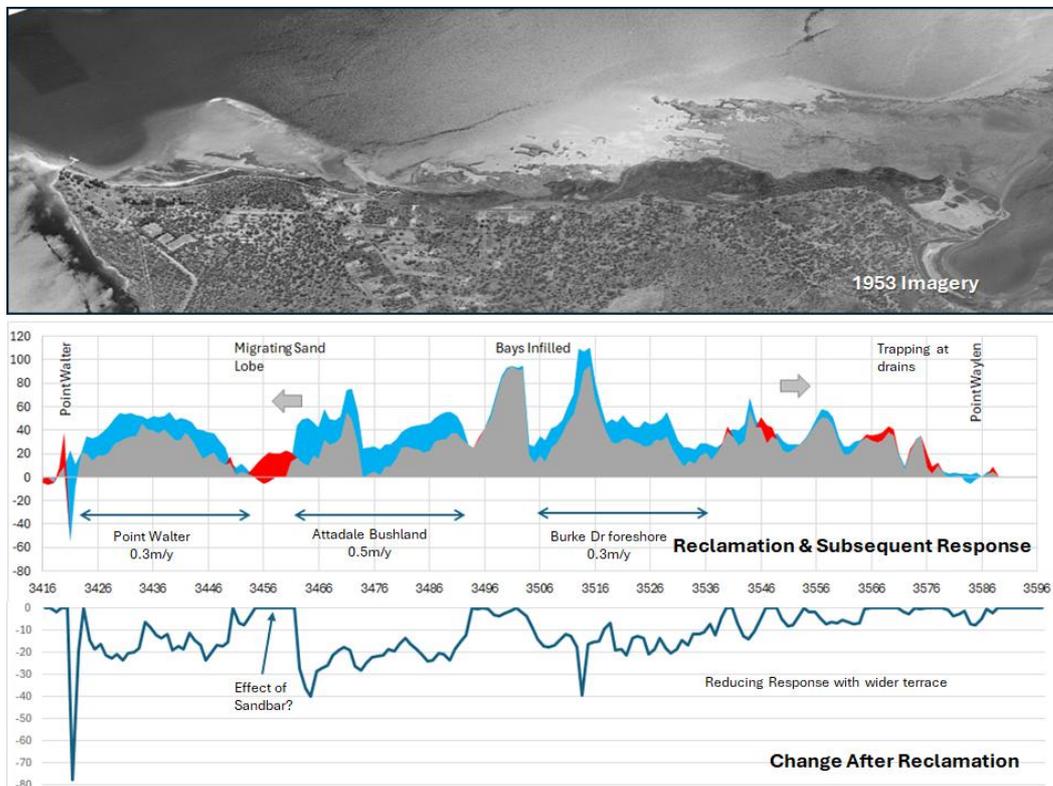
Figure 29. Attadale foreshore response after reclamation

Sediment transport along Attadale foreshore following reclamation has developed as three focal areas of erosion pressure (Figure 29). Immediately following placement, mobility was high, with a reducing rate of change following establishment of foreshore vegetation, including riparian sedges and nearshore Sheoak (Figure 29).

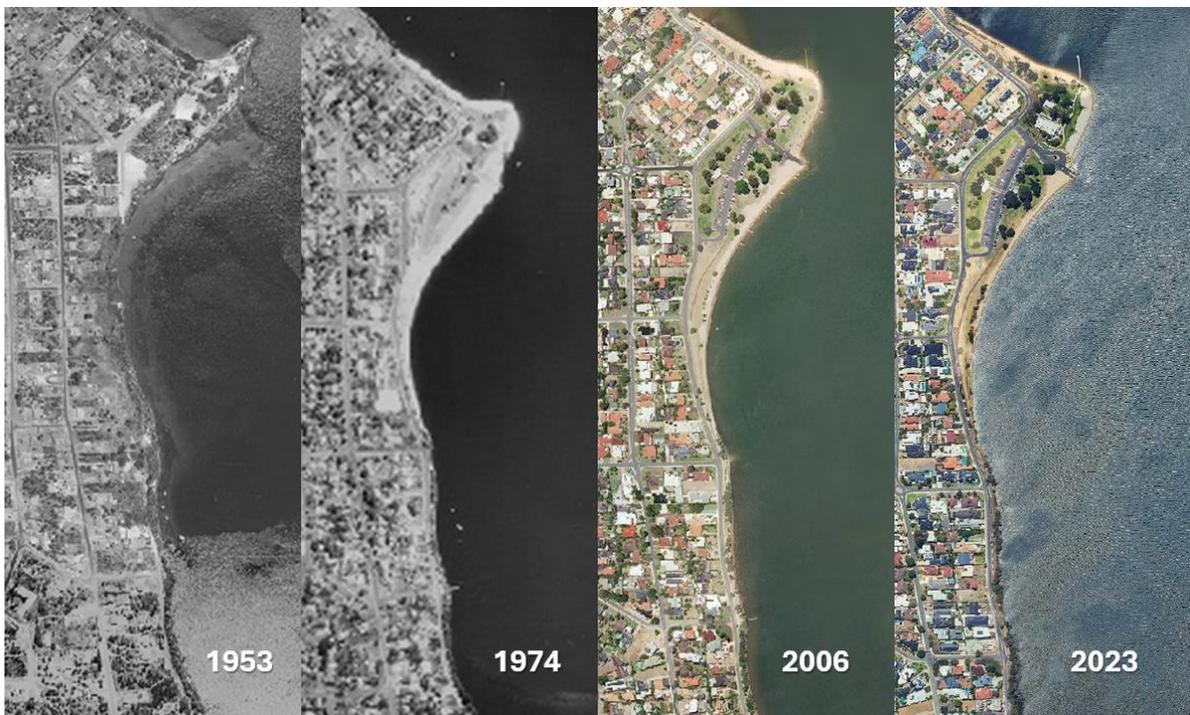
Figure 30. Deepwater Point Attadale foreshore response after reclamation.

- Behaviour near **Deepwater Point** has seen erosion pressure on the originally reclaimed foreshore extend to the foreshore ~500 m to the south. The arcuate beach, which formed following reclamation, has progressively rotated, with additional net loss from the southern end of the beach, near Queens Road (Figure 30). Trapping by the ramp has had a local effect only, with renourishment and headlands constructed in 2018 partly offsetting the erosion previously experienced north of the ramp.

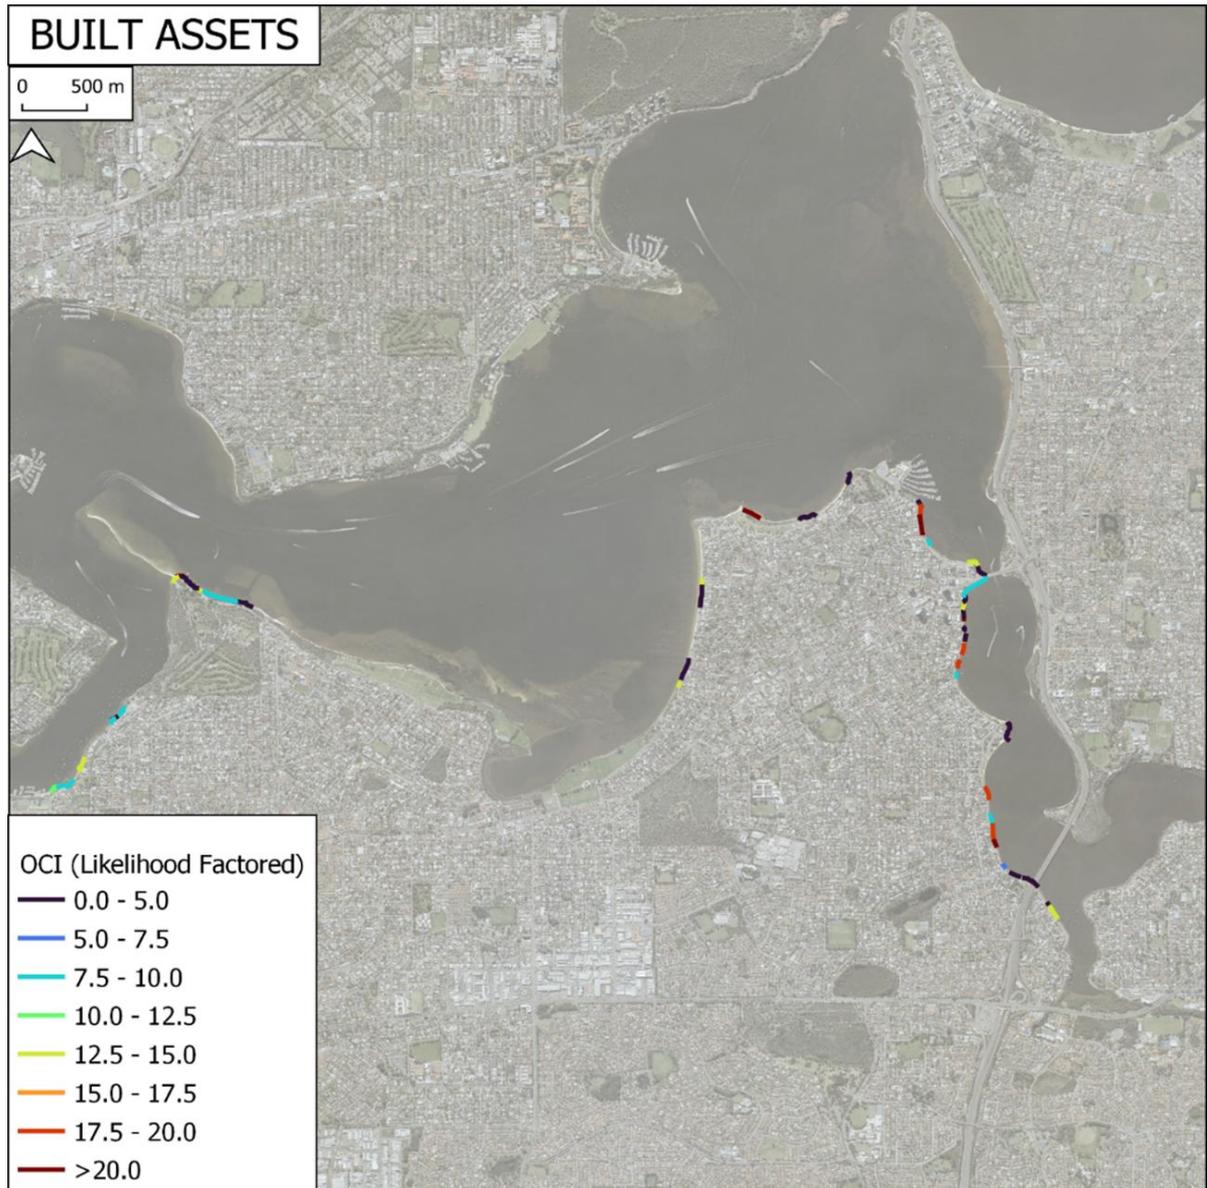
Figure 33. Built asset overall condition index, including likelihood.

COM	Segment Name (DBCA)	OCI (2019)	OCI (2025)	OCI-L
13	CLPle03 Henry Bridge.B06	13	19	22
13	CLPle03 Henry Bridge.B09	18	19	22
11	CLPle06 Apex Reserve-John XXIII Rowing Club.B04	3 (new)	19	22
3	SLBic01 Point Walter East-Boat ramp and jetty.B06	13	19	22
10	SLApl01 Beach Rd to Coffee Point Reserve.B04	18	19	22
13	CLPle03 Henry Bridge.B07	13	19	19
11	CLPle05 The Esplanade-Rookwood Street Jetty.B??	not assessed	13	19
11	CLPle06 Apex Reserve-John XXIII Rowing Club.B01	13	13	19
10	SLApl01 Beach Rd to Coffee Point Reserve.B05	13	13	19

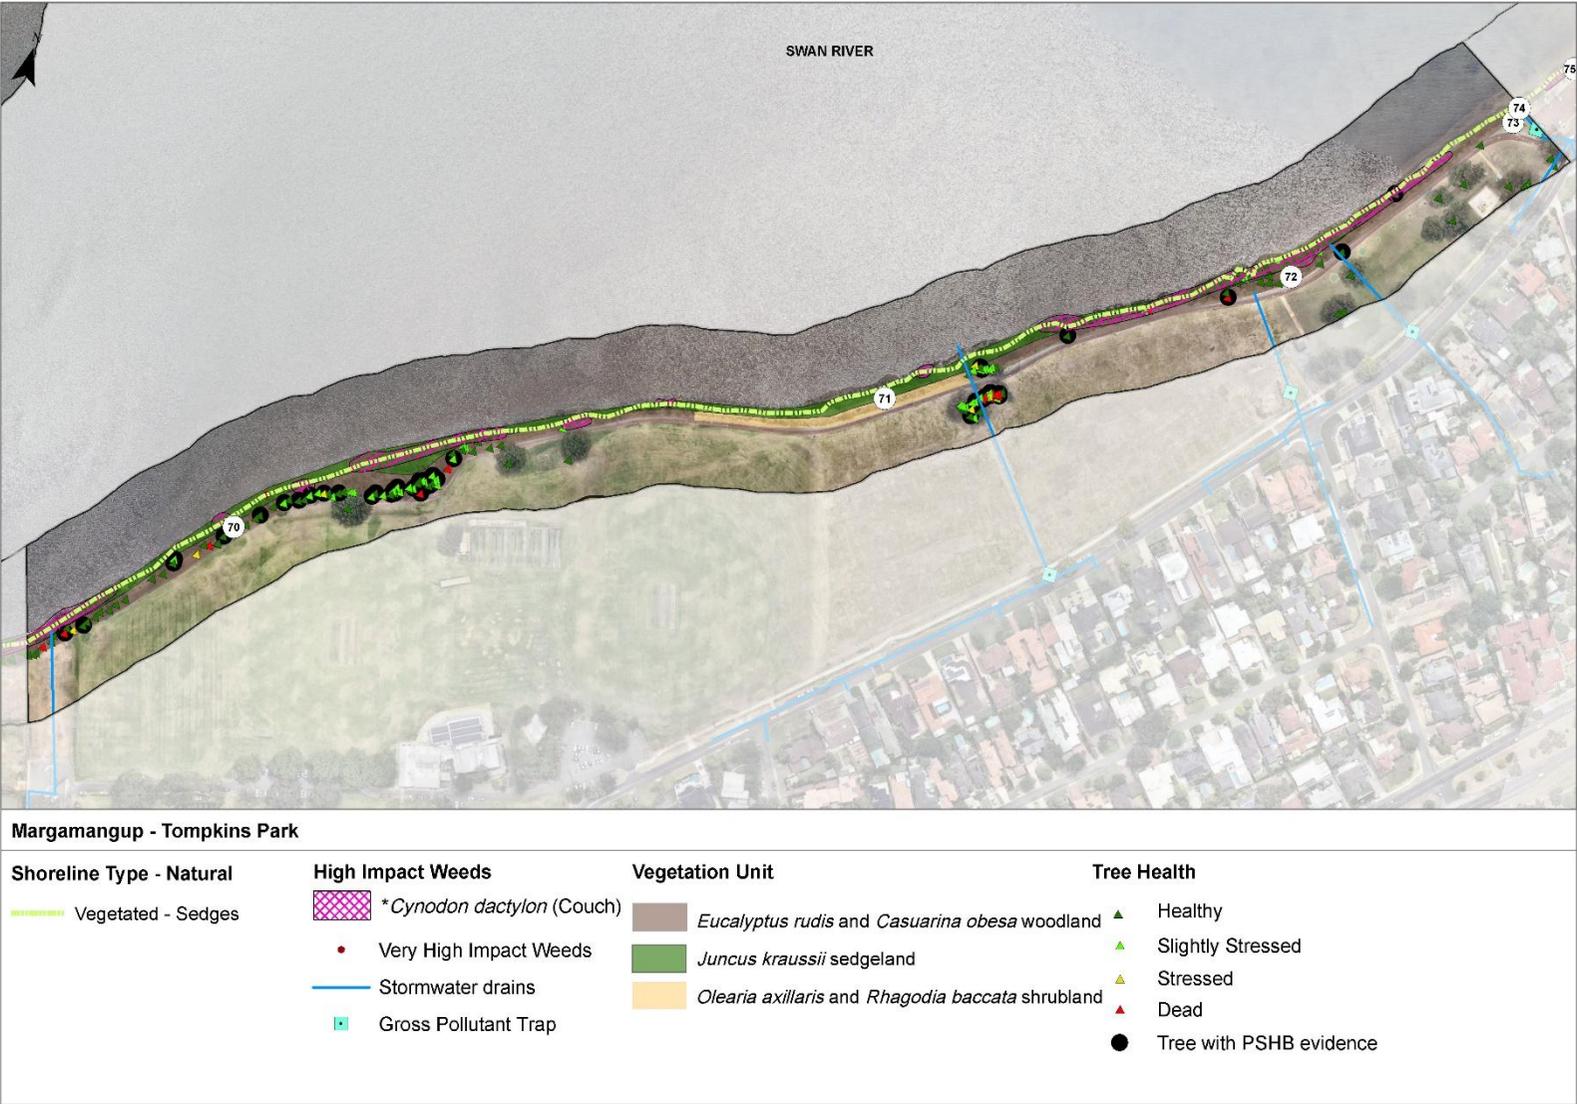
Figure 43. Marradungup – Tompkins Park key management action sites

Eroded areas are steep and will require long term management. Movement of the pathway landward to accommodate wider vegetation buffer with gentler slope is recommended.

No.	Management Actions	Priority for Management	Budget Allocation
COM 5. MARGAMANGUP - TOMPKINS PARK			
70	Control the regrowth of Giant Reed and maintain and supplementary plant bare areas of the foreshore.	High	Maintenance
71	Ensure dense planting of <i>J. kraussii</i> and <i>M. juncea</i> (this is a groundwater seep area). Control weeds.	High	Maintenance
72	Maintain existing vegetation to reduce the possibility of weed infestation.	High	Maintenance
73	Extend sedge planting from the existing to the pathway. Consider local heritage significance when planning works in the area.	Medium	Maintenance
74	Check and repair cracks in the headwall mortar. Monitor for erosion around the headwall and revegetate as required.	Low	Maintenance

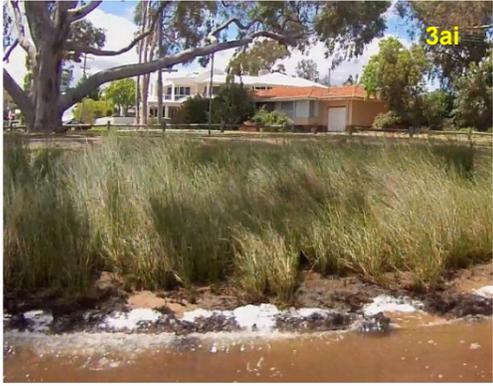
(b) Moderate to wide tree cover with low undercutting for steep banks or wide tree cover with moderate undercutting for gentle-grade banks.			(iv) veg cover 50-70%, and only areas width <5m are in allocated recreational beaches or boat ramps
3	(a) Narrow band of sedge with good coverage or moderate width sedge with adequate coverage	Fair Condition

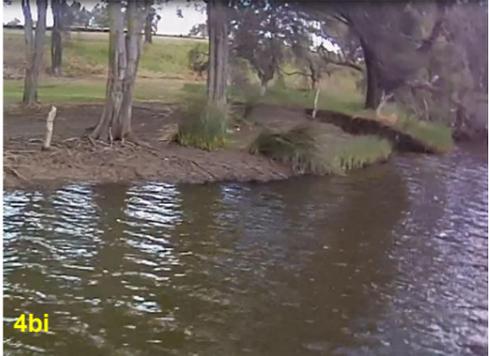
(b) Single line of trees with good alongshore coverage OR moderate width with moderate undercutting			(i) >10m tree width, veg cover 100%, 0% undercutting, <10% erosion and steepness <1:1 OR
4	(a) Narrow band of sedge with limited coverage	Poor Condition

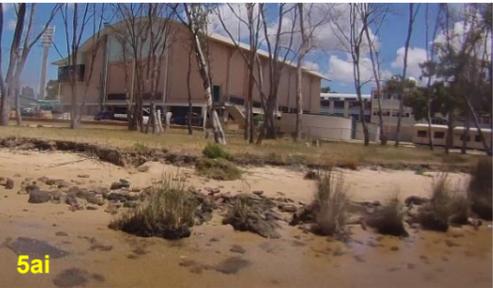
(b) Single line of trees with >30% alongshore tree loss and >40% undercutting/erosion			(iii) Destabilising processes by human extra influence impacting <10% of the alongshore length
5	(a) Limited sedge remaining and no longer providing stabilisation	Failed Shoreline

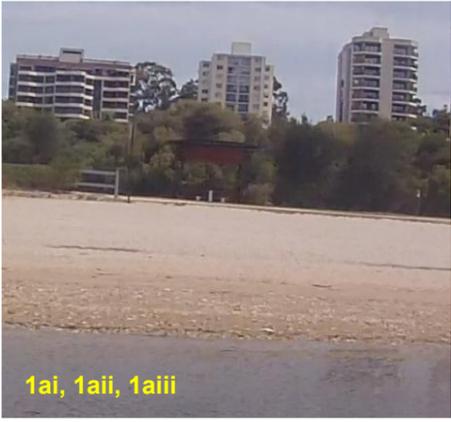
Sedimentary 1 of 2 (a–beach/perched, b–exposed bank)				
Rating	Condition descriptor	Performance	Photo (with associated code)	
1	(a) Relatively stable	Good Condition

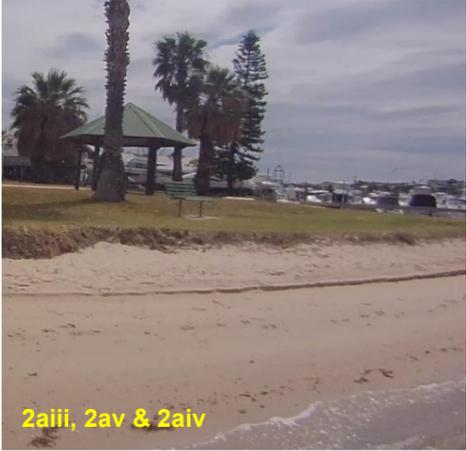
(b) Relatively stable			(ii) beach width >4m and accreted >1m from 2008-2015 (iii) low damage factors to landward with minimal scarping, undercutting and retreat (i) Vertical scarps/exposed face of <0.3m for <50% of the alongshore length (trees/sedge may cover 50% of the shoreline) (ii) low damage factors (<10% alongshore extent of undercutting/incising/slumping) (iii) Destabilising processes by human extra influence impacting <10% of the alongshore length
2	(a) Limited areas of erosion of the beach or of the bank behind the beach	Minor Defects

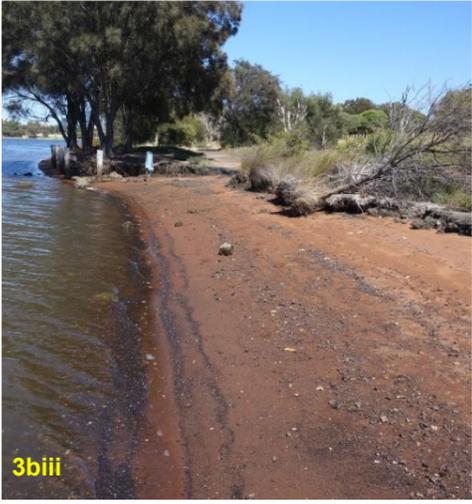
(b) Limited areas of, or low elevation, erosion indicators			(i) 40-50% vegetation cover and ~50% alongshore extent of undercutting/incising/slumping of 0.5-0.75m height (ii) Vertical scarps/exposed face of 0.3-0.75m for 20-50% of the alongshore length (iii) Vertical scarps/face of <0.3m vertical height for >50% of the alongshore length (iv) Destabilising processes by human extra influence impacting 10-25% of the alongshore length
3	(a) Some erosion of the beach or of the bank behind the beach	Fair Condition

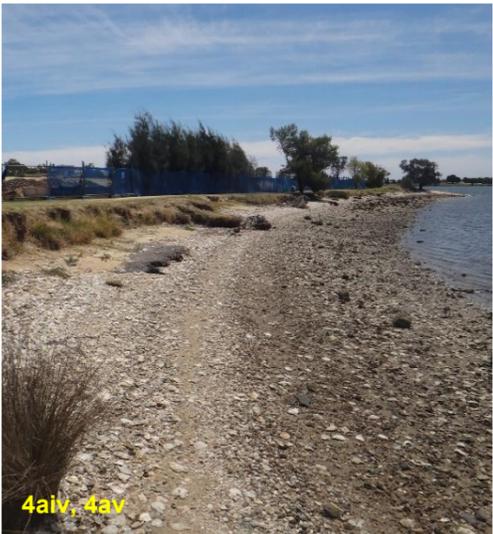
(b) Some areas of, or low-to-moderate elevation, erosion indicators			(i) 20-40% vegetation cover and >60% alongshore extent of undercutting/incising/slumping of 0.5-0.75m height (ii) Vertical scarps/exposed face of 0.75 to 1.5m for 20-50% of the alongshore length (iii) Vertical scarps/exposed face of 0.3 to 0.75m vertical height for >50% of the alongshore length (iv) Retreat of 2-5m across 20-50% of the alongshore length from 2008-2015 (this may most likely be a condition 4) (v) Destabilising processes by human extra influence impacting 25-50% of the alongshore length
4	(a) Moderate erosion of the beach or of the bank behind the beach	Poor Condition

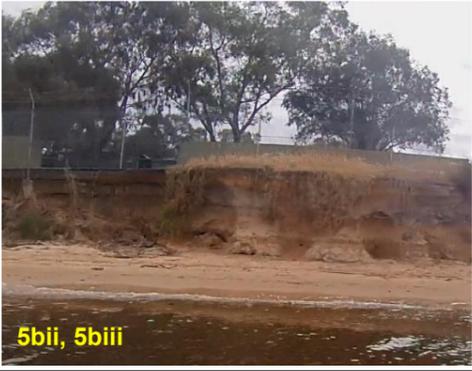
Sedimentary 1 of 2 (a–beach/perched, b–exposed bank)				
Rating	Condition descriptor	Performance	Photo (with associated code)	
	(b) Extensive erosion on moderate to high elevation exposed banks

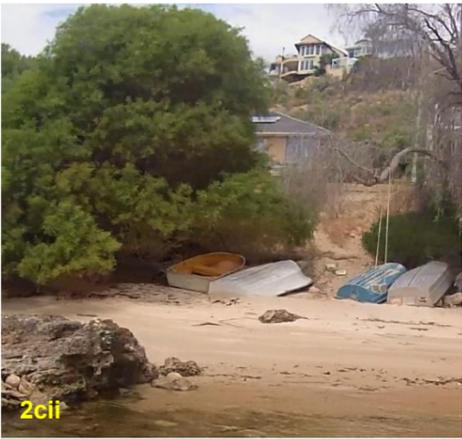
(d) Relatively stable			(ii) <10% undercutting/incising/slumping/scarping/slip failure (technically wouldn't be defined as a scarp).
2	(c) Limited areas of, or low elevation, vertical scarps or slips	Minor Defects

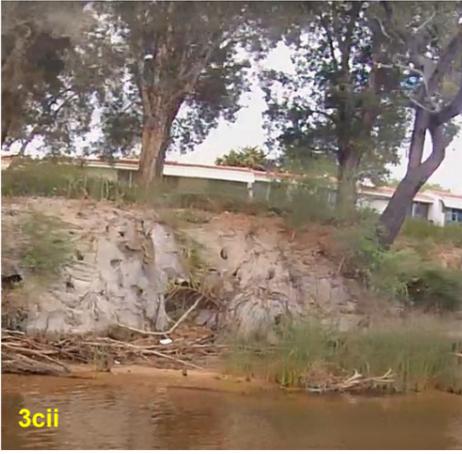
(d) Some sedimentation, limited areas of scarps and limited bare sediment			(ii) straight or meandering channel (implying low sedimentation)
3	(c) Some areas of low-to-moderate elevation vertical scarps or slips	Fair Condition

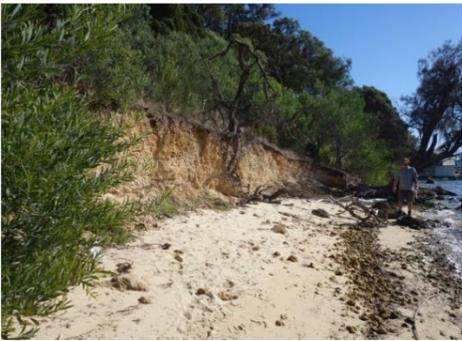
(d) Moderate sedimentation, some scarps and moderate vegetation cover			(i) vertical scarps or slips 0.2 - 0.5m height for >50% of the alongshore length
4	(c) Moderate areas of moderate-to-high elevation vertical scarps or slips	Poor Condition

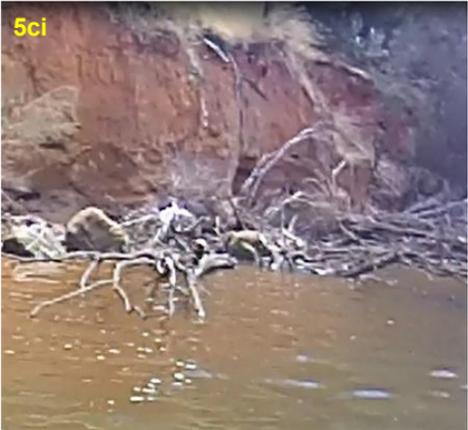
<p>5ci</p>	<ul style="list-style-type: none"> (i) vertical scarps on banks of main river channel for >70% of alongshore length (ii) extensive sedimentation, with anastomosing channel (iii) bare sediment for >90% of alongshore length (<10% vegetation)

Sedimentary 2 of 2 (c – scarp, d – embankment)				
Rating	Condition descriptor	Performance	Photo (with associated code)	
	(d) Extensive sedimentation, extensive scarps or poor vegetation cover

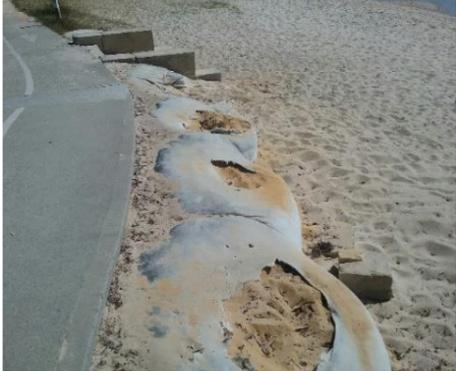
9	Manage foreshore access to ensure traffic is directed away from sensitive areas and diverted to designated public access points. *	Fences, stairs and paths are installed throughout the Melville foreshore to manage traffic but trampling in areas of unrestricted access is still a problem.	Trampling is still a problem, however a number of foreshore sites have been fenced off and provide good protection with minimum visual impact.
10	Remove failed foreshore treatments along the foreshore that have become potential safety hazards.	Observation recorded as part of the 2019 survey. Some areas noted have not been removed, such as failed sandbags located -The Strand opposite #54A

This area has been rehabilitated, however additional areas are showing degradation - Refer to site specific report cards.
