# City of Melville

## FORESHORE MANAGEMENT PLAN

October 2025  
For City of Melville

<b>Report</b>		<b>25001.RPT001</b>		
Version	Date	Prepared by	Review/Approval	Issue Details
1	16.10.25	RT, ME, KT	JS, DW	Draft 1 for comment
2	15.07.2025	RT, ME	JS, DW	Draft 2 for review
3	16.10.2025	RT	JS	Final Document Issue

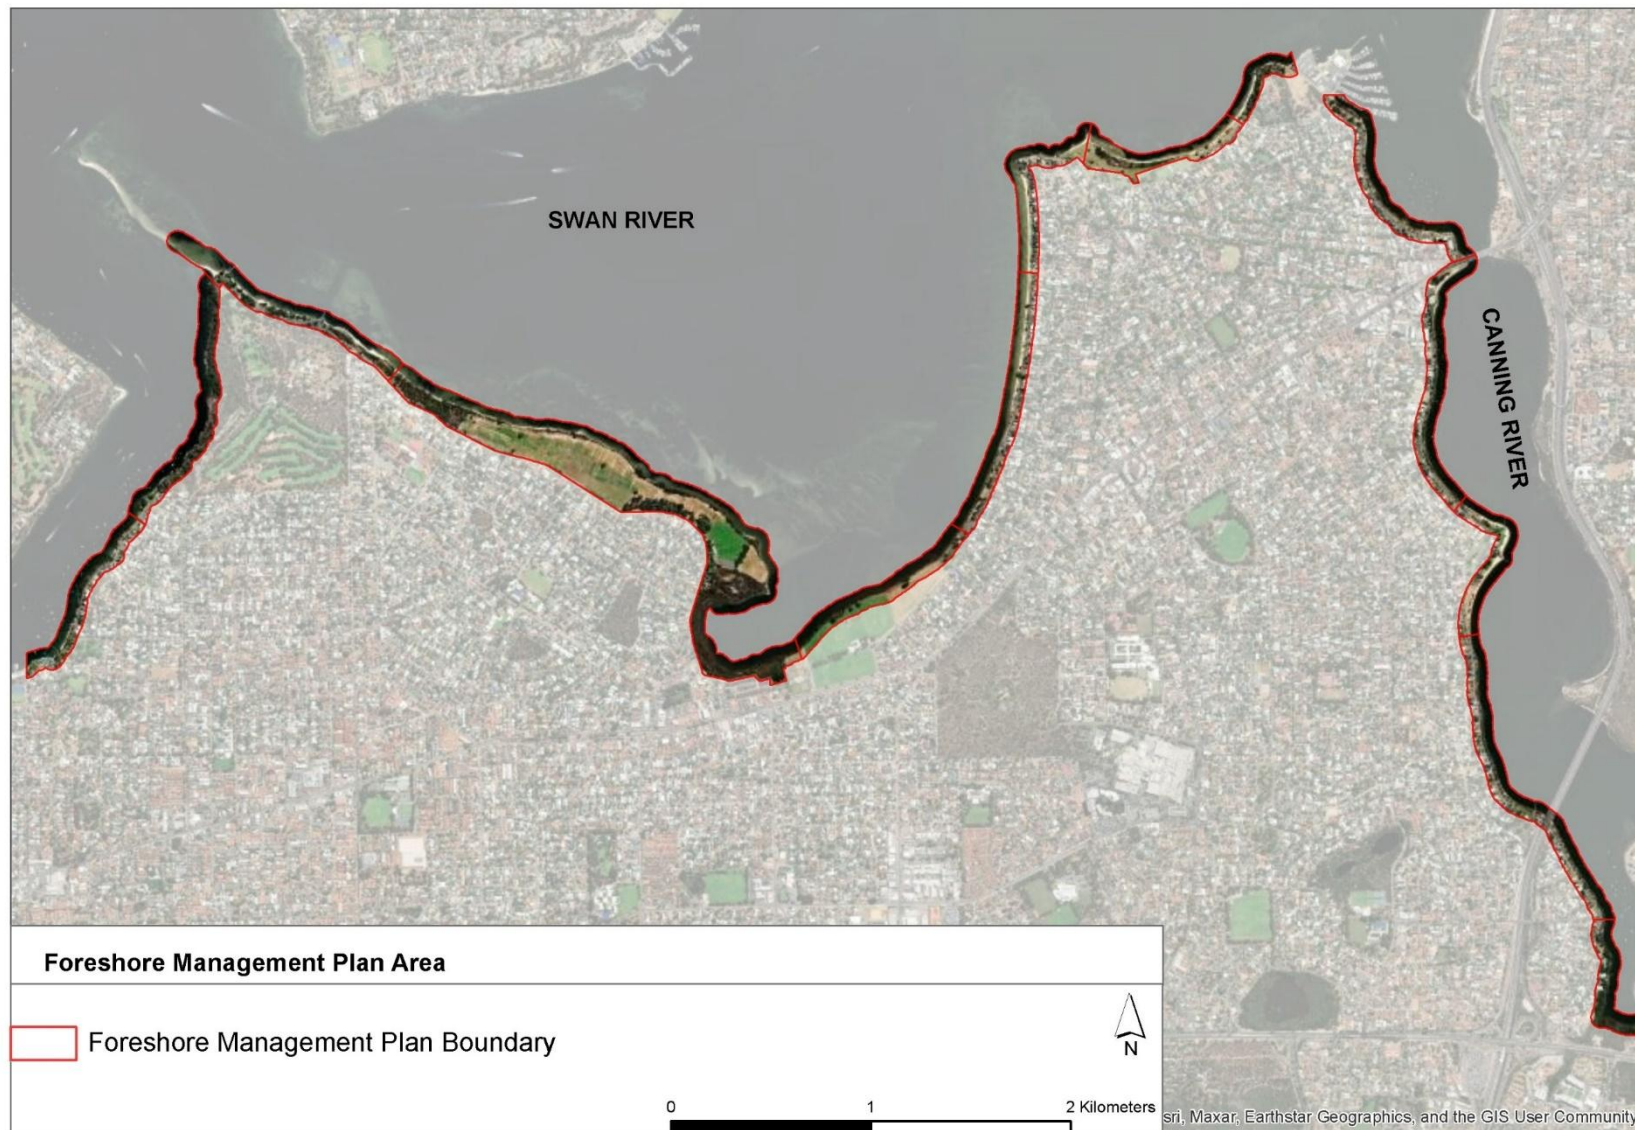
Figure 1. Foreshore Management Plan area.

Given that the foreshore zone is very narrow and difficult to present visually at a large scale, a 50 m buffer boundary was allocated from the City of Melville cadastral boundary for mapping purposes (Figure 1). This boundary was used for the assessment of vegetation flora and fauna by NAMS (2024), and all of the statistics regarding flora, fauna and tree health refer to this zone. This boundary may be revised in the future as the City undertakes updates to asset classification and numbering systems.

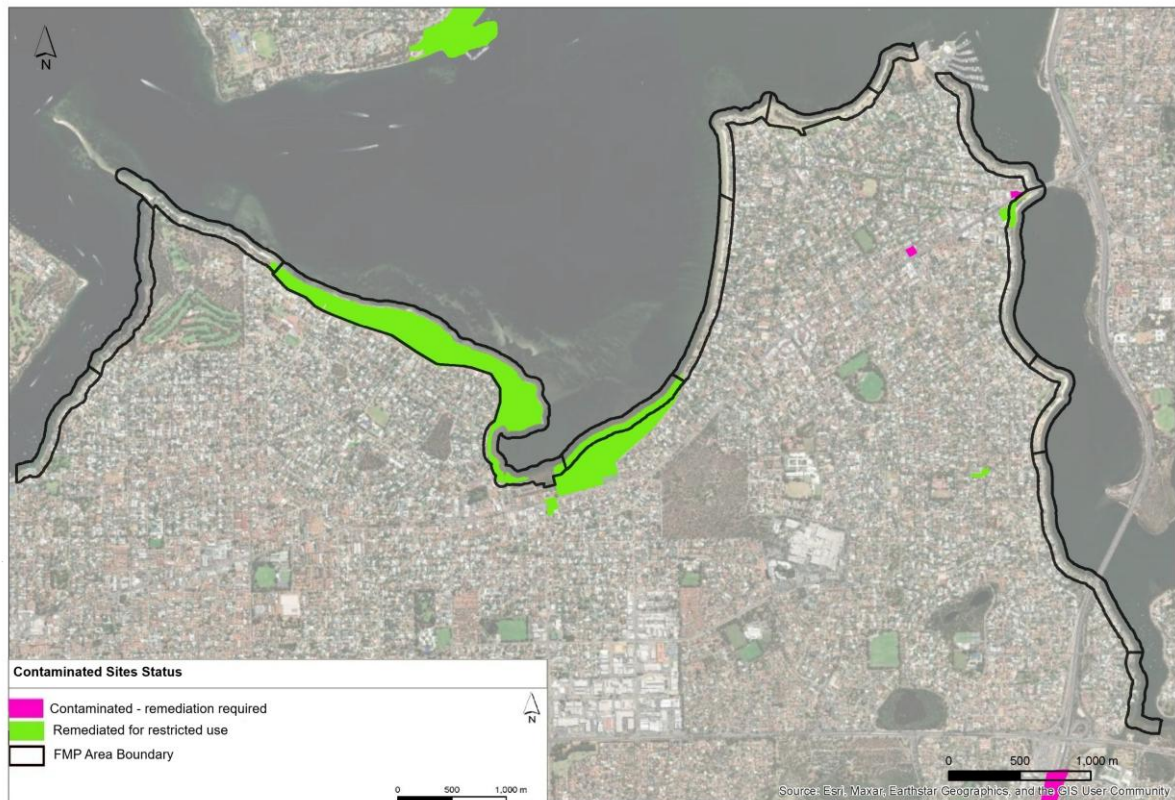
**Figure 7. Location and extent of contaminated sites associated with the foreshore.**

The past landfill activities in the foreshore area have resulted in Attadale Reserve, Troy Park, and Thompson Reserve being classified as contaminated. Apex Reserve, located adjacent to Canning Bridge, is also listed in the contaminated sites database (DWER, 2025). All areas are currently placed in the “Remediated for Restricted use” category based on the site investigations conducted in 2015, 2016 and 2017, respectively (DWER, 2025) (Figure 7).

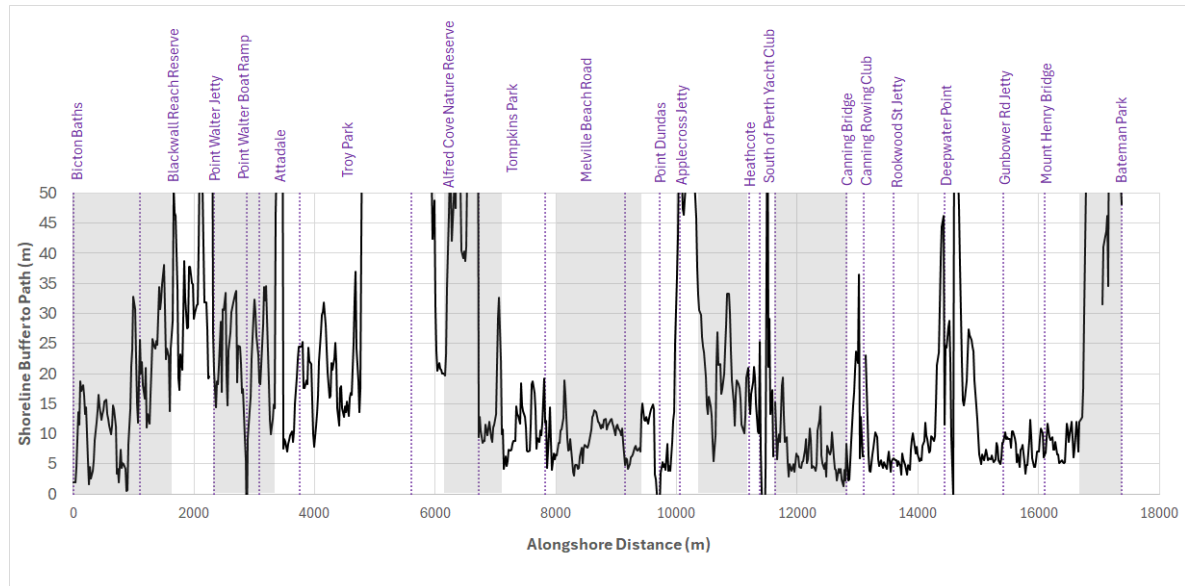
**Figure 31. Available Buffer Distance to Foreshore Path**

Relative exposure and perceived foreshore dynamics have been influential in land development pressure along the Melville foreshore. Wider setbacks were established for the Melville Water foreshore, which is subject to greater waves. Along the Canning Water foreshore, roads and paths were built much closer to the original shore (Figure 31), creating a limited foreshore reserve within which to support riparian zone evolution, or tolerate erosion pressure.

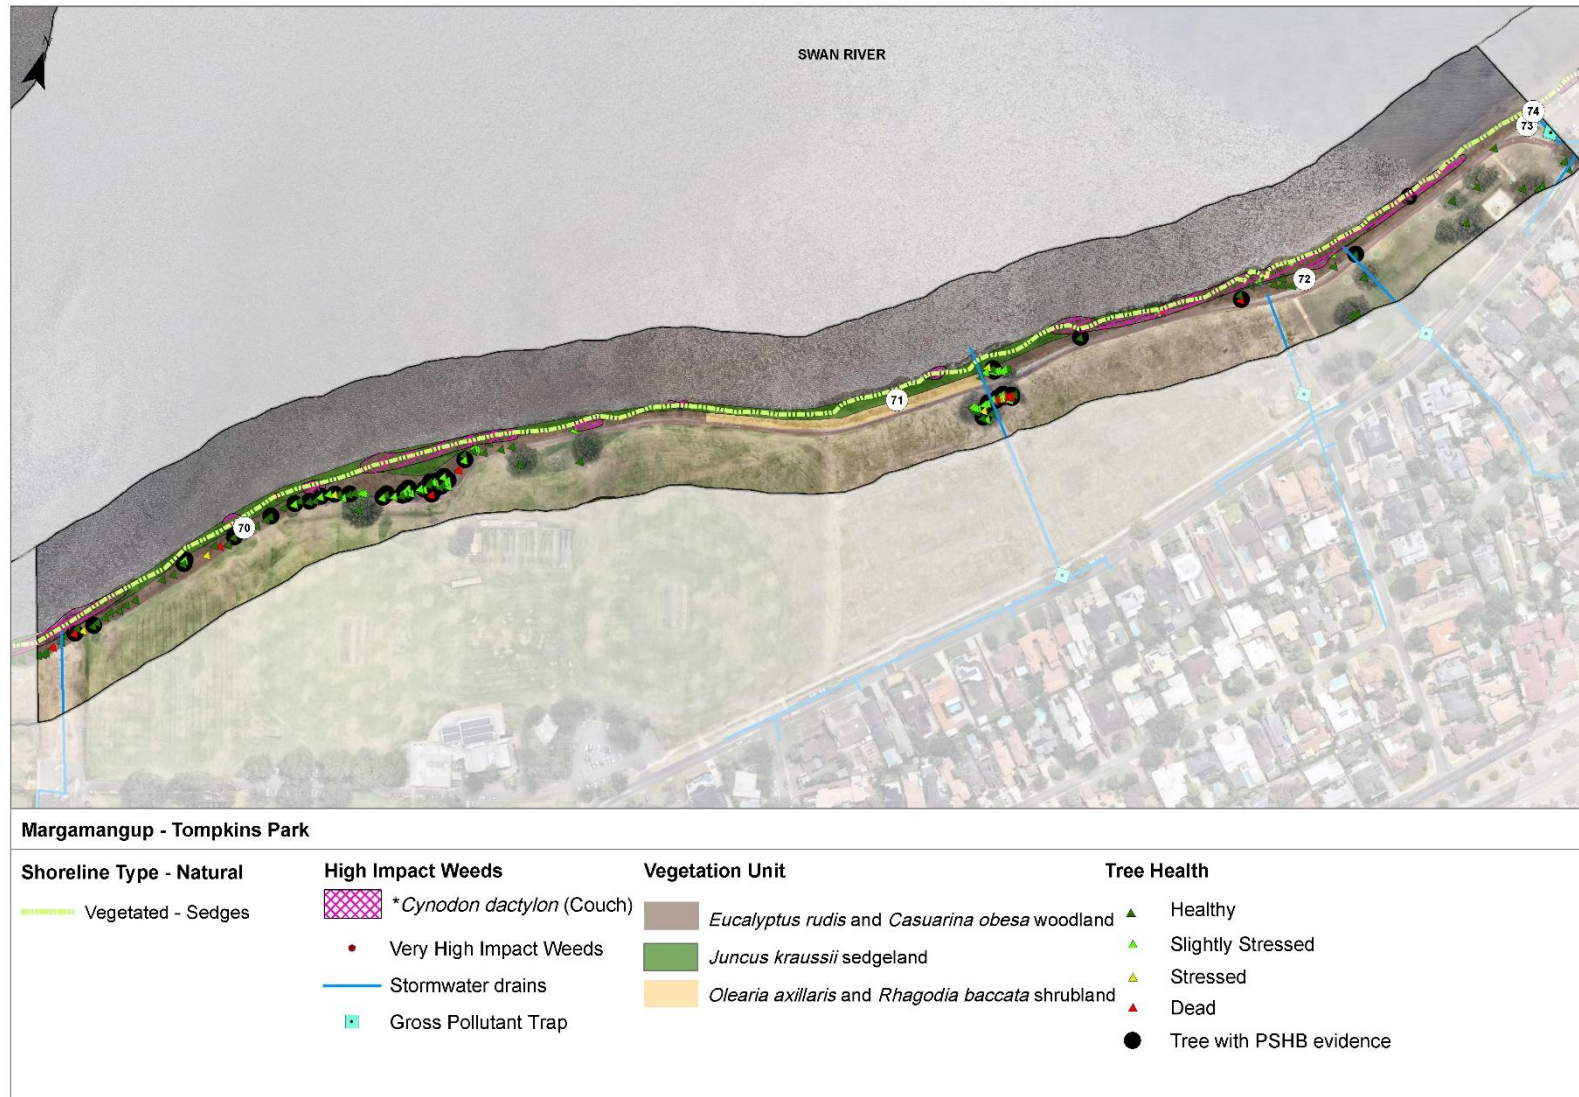
Figure 43. Marradungup – Tompkins Park key management action sites

No.	Management Actions	Priority for Management	Budget Allocation
<b>COM 5. MARGAMANGUP - TOMPKINS PARK</b>			
<b>70</b>	Control the regrowth of Giant Reed and maintain and supplementary plant bare areas of the foreshore.	High	Maintenance
<b>71</b>	Ensure dense planting of <i>J. kraussii</i> and <i>M. juncea</i> (this is a groundwater seep area). Control weeds.	High	Maintenance
<b>72</b>	Maintain existing vegetation to reduce the possibility of weed infestation.	High	Maintenance
<b>73</b>	Extend sedge planting from the existing to the pathway. Consider local heritage significance when planning works in the area.	Medium	Maintenance
<b>74</b>	Check and repair cracks in the headwall mortar. Monitor for erosion around the headwall and revegetate as required.	Low	Maintenance

Eroded areas are steep and will require long term management. Movement of the pathway landward to accommodate wider vegetation buffer with gentler slope is recommended.

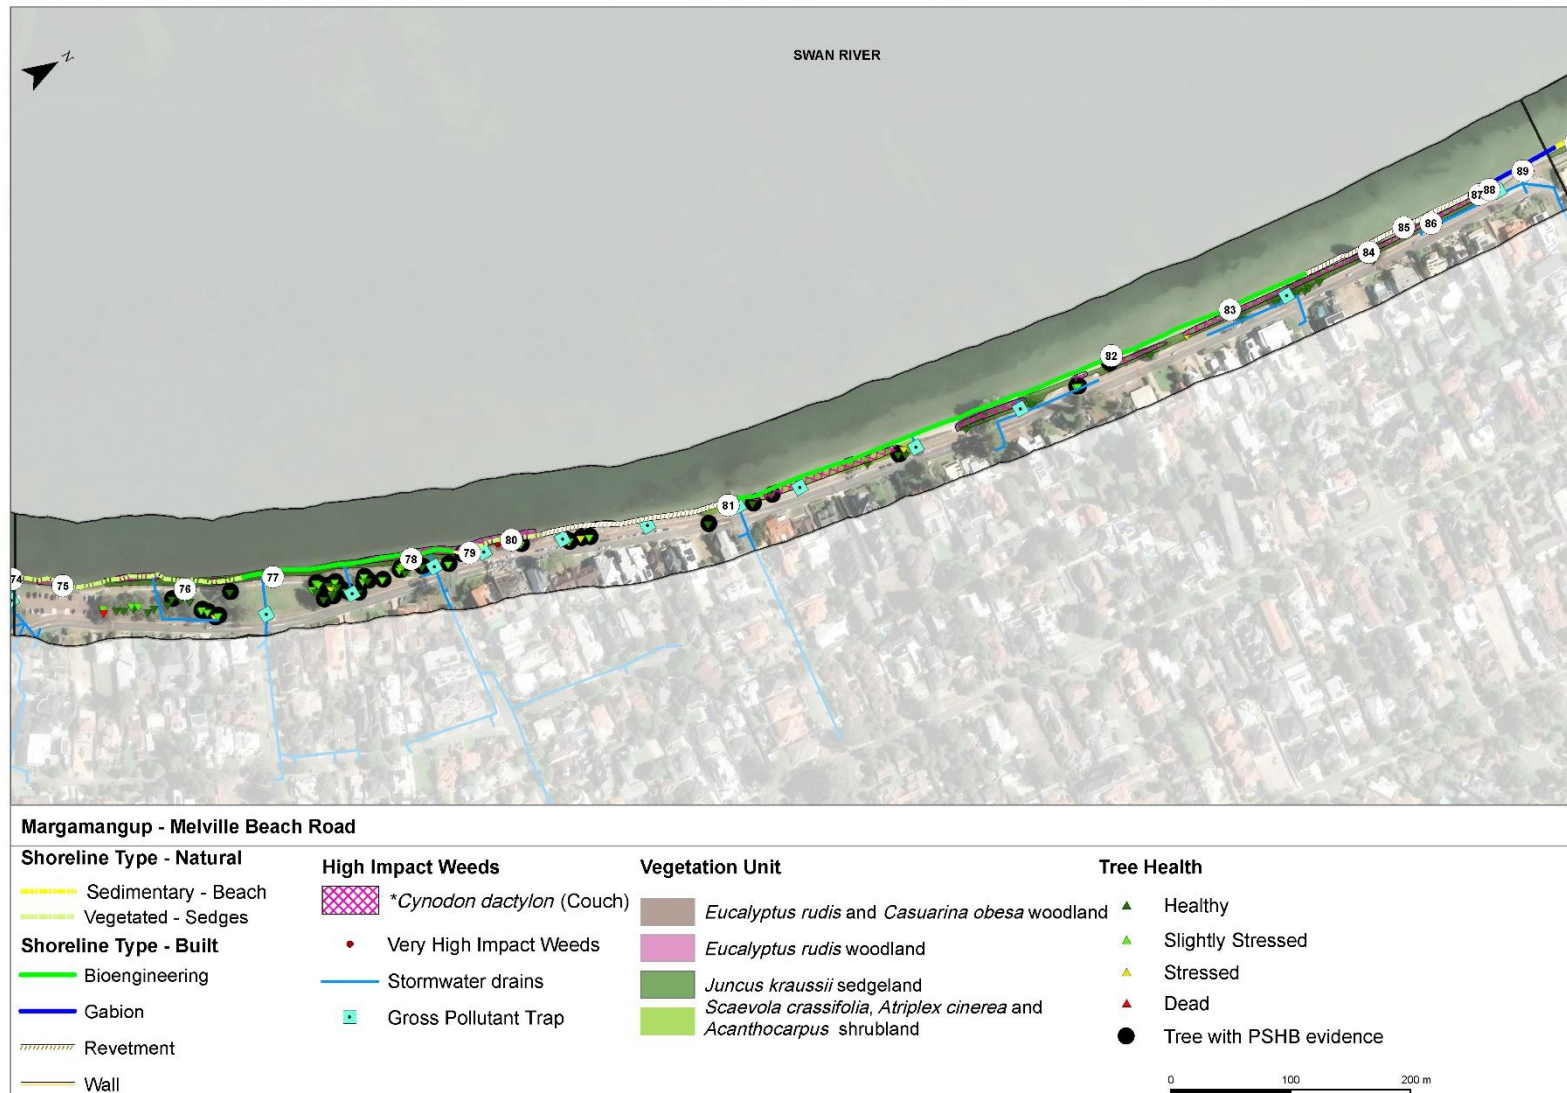
Figure 44. Margamangup - Melville Beach Road key management action sites

No.	Management Actions	Priority for Management	Budget Allocation
<b>COM 6. MARGAMANGUP - MELVILLE BEACH ROAD</b>			
75	Damaged area of revetment to be re-patched. See P17 note in MP Rogers 2024 report.	Medium	Maintenance
76	Move pathway away from the shoreline and revegetate with sedges ( <i>J. kraussii</i> ).	Low	Capital Works Project
77	Remove grass and extend revegetation with sedges to the path.	Medium	Maintenance
78	Remove two Canary palm juvenile plants and revegetate with <i>J. kraussii</i> .	High	Maintenance
79	Monitor erosion and revegetate with large <i>J. kraussii</i> to reduce scour and maintain the existing <i>M. raphiophylla</i> tree.	Medium	Maintenance
80	Control weeds and revegetate the area between the wall and revetment with <i>J. kraussii</i> .	Medium	Maintenance
81	Use a selective herbicide to control turf grasses within vegetation.	High	Maintenance
82	Control Couch using the selective herbicide. Check overlaps on brushwall and fill in gaps as required. revegetate as per planting plans. Water the revegetated area during summer to ensure establishment. Tighten any loose logs and replace any broken wires.	High	Maintenance

83	Repair and replace any torn Coir mesh and revegetate.	High	Maintenance
84	Repair the bottom of the stairs and revetment and revegetate in front with large sedges of <i>J. kraussii</i> .	Medium	Maintenance
85	Control weeds and revegetate with large sedges of <i>J. kraussii</i> , <i>F. nodosa</i> and <i>C. gymnocaulos</i> .	High	Maintenance
86	Inspect the existing mortared revetment for damage and/or cracks and repair as needed.	Medium	Maintenance
87	Maintain safe access to the stairs (remove weeds).	High	Maintenance
88	Monitor erosion around the headwall and repair as required.	Medium	Maintenance
89	Monitor the gabion and repair as required. Utilise photo monitoring to check the stability of the existing lean. Plan for repair.	Medium	Maintenance

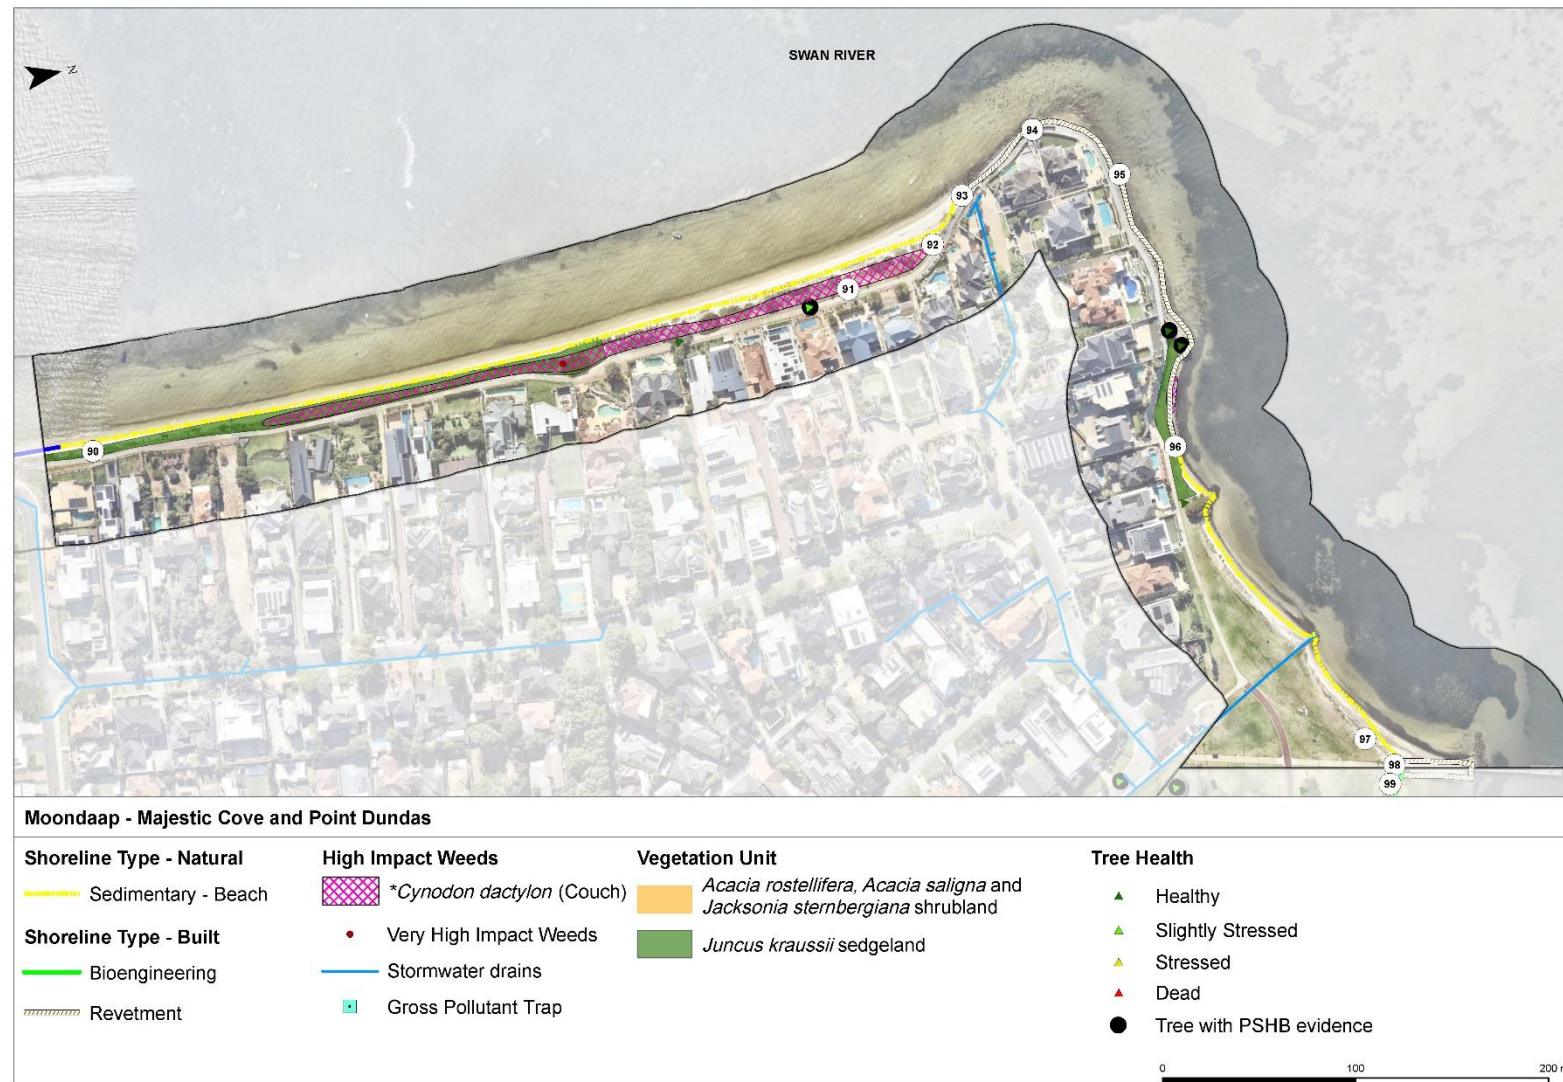
Figure 45. Moondaap - Majestic Cove and Point Dundas key management action sites

No.	Management Actions	Priority for Management	Budget Allocation
<b>COM 7. MOONDAAP - MAJESTIC COVE AND POINT DUNDAS</b>			
<b>90</b>	Control weeds, regrade and revegetate. Ensure large stock is available for installation riverward. Ensure any earthworks required are conducted at the same time as the PSP upgrade. Install the pathway as far landward as possible.	High	Capital Works Project
<b>91</b>	Maintain the grassed area for beach access.	High	Maintenance
<b>92</b>	Repair damaged top blocks and re-mortar joints.	Low	Maintenance
<b>93</b>	Install additional <i>M. cuticularis</i> .	Medium	Maintenance
<b>94</b>	Inspect rock revetment and mortared slope biannually for cracks and damage and repair.	High	Maintenance
<b>95</b>	Maintain the jetty in a serviceable condition. Inspect as per schedule every 5 years unless significant deterioration or damage is noted.	High	Maintenance
<b>96</b>	Monitor and repack revetment to maintain function.	Medium	Maintenance

<b>97</b>	Renourish and redistribute existing sand as required.	Low	Maintenance
<b>98</b>	Maintain existing sedges.	High	Maintenance

Please note: Action 94 is for an asset that is privately owned and is not maintained by the City.

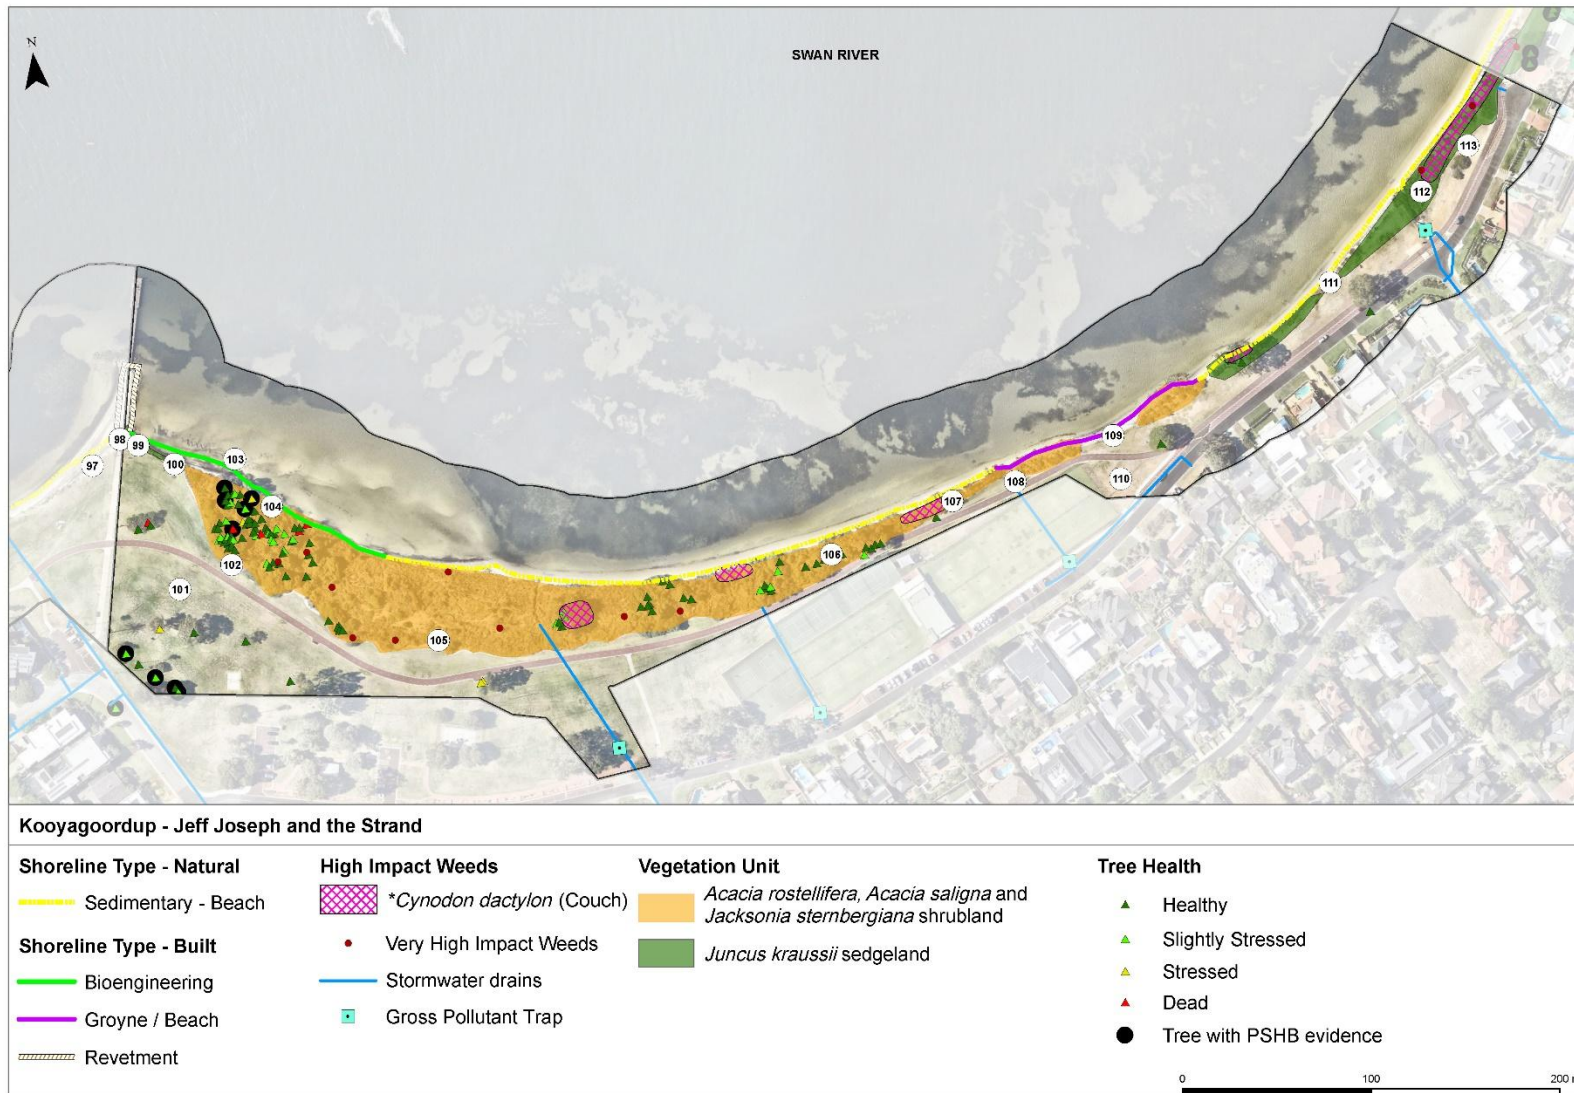
Figure 46. Kooyagoordup - Jeff Joseph and the Strand key management action sites

No.	Management Actions	Priority for Management	Budget Allocation
<b>COM 8. KOOYAGOORDUP - JEFF JOSEPH AND THE STRAND</b>			
99	Regrade to remove turf and revegetate.	High	Capital Works Project
100	Maintain beach access.	High	Maintenance
101	Plan planting of advanced trees for the parkland areas - plan in a way that does not obstruct views to reduce the possibility of vandalism.	Medium	Capital Works Project
102	Remove turf between the pathway and the existing vegetation and revegetate with sedges, shrubs (low) and trees (all the way past tennis courts).	High	Capital Works Project
103	Baffles have minimal function only. Consider removal.	Low	Maintenance
104	Consider revegetation with mature sedges and low brushwall to help retain sand.	Medium	Maintenance
105	Remove exotic tree saplings and juveniles.	High	Maintenance
106	Remove Canary Palm	High	Maintenance
107	Revegetate gaps in sedges to provide continuous protection to the shoreline and reduce weed incursion.	High	Maintenance

108	Maintain access to the bubble-up pit.	High	Maintenance
109	Regularly inspect GSCs and repair as required.	Medium	Maintenance
110	Plan for revegetation of the area. Consult with the Tennis Club and the adjacent residents. Include a cluster of trees.	Low	Capital Works Project
111	Widen sedge area and plan for regular informal access to the beach.	High	Maintenance
112	Collect <i>Sporobolus virginicus</i> (Marine Couch) seed and propagate for use in the local areas instead of turf.	Medium	Maintenance
113	Remove turf and revegetate the area between the drain and the Scout hall. Ensure follow up weed control for Sea Spinach and Couch.	Low	Capital Works Project

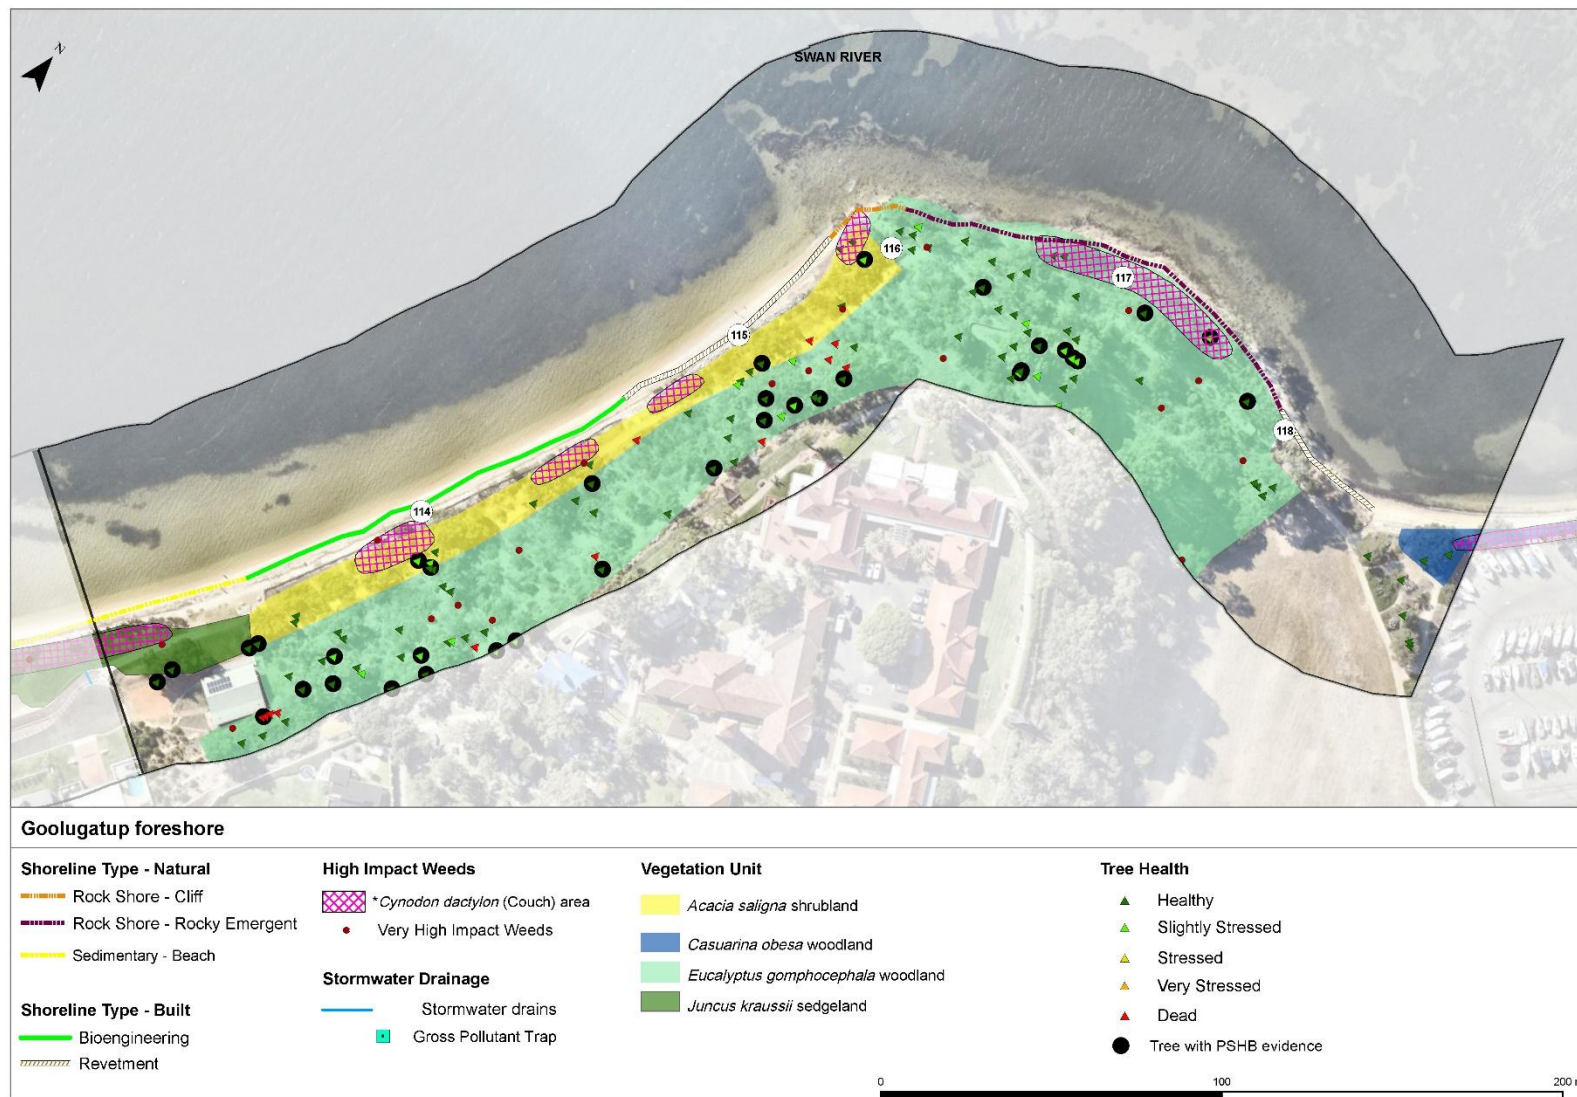
Figure 47. Goolugatup Foreshore key management action sites

No.	Management Actions	Priority for Management	Budget Allocation
<b>COM 9. GOOLUGATUP FORESHORE</b>			
<b>114</b>	Control Couch and revegetate. No marine couch in the area with a brushwall. Ensure plants are watered in the first summer to assist with establishment. Monitor and repair any brushwall damage.	High	Maintenance
<b>115</b>	Monitor and maintain revetment. Repack as required to ensure integrity.	Medium	Capital Works Project
<b>116</b>	Repair eroded scarp. Utilise erosion matting, brush palisades and tube stock. Check fencing. Remove weeds like Canary Palm on the lower slope.	Medium	Capital Works Project
<b>117</b>	Monitor, control weeds and revegetate to maintain an adequate and resilient setback to the path.	Medium	Capital Works Project
<b>118</b>	Repack and re-mortar exposed material (rocks) on the access stairs. Repack revetment. Monitor and repair any damage to the erosion control fabric.	Medium	Maintenance

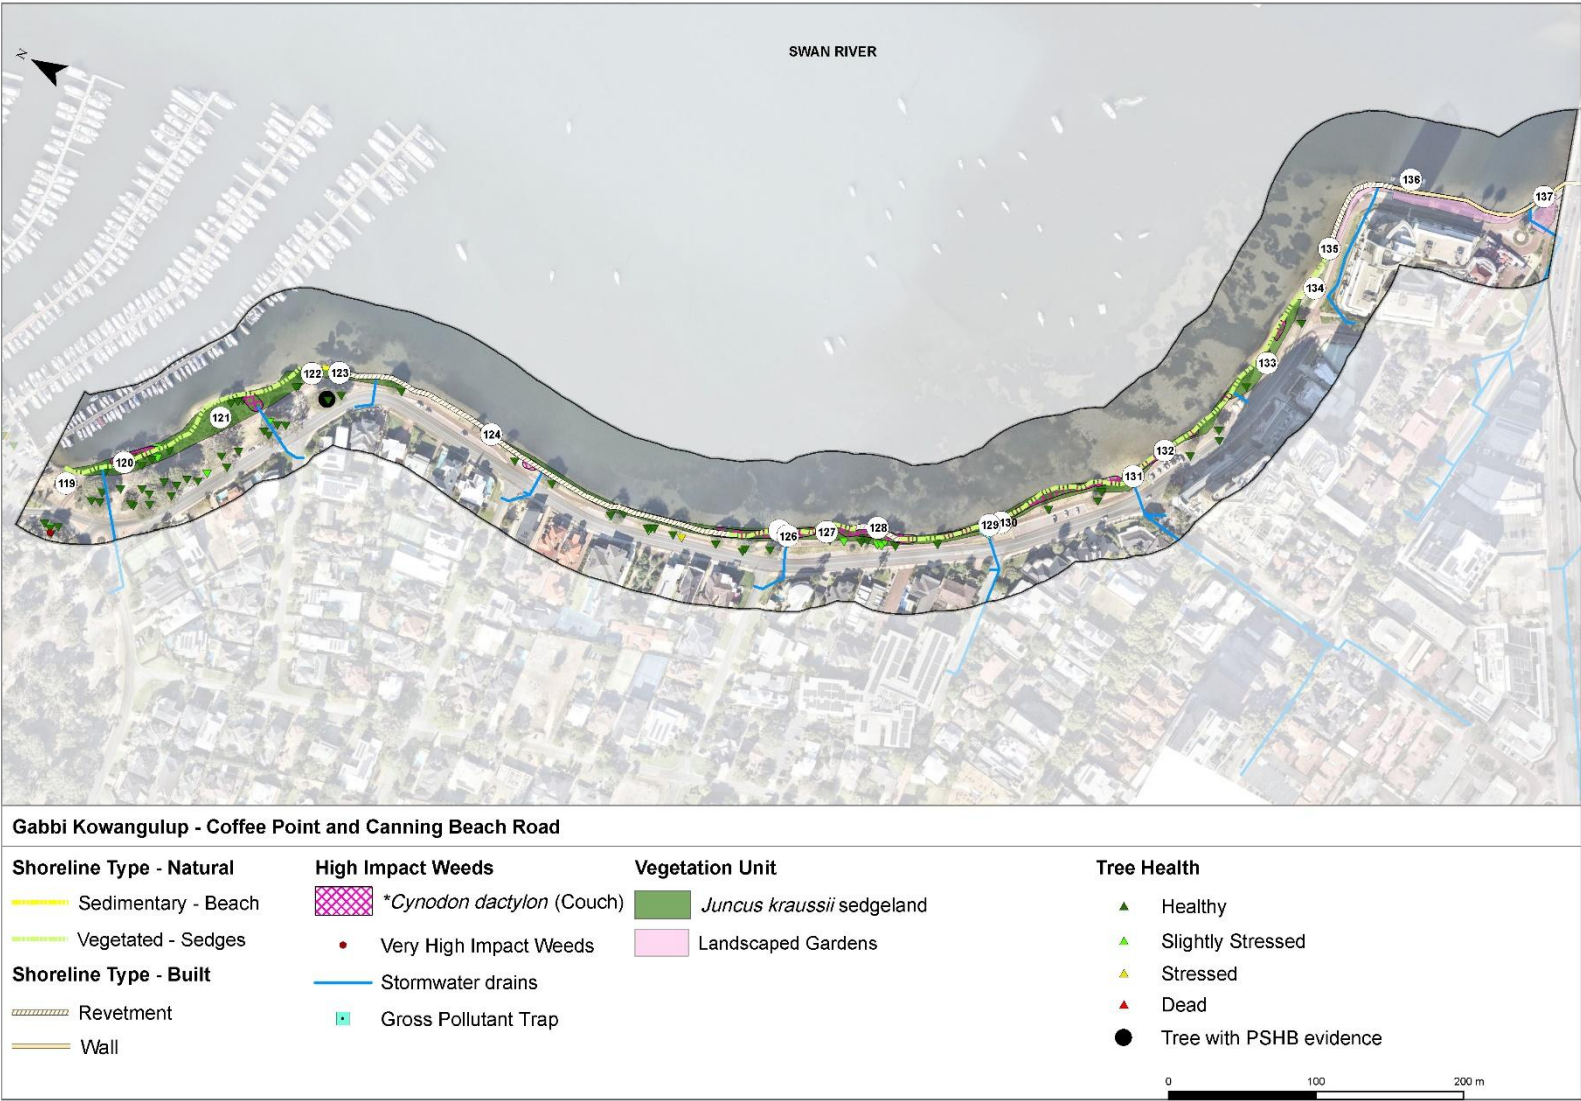
Figure 48. Gabbi Kowangulup - Coffee Point and Canning Beach Road key management action sites

137	Re-mortar joints and reinstate damaged blocks.	Low	Maintenance

Please note: Actions 132 & 133 will be delivered via a Development Application agreement

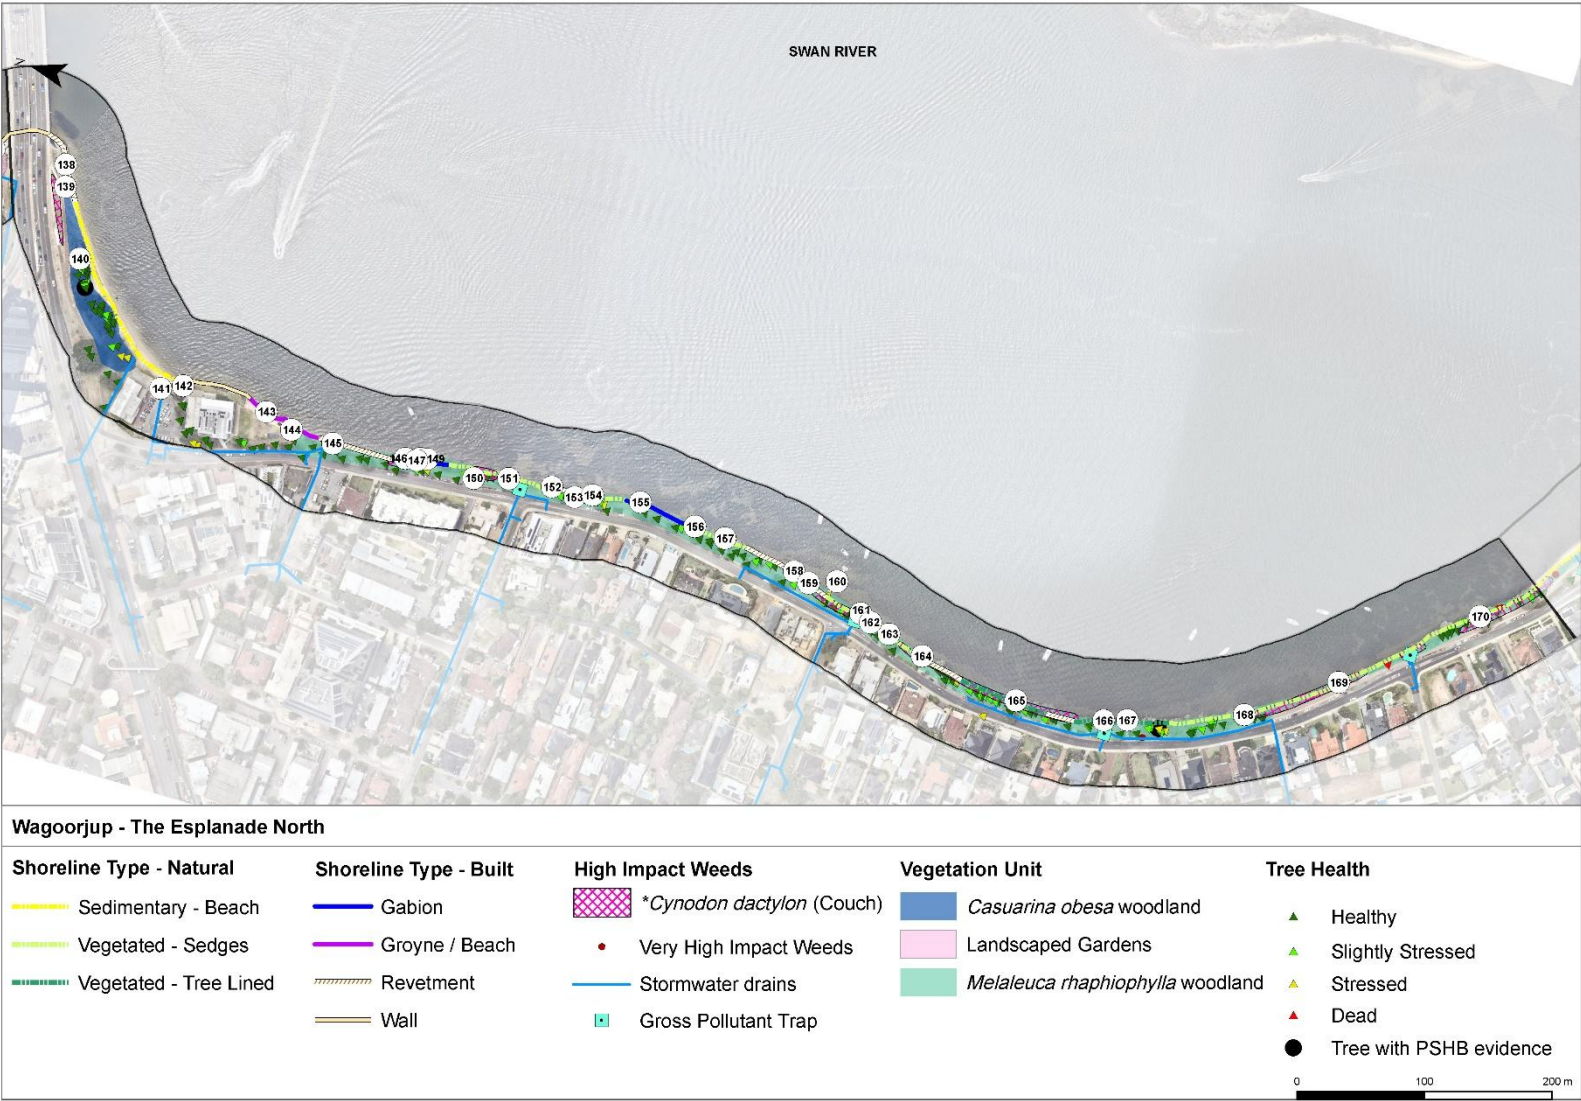
Figure 49. Wagoorjup - The Esplanade North key management action sites

No.	Management Actions	Priority for Management	Budget Allocation
<b>COM 11. WAGOORJUP - THE ESPLANADE NORTH</b>			
154	Remove dead tree branches. Install brushwall to tie into existing sedges. Renourish with sand and revegetate the eroding bank. Path dips in the area - fix path.	High	Capital Works Project
155	Monitor the condition of the gabion annually.	High	Maintenance
156	Renourish with sand and install brushwall or repack rocks where present. Plan for the restoration of this area as erosion is too close to the path.	High	Capital Works Project
157	Repack rocks where present. Revegetate with sedges to the path where space available. Plan for the restoration of this area.	High	Capital Works Project
158	Prune Myoporum, Maintain access.	High	Maintenance
159	Close (temporary fence) access and direct to the north. Revegetate with sedges.	Medium	Maintenance
160	Clean up graffiti. Reinstall the missing stringer end cap. repack scour protection under the abutment. Minor paint touch-up on the handrail.	Medium	Maintenance

161	Repack rocks around the drain outlet. Plan for the replacement/upgrade of the drain.	Medium	Capital Works Project
162	Path reinforcement & infill planting	Medium	Maintenance
163	Remove grass and revegetate with <i>Juncus</i> and fill in gaps within existing sedges.	Medium	Maintenance
164	Repack rocks especially close to light pole. Revegetate with sedges. The plan for restoration may need to increase the rock crest height to the path level.	High	Capital Works Project
165	Revegetate the upper embankment with <i>M. juncea</i> .	Medium	Maintenance
166	Progressively remove turf and allow sedges to spread. Alternatively, remove altogether and revegetate with <i>M. juncea</i> (more climate resilient).	Medium	Maintenance
167	Repack rock revetment. Revegetate the path with sedges.	Medium	Capital Works Project
168	Old drain. check for function and replace as part of Capex works.	Medium	Capital Works Project

169	Close out the gap in riparian edge by planting large bags of <i>Juncus kraussii</i> . Remove grass from the path and revegetate with <i>M. juncea</i> .	Medium	Maintenance
170	Revegetate with sedges to the path and the beach access.	High	Maintenance

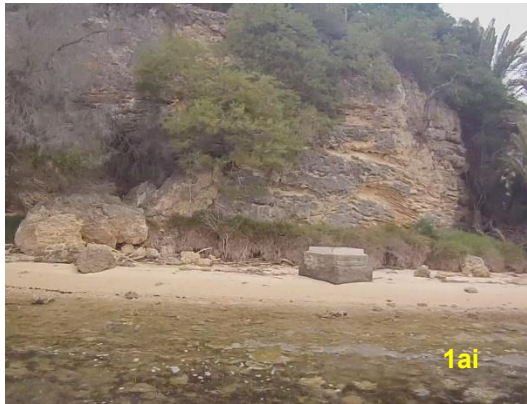
Rocky (a – cliffs, b – rocky emergent (inc. pool/riffles))				
Rating	Condition descriptor	Performance	Photo (with associated code)	Detail
1	(a) Relatively stable	Good Condition

(i) cliffs/steep bank with talus or beach buffer ensuring cliff/steep bank is generally protected from the hydraulic zone in most conditions. No undercutting/incising/cracking/slips.

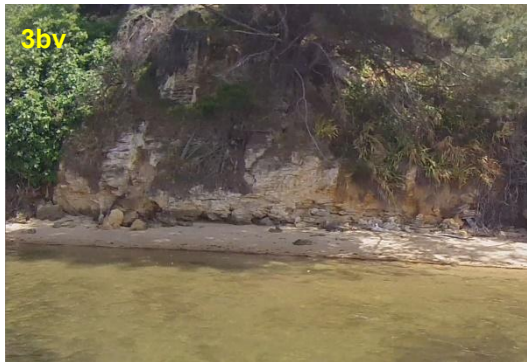
(i) 25-50% length undercutting/incising OR (ii) cracking 5-33% OR (iii) vertical scarps/slips of 0.5 to 1m vertical height.

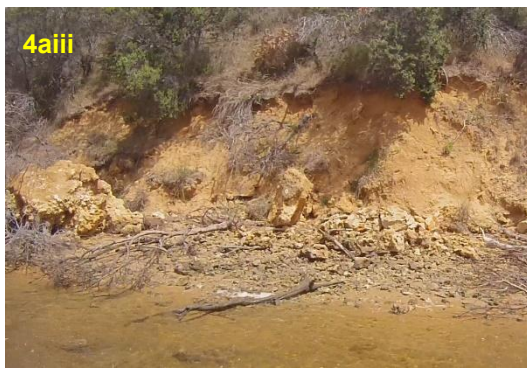
(i) >0.5m horizontal undercutting/incising (>50% length) OR (ii) cracking >33% OR (iii) vertical scarps/slips of 1-2m horizontally/1-2m vertical height

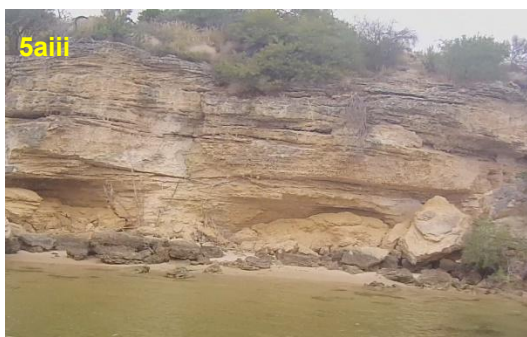
(i) evidence of recent (<5 year?) cliff collapse OR (ii) slip failure on steeply scarped foreshore OR (iii) vertical scarps/slips of >2m horizontally/>2m vertical height.

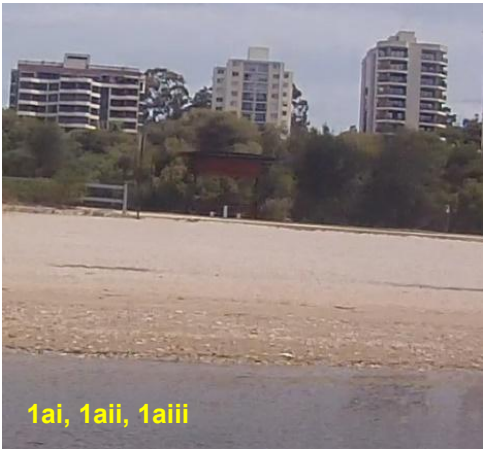
1ai, 1aii, 1aiii	(i) wide beach (>10m), gentle grade (<1V:6H) and <10% alongshore erosion to landward

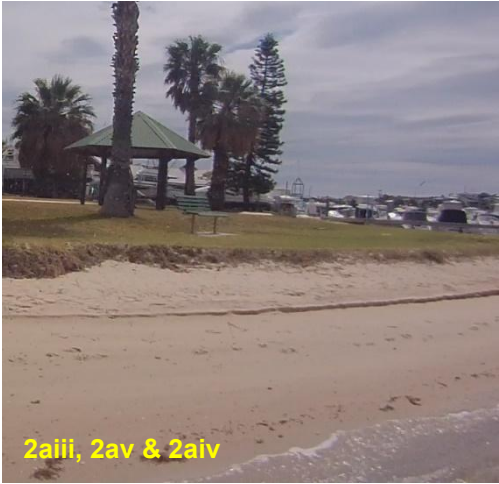
2aiii, 2av & 2aiv	(i) Beach width >4m and <10% erosion (ii) Beach grade >1:6 and <10% alongshore erosion (iii) Beach grade <1:6 and 10-40% alongshore erosion with scarping <0.5m vertically (iv) Some realignment of the beach from 2008-2015 with no gross change (v) Scarps of 0.2-0.5m vertically on bank to landward

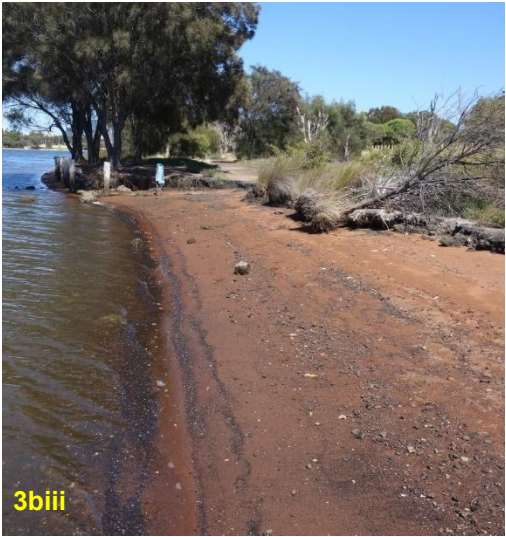
3biii	(i) Beach width <1m and 10-40% erosion (ii) Beach grade >1:6 and 10-40% alongshore erosion with >40% scarping along the backshore (iii) Beach grade <1:6 and 40-70% alongshore erosion (iv) Realignment of the beach from 2008-2015 (gross change 0.5-2m horizontal) (v) Scarps of 0.5-1m vertically on bank to landward

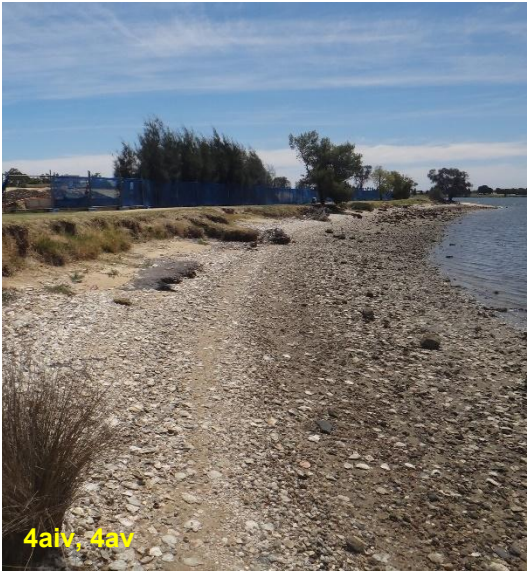
4aiv, 4av	(i) Beach width <1m and 40-70% erosion (ii) Beach grade >1:6 and 40-70% alongshore erosion with >40% scarping along the backshore with scarps >1m height (iii) Beach grade <1:6 and >70% alongshore erosion (iv) Retreat of 2-5m from 2008-2015 or realignment of the beach (gross change >2m horizontal) (v) Scarps of 1-1.5m vertically on bank to landward

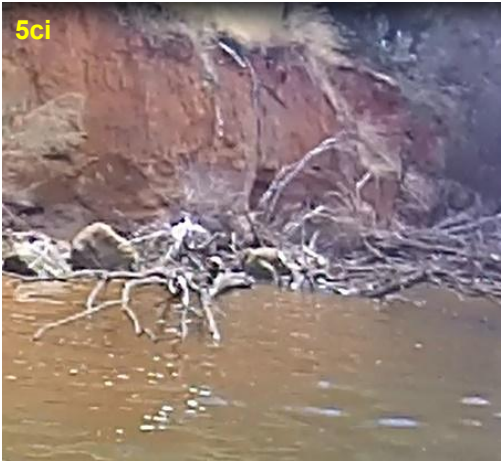
Sedimentary 2 of 2 (c – scarp, d – embankment)				
Rating	Condition descriptor	Performance	Photo (with associated code)	
	(d) Extensive sedimentation, extensive scarps or poor vegetation cover		<div><div>5ci</div>

</div>	(i) vertical scarps on banks of main river channel for >70% of alongshore length (ii) extensive sedimentation, with anastomosing channel (iii) bare sediment for >90% of alongshore length (<10% vegetation)

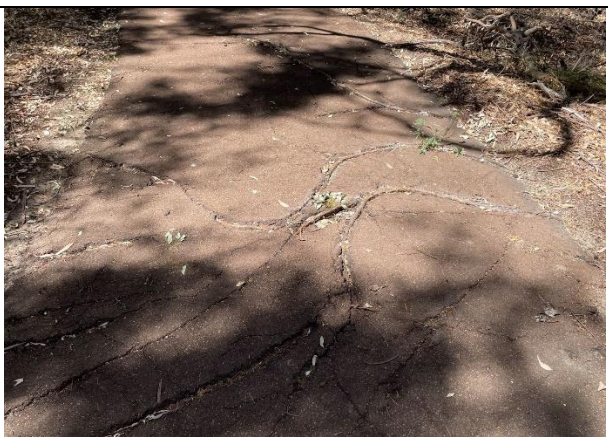
<p>Tree roots are still present and growing through the bitumen path. Path needs repair.</p>

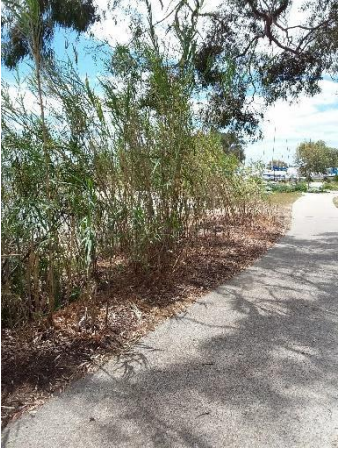
Item Number	General Recommendations (2014)	Comments (2019)	Comments (2025)
<b>PHWB2</b>	Weed control of Giant Reed infestations east of Point Heathcote	Weed control has not been undertaken. <i>*Arundo donax</i> (Giant Reed) still dominates the area

Giant reed was removed (mechanically) and sprayed. There is an ongoing management for regrowth.
<b>PHWB3</b>	Connect vegetation along The Strand and Jeff Joseph Reserve through revegetation	Does not appear to have taken place. Replacement of asset has been undertaken	Additional planting was conducted near Sea scout club, however the area is largely impacted by turf grasses such as Couch.
<b>PHWB4</b>	Maintain weed control within the areas of vegetation in good condition in Jeff Joseph Reserve	Some control work is apparent; however ongoing work is required.	Weed control is ongoing. Some improvements achieved, however further control of turf grasses particularly Couch, mature Canary palm and poplar trees is required.
