# City of Melville

## FORESHORE MANAGEMENT PLAN

October 2025  
For City of Melville

<b>Report</b>		<b>25001.RPT001</b>		
Version	Date	Prepared by	Review/Approval	Issue Details
1	16.10.25	RT, ME, KT	JS, DW	Draft 1 for comment
2	15.07.2025	RT, ME	JS, DW	Draft 2 for review
3	16.10.2025	RT	JS	Final Document Issue

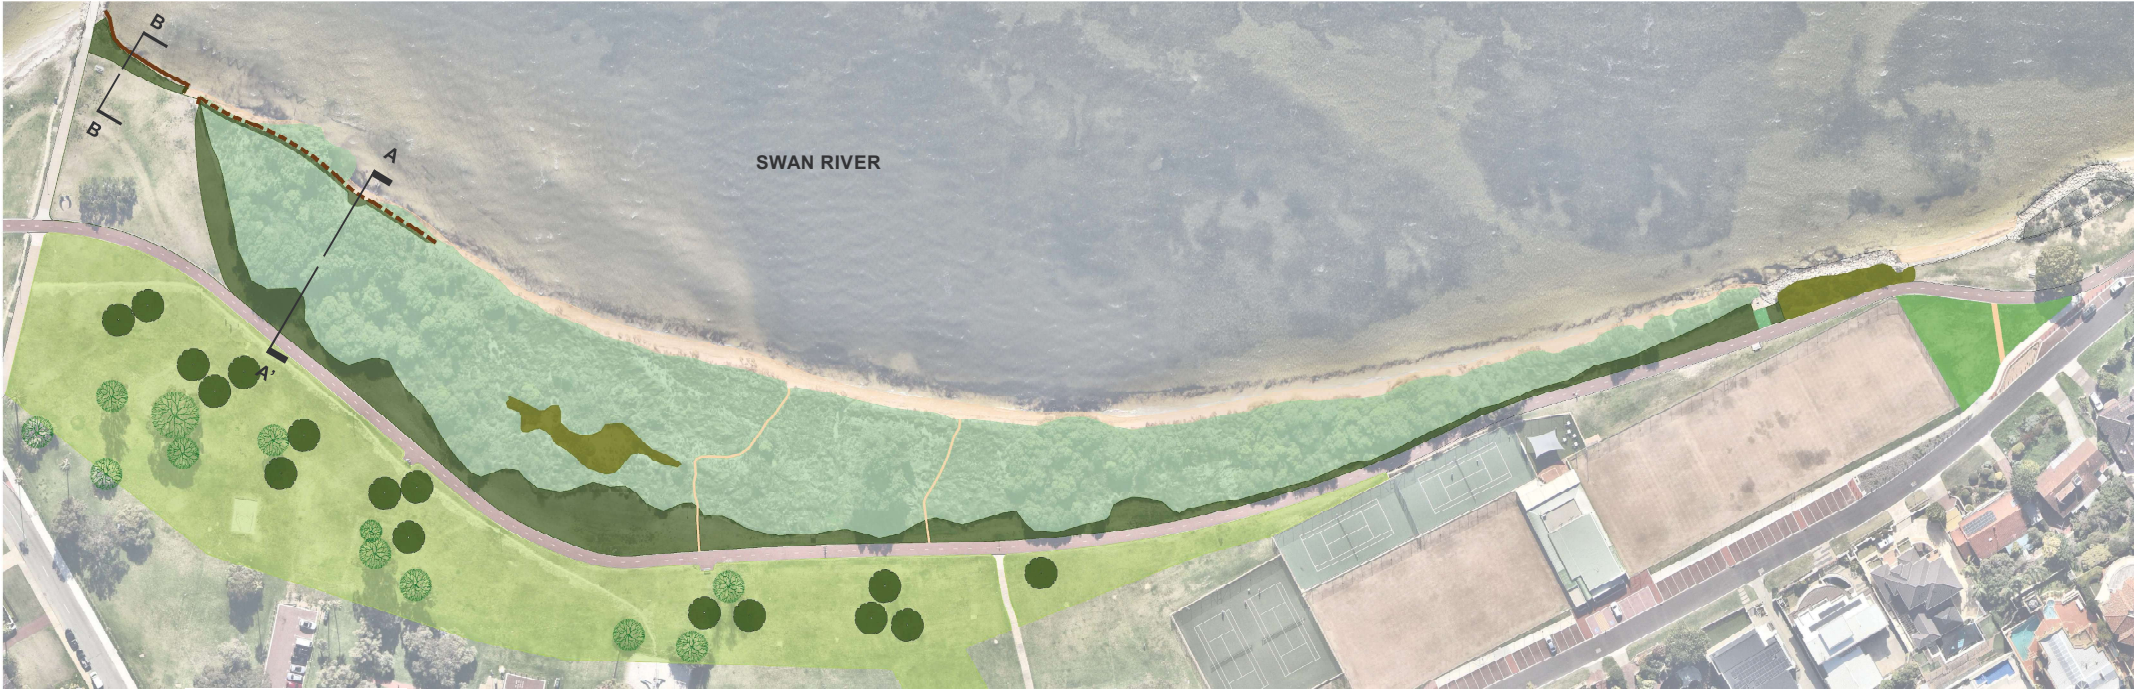
JEFF JOSEPH RESERVE - CONCEPT PLAN

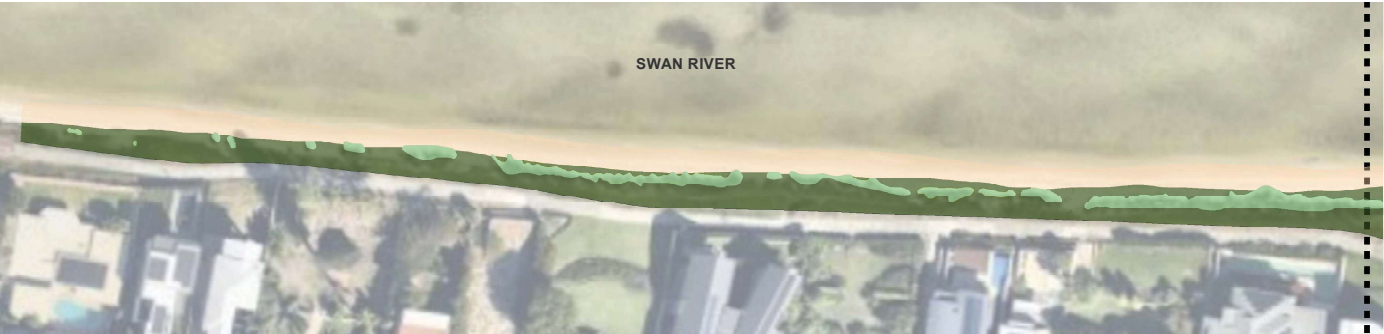
CONCEPT PLAN - SOUTH

MAJESTIC COVE - CONCEPT PLAN

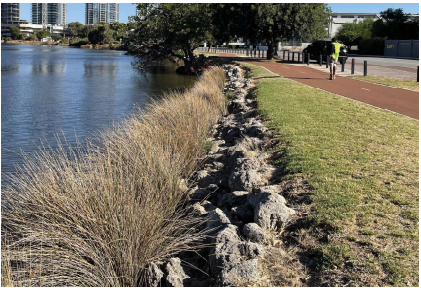
EXISTING CONDITION A-A

EXISTING CONDITION A-A'

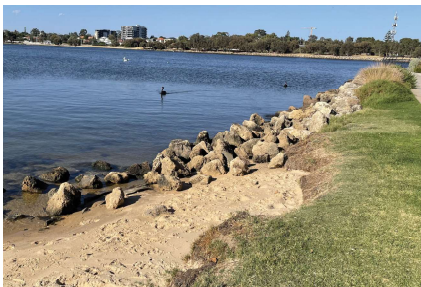
EXISTING CONDITION B-B

EXISTING CONDITION B-B'

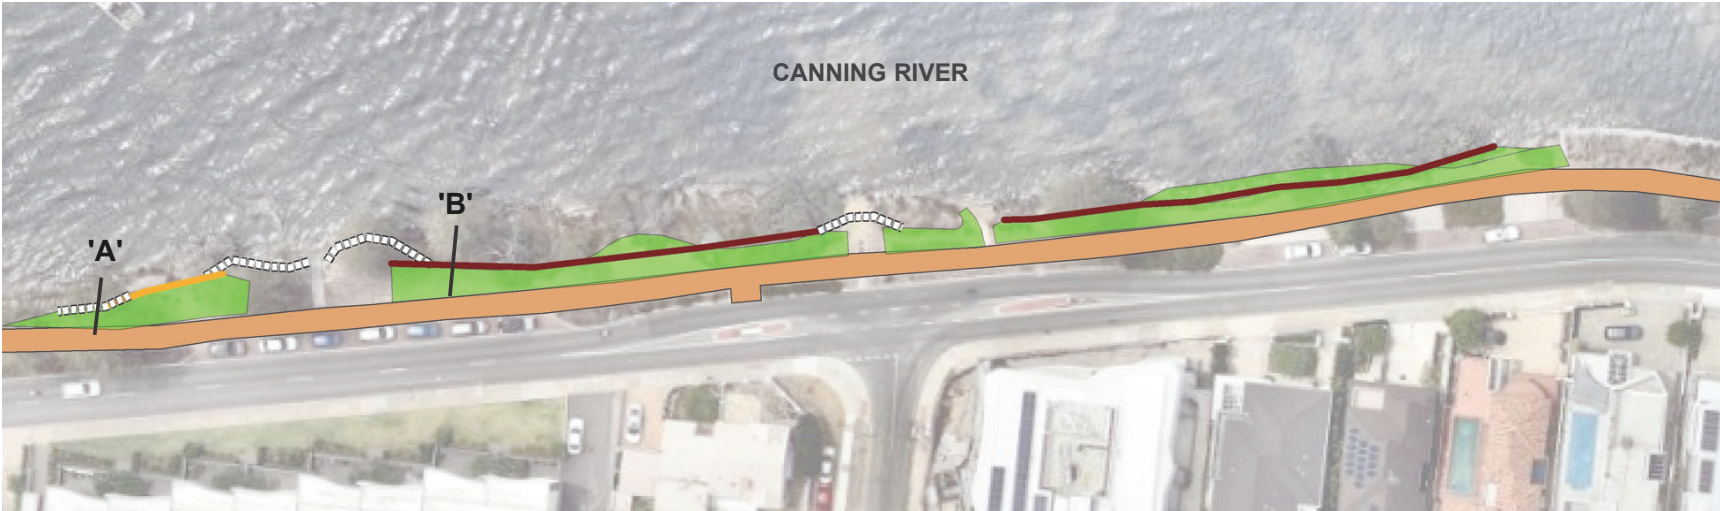
THE ESPLANADE - CONCEPT PLAN - SITE A

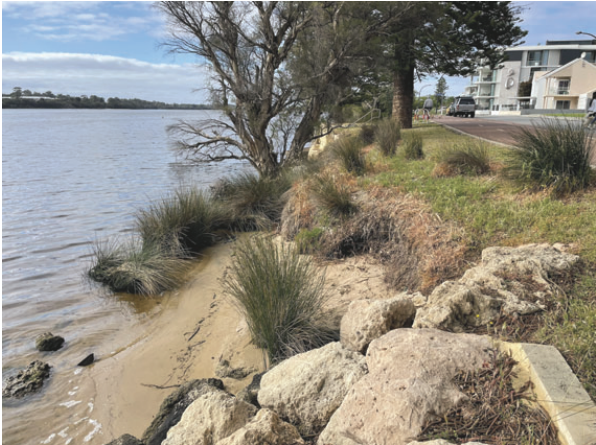
BRUSHWALL WITH ROCK TOE - SECTION 'A'

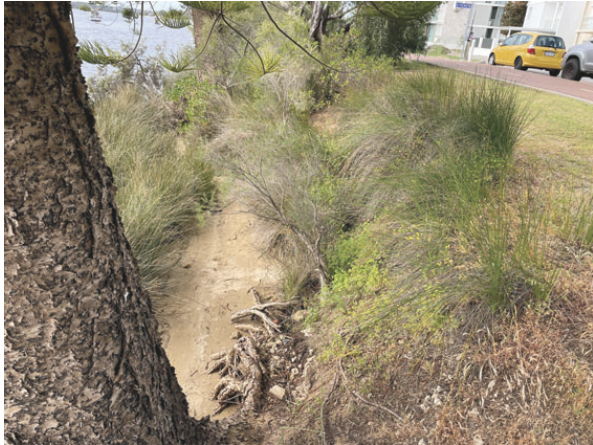
BRUSHWALL WITH DENSE SEDGE PLANTING - SECTION 'B'

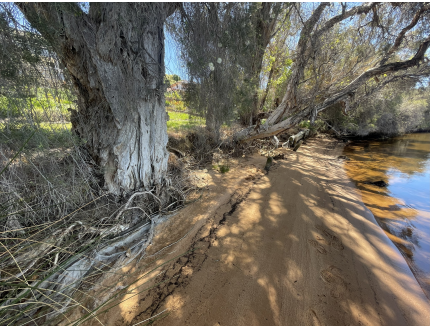
EXISTING CONDITION - SITE C

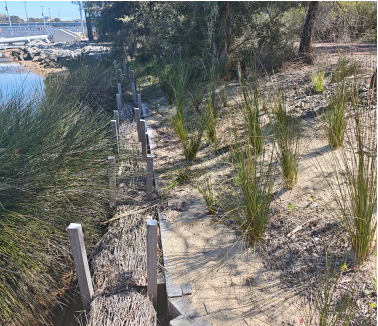
EXAMPLE OF RETAINING TIMBER WALL WITH BRUSHWALL WAVE DEFLECTOR
