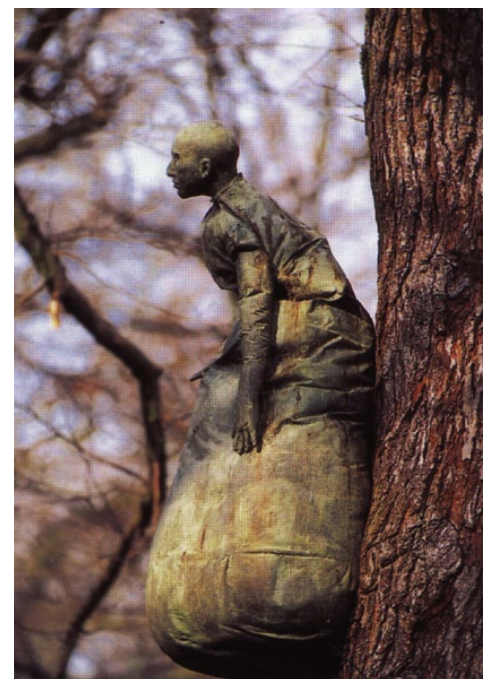
Environmental sculpture integrated with trees

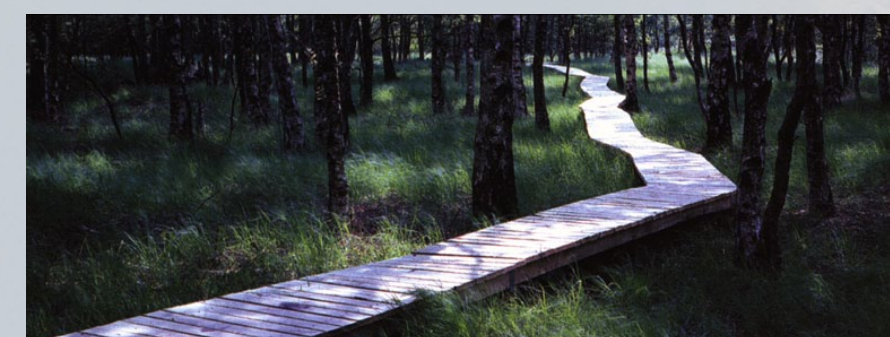
Boardwalk traverses wetland zone

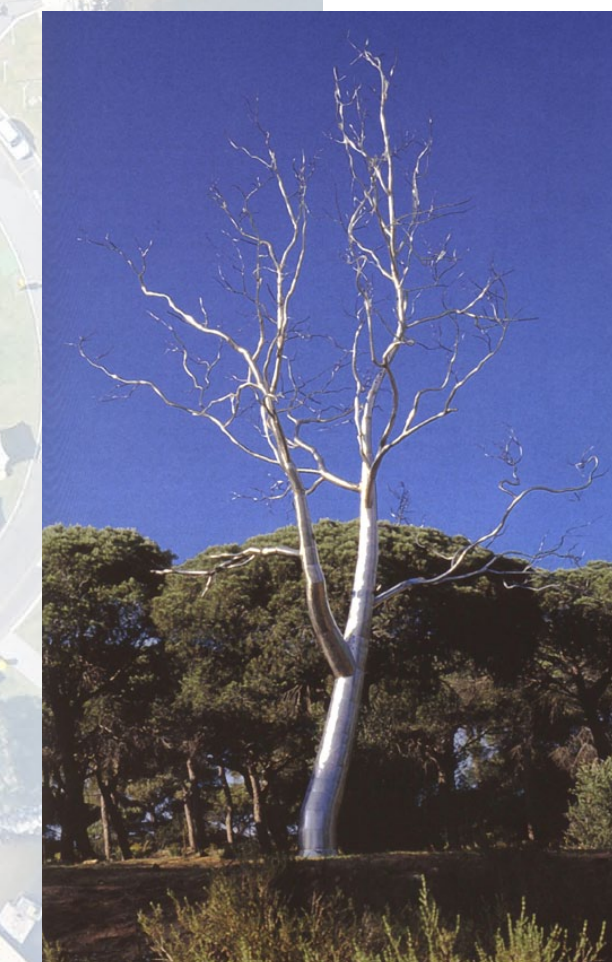
Natural landscape interpreted in sculpture

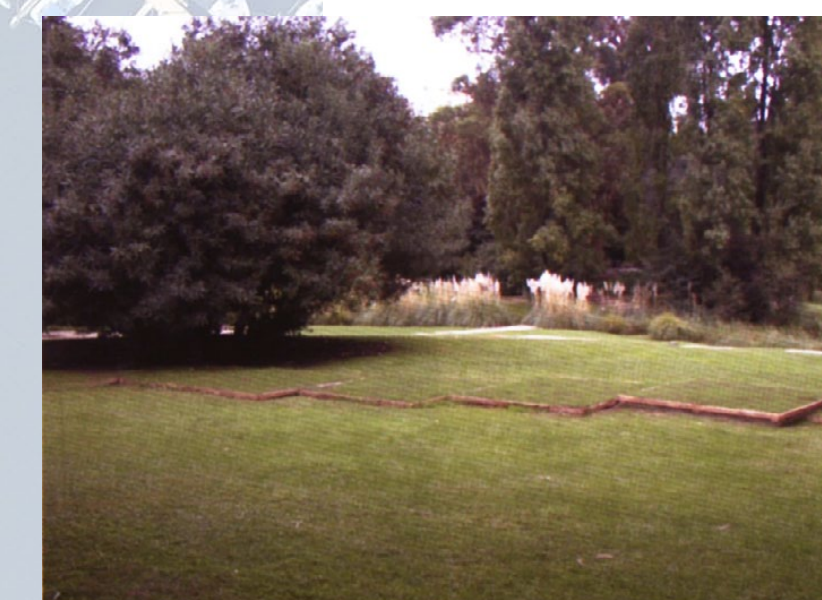
Artwork expressed as building foundation and earth form

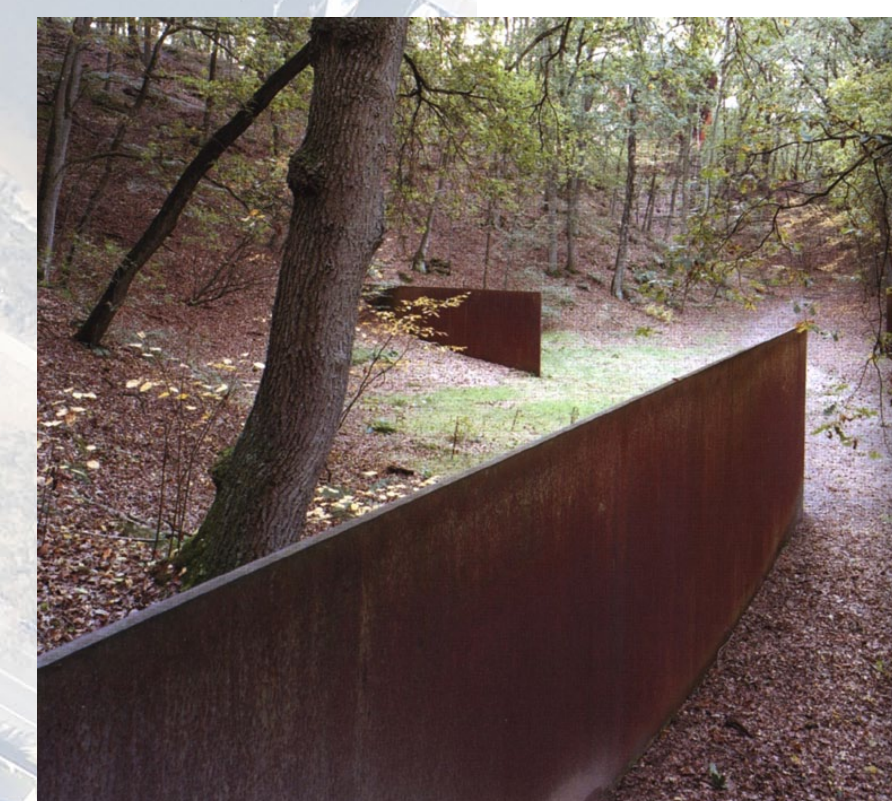
Use of corten steel in structures or sculpture
